INTERIM FINAL DRAFT REPORT  
ON  
EMBANKMENT FAILURE  
FLORIDA POWER & LIGHT COMPANY  
MARTIN PLANT COOLING RESERVOIR

April 1980

South Florida Water Management District  
West Palm Beach, Florida

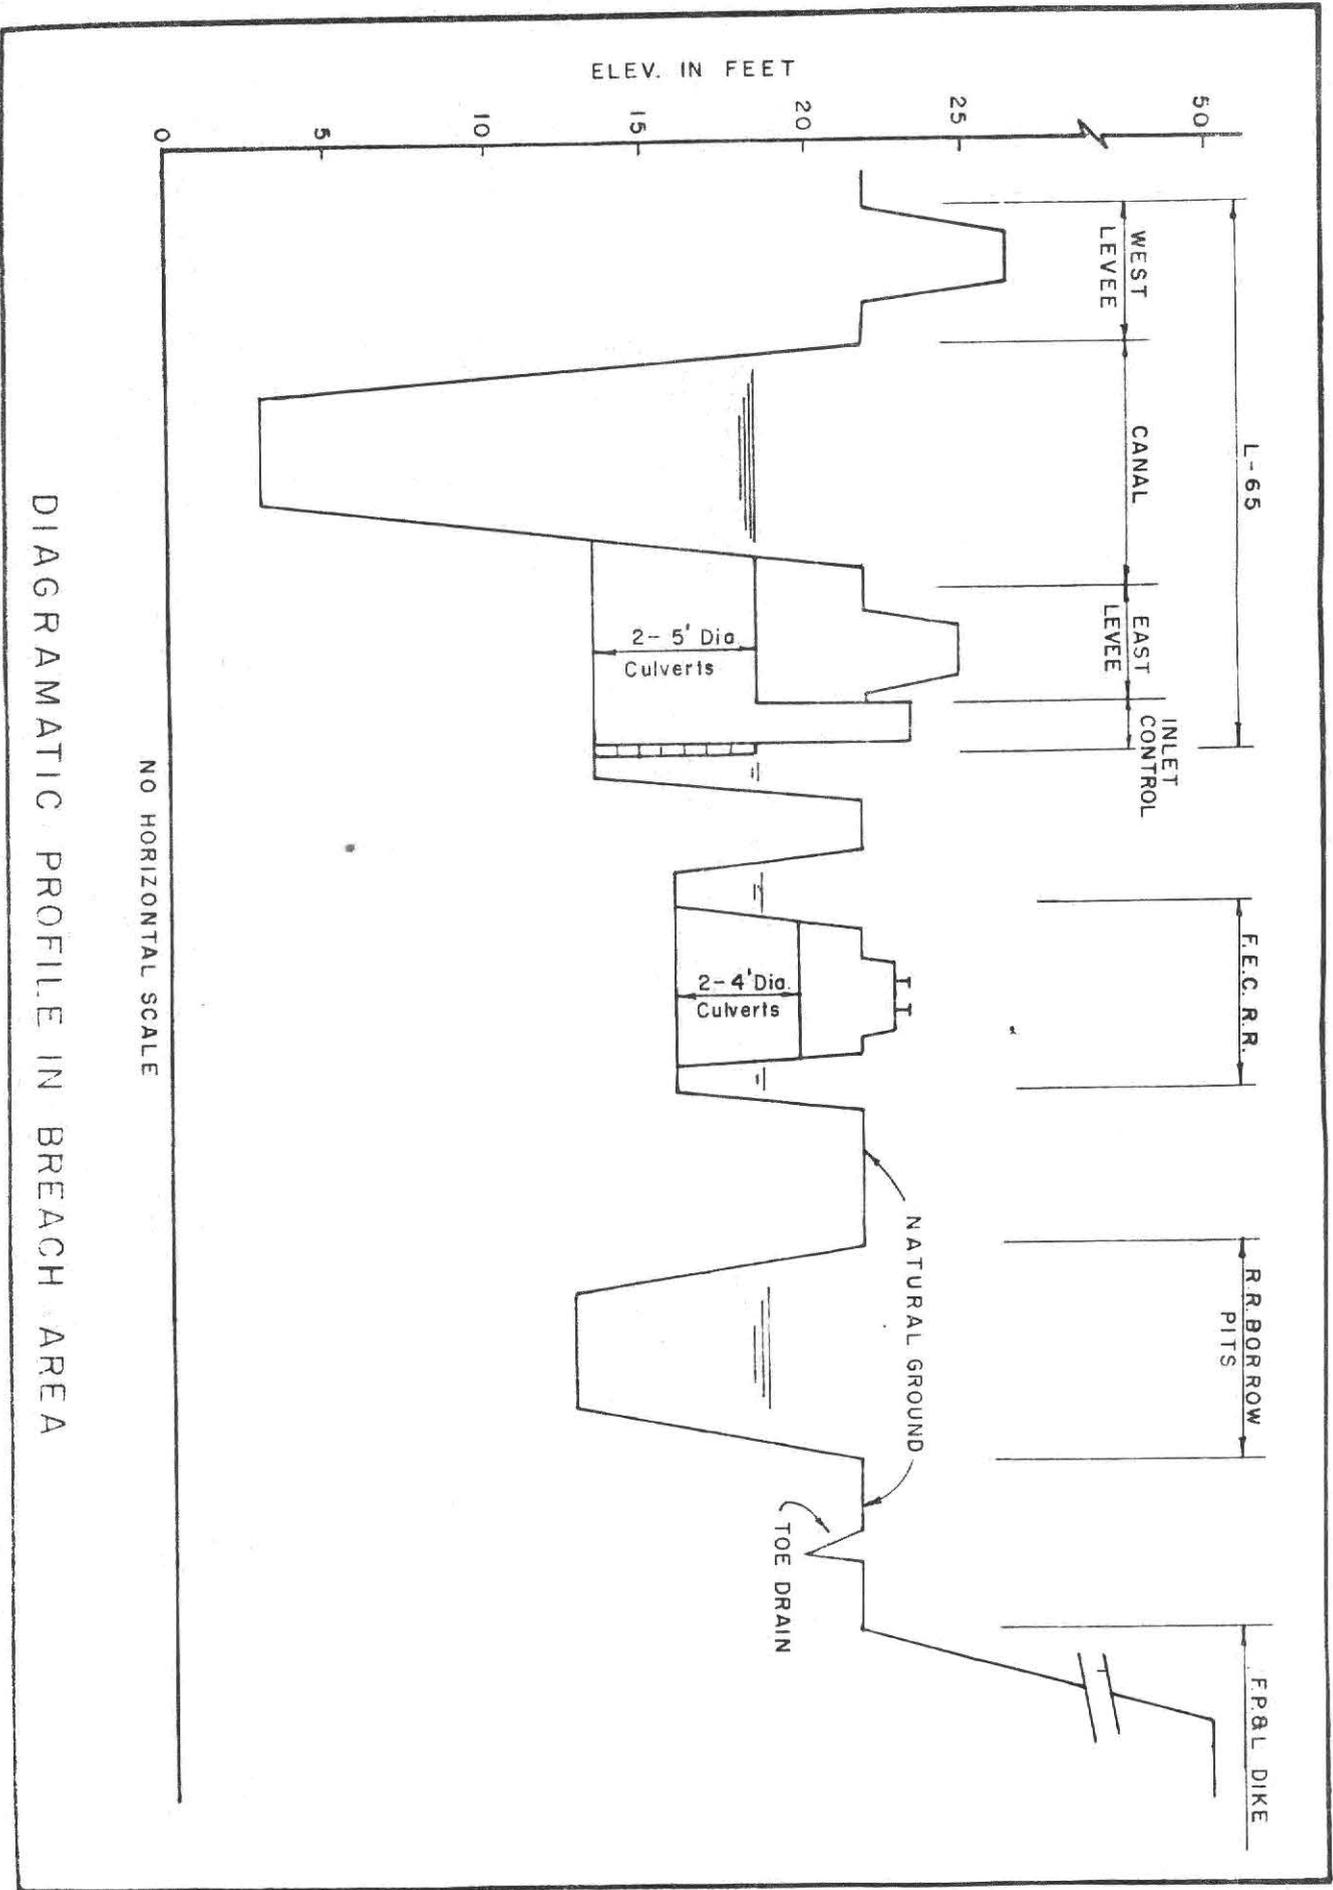
Figure 1-3

DIAGRAMATIC PROFILE IN BREACH AREA

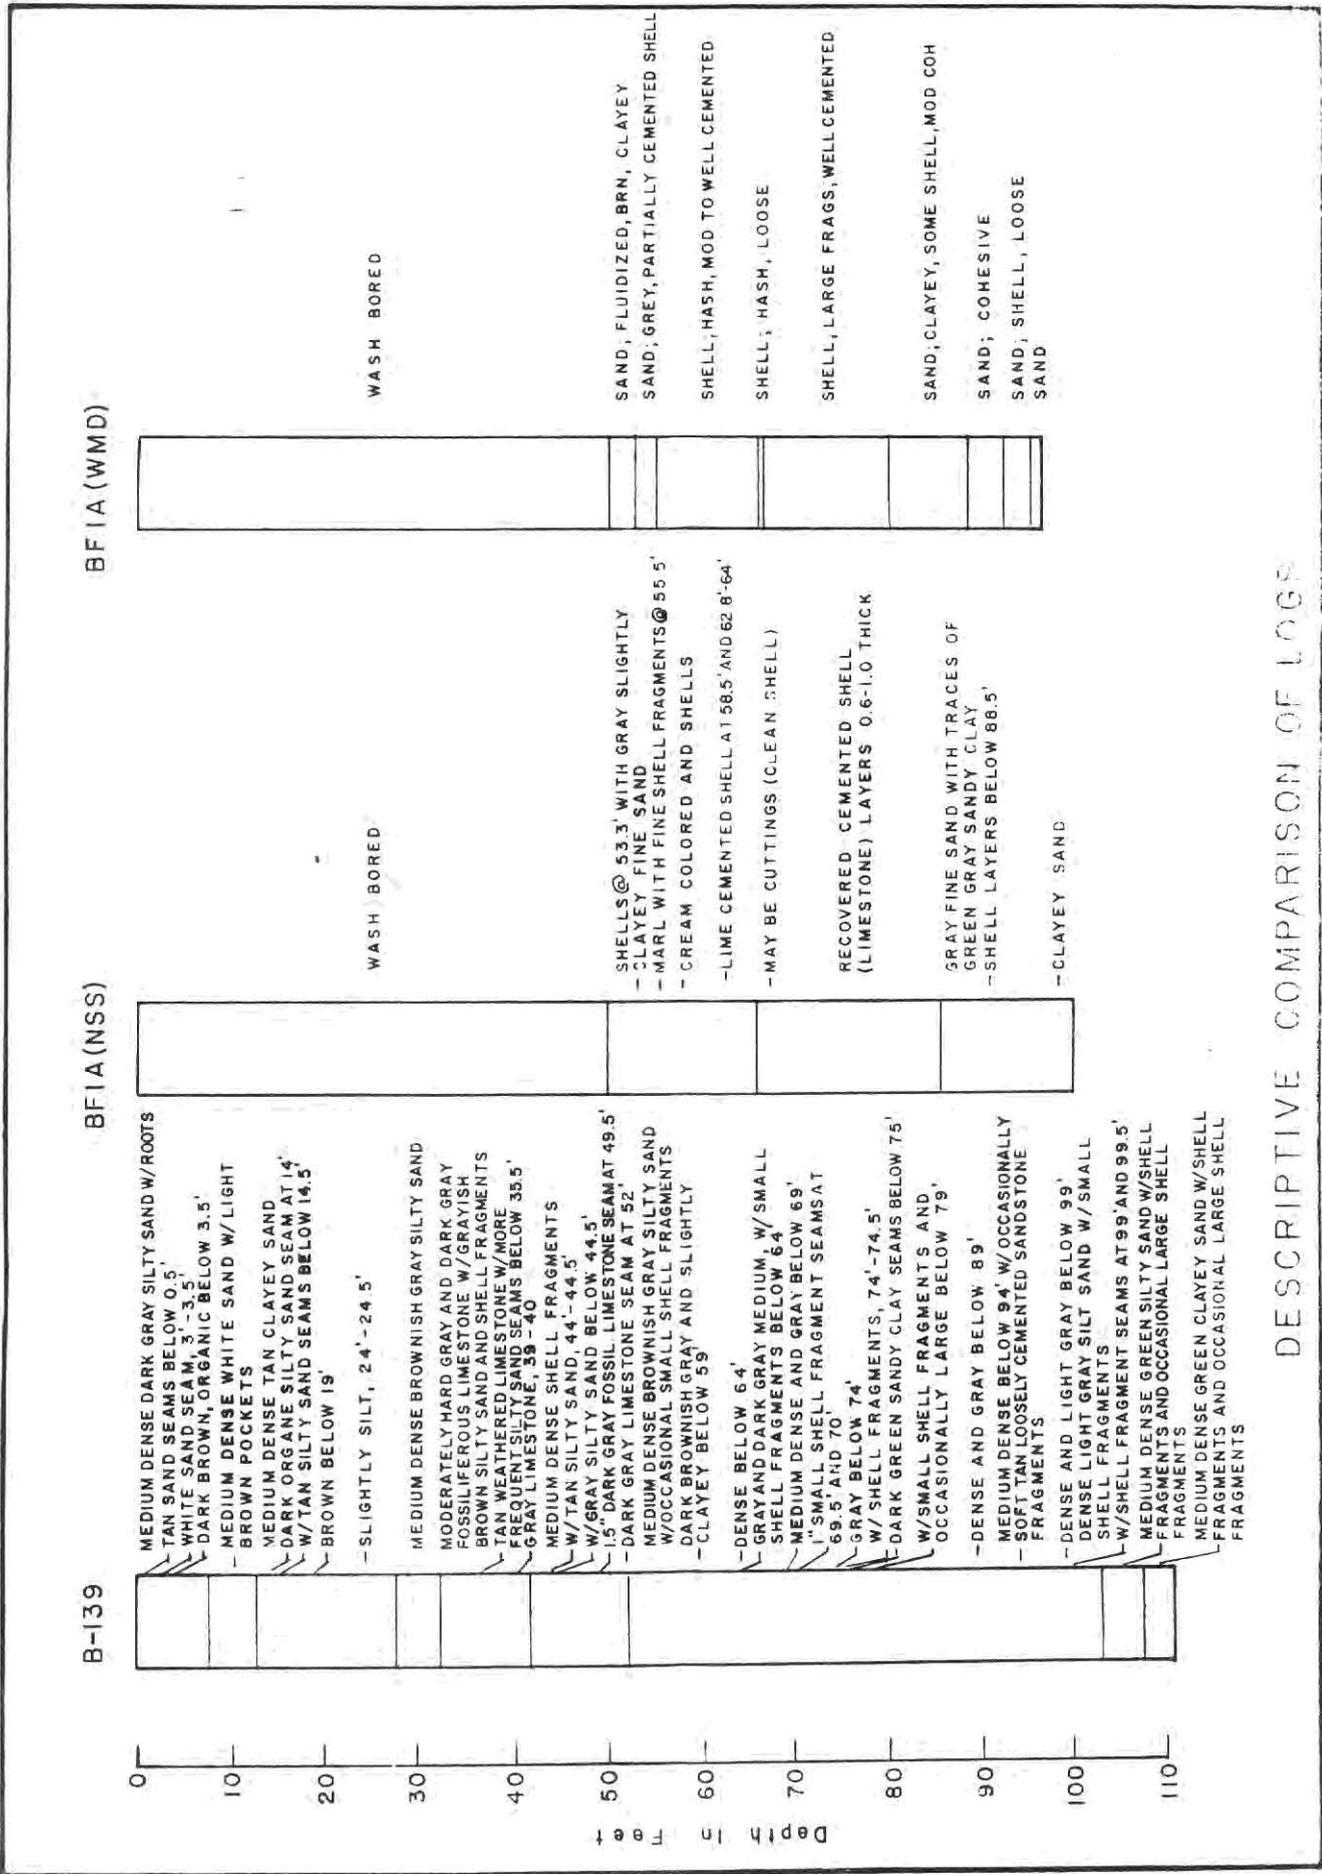
Figure 5-3

DESCRIPTIVE COMPARISON OF LOGS

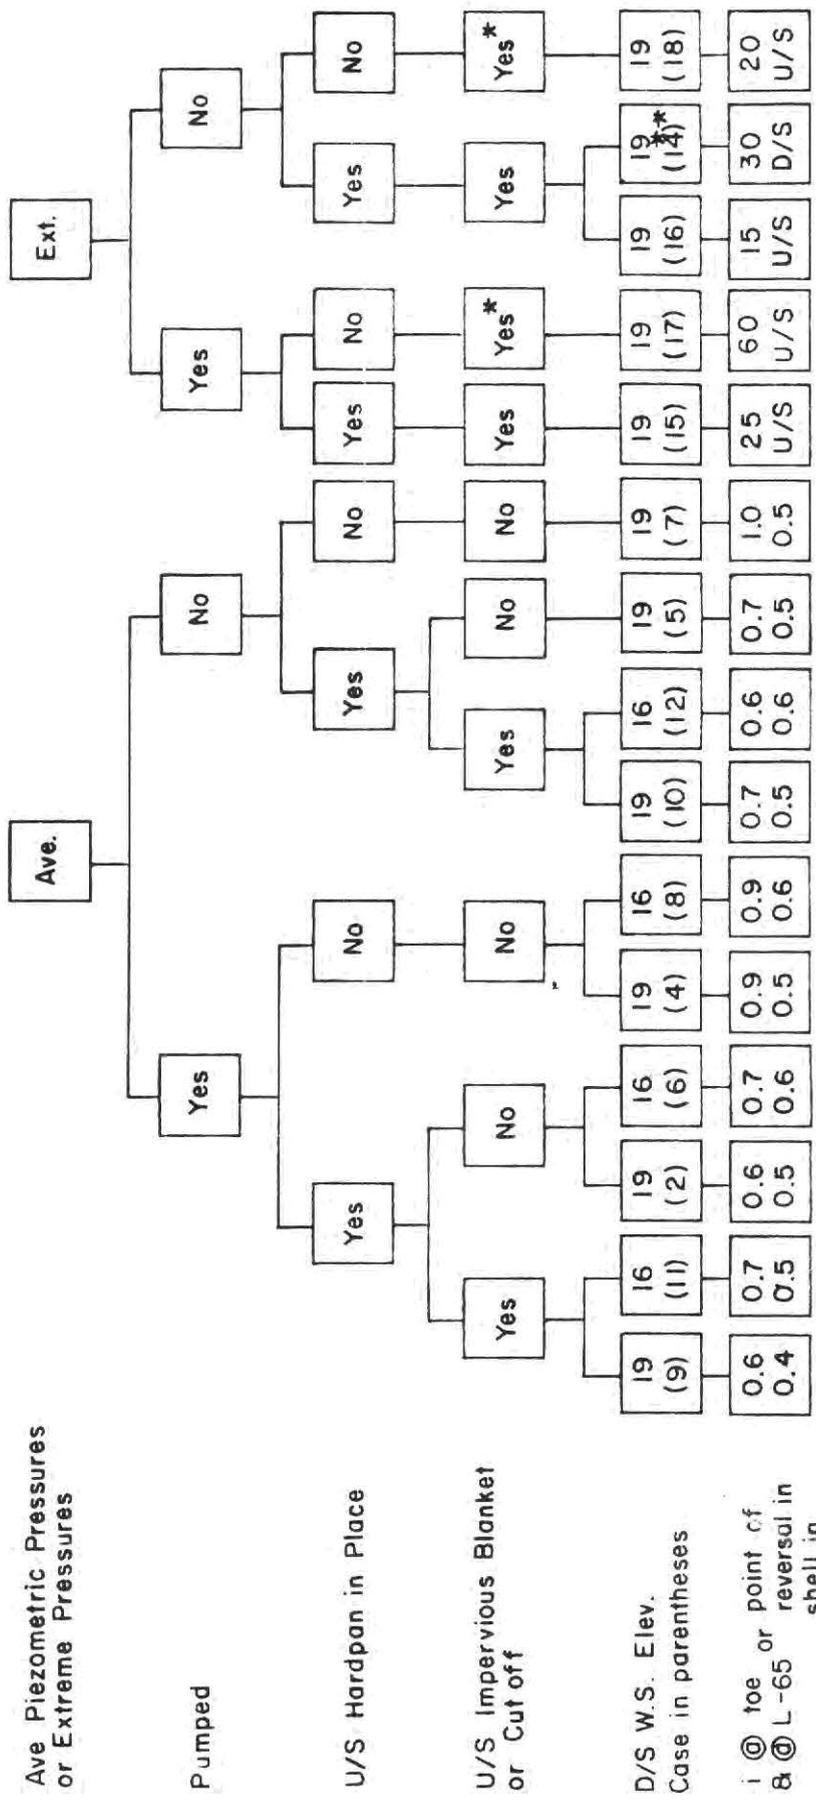
Figure 5-13

# POST FAILURE FLOW NET ANALYSES WITH REMEDIAL WORK IN PLACE

\* U/S BLANKET 65' LONG, OTHER BLANKETS 250' LONG.  
 \*\* CASE 14 IS THE ONLY CASE WITH NO D/S DRAIN.

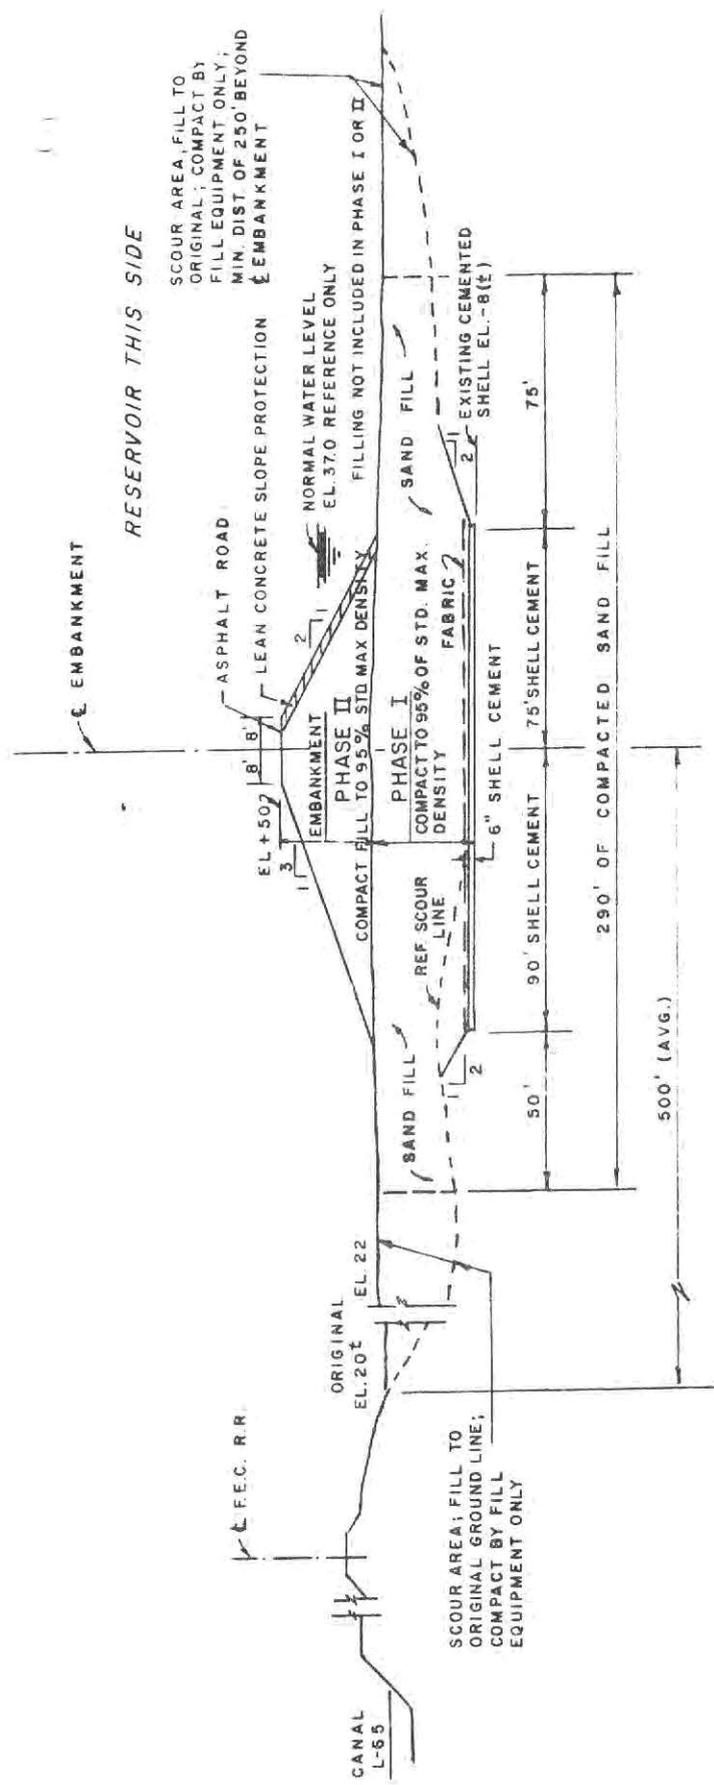
**PHASE I AND PHASE II REPAIRS**

FP&L proposed to replace the foundation and embankment in the

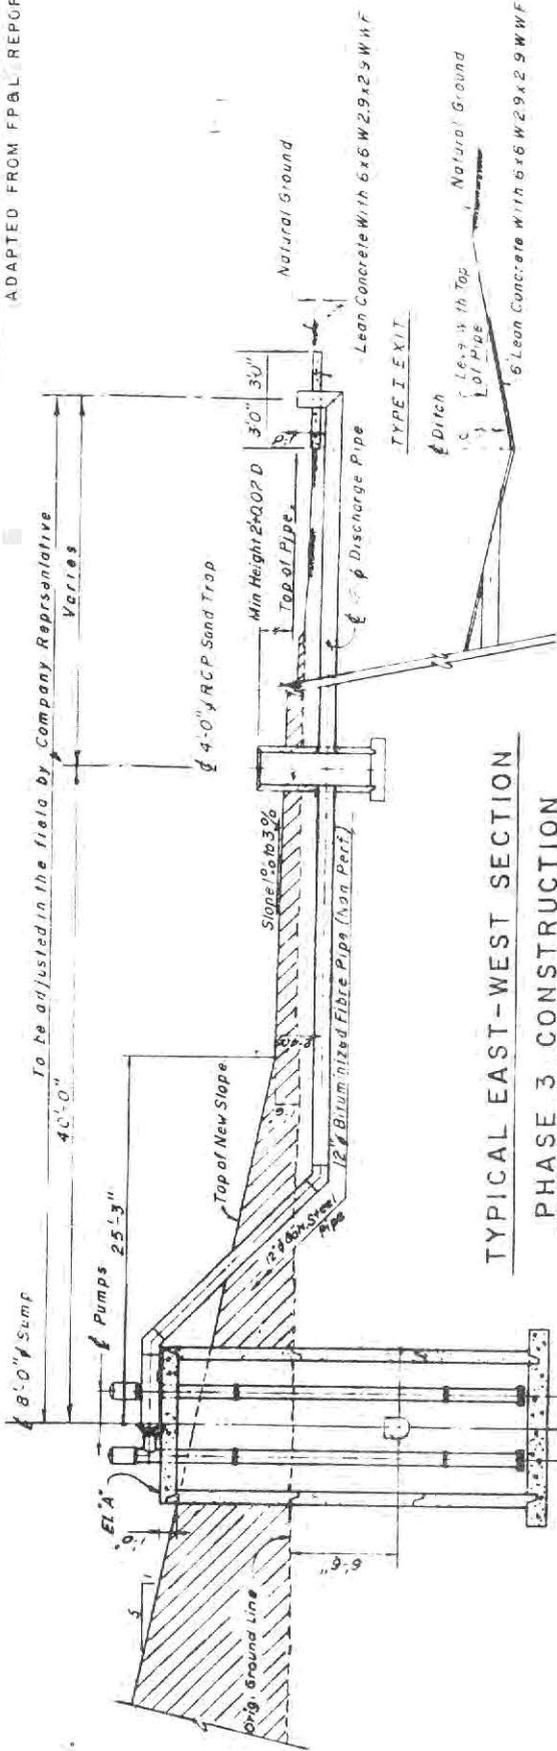
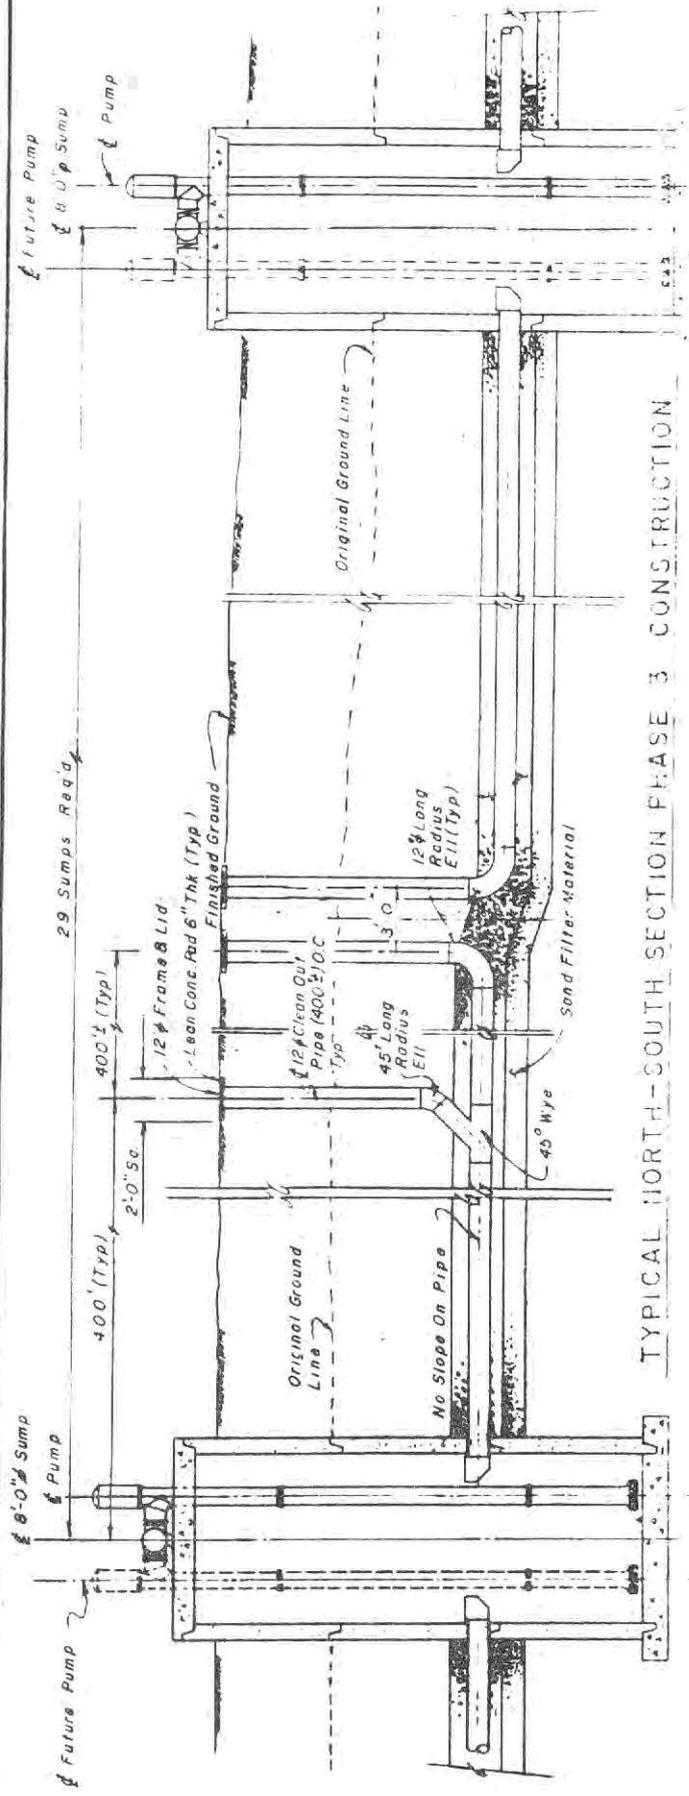
TYPICAL EAST-WEST SECTION  
PHASE 3 CONSTRUCTION

TYPICAL NORTH-SOUTH SECTION PHASE 3 CONSTRUCTION

vertical cracks and further, of repairing and resealing all horizontal separations between layers of soil cement that occurred as a consequence of the rapid drawdown brought on by the embankment failure. A disagreement exists between District and FP&L as to the efficacy and the necessity for the sealing of the vertical shrinkage cracks. The District position is that the sealing will not be permanent and also that it is not necessary.
