PRELIMINARY REPORT ON
RAINSTORM OF APRIL 23-26, 1982

Steve Lin

Water Resources Division
Resource Planning Department

May 6, 1982

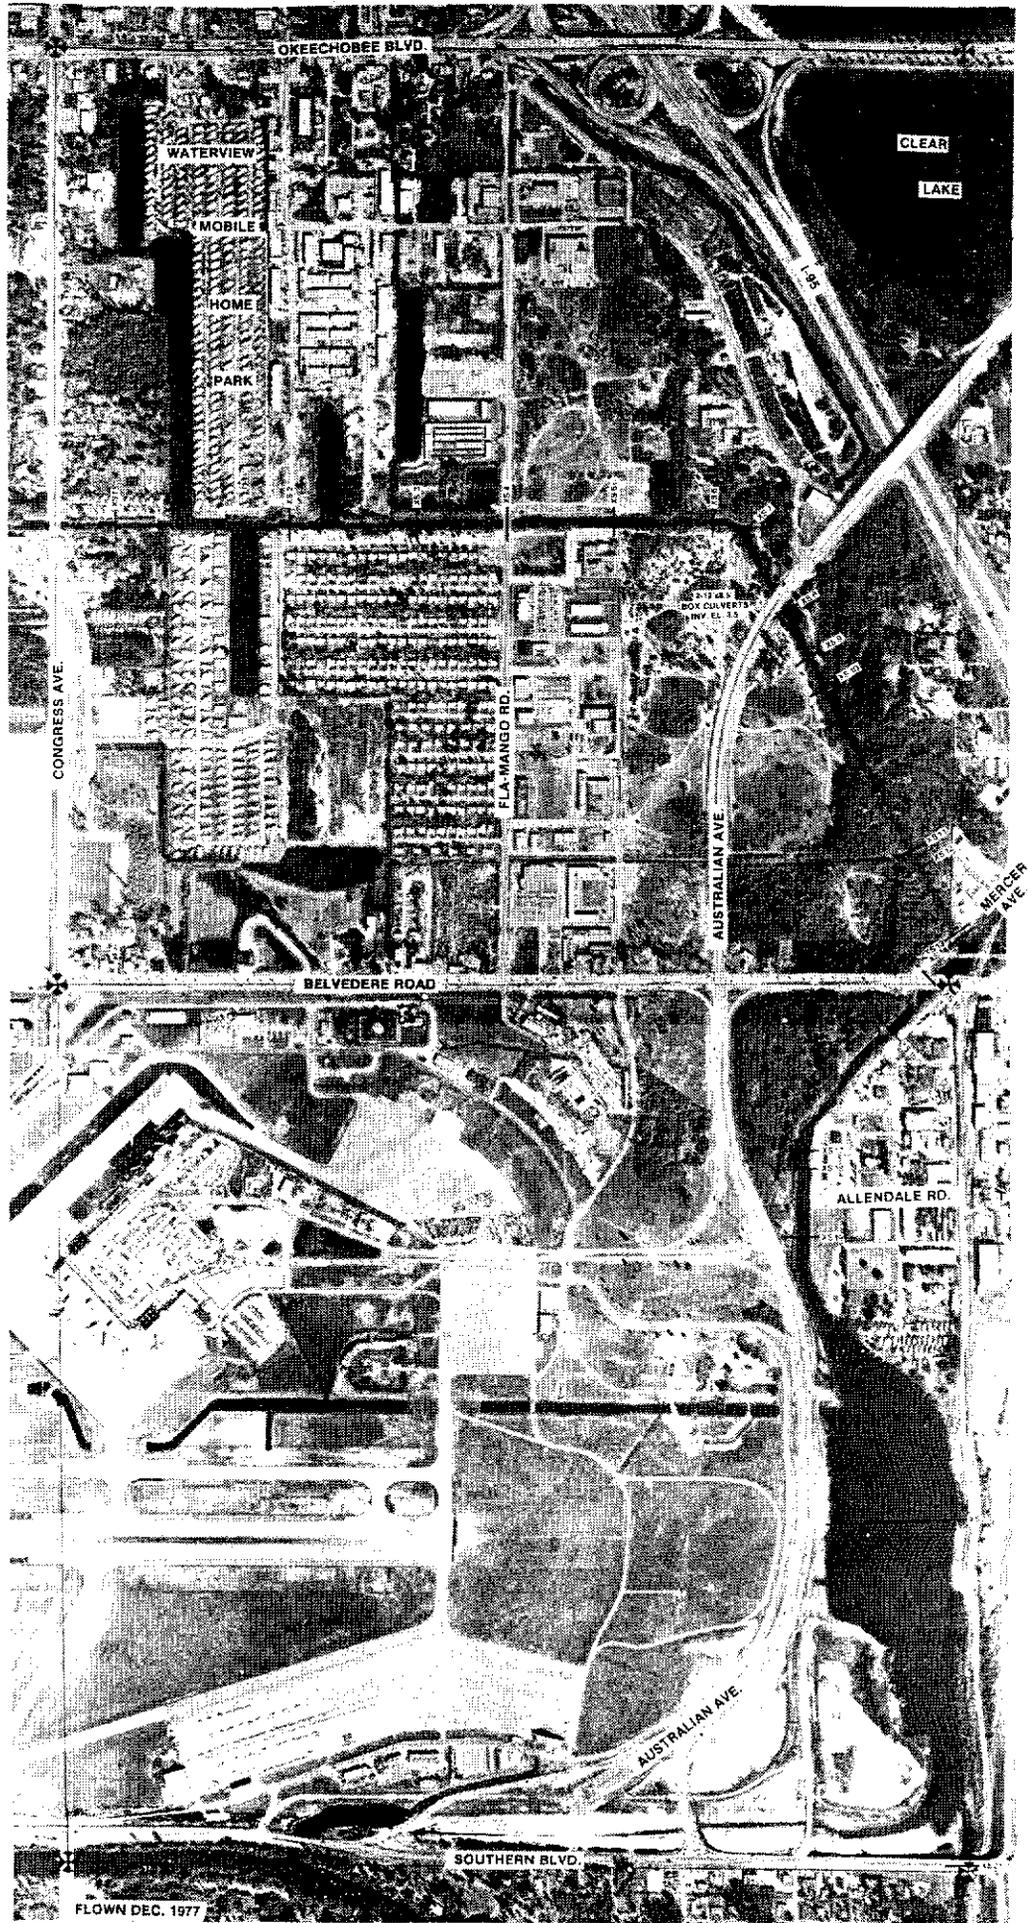
The following high water marks (refer to Figure 3A for locations) were surveyed on April 29, 1982 as compared to the high water marks for the March 28-29, 1982 and September 17-18, 1960 rainstorms.

It should be noted that the high water mark at the Australian Avenue Bridge crossing the stub canal was 0.4 feet higher than at Waterview Mobile Home Park during this rainstorm. This has been checked twice to be sure that the water level did approximate this elevation at Australian Avenue. The possible explanation for this is that water must have spilled over the spillway from Clear Lake into the stub canal downstream of Australian Avenue during this rainstorm, together with discharge from the Palm Beach Lakes south area. This amount of water may have caused a momentary backwater to this site long enough to leave a high water mark.

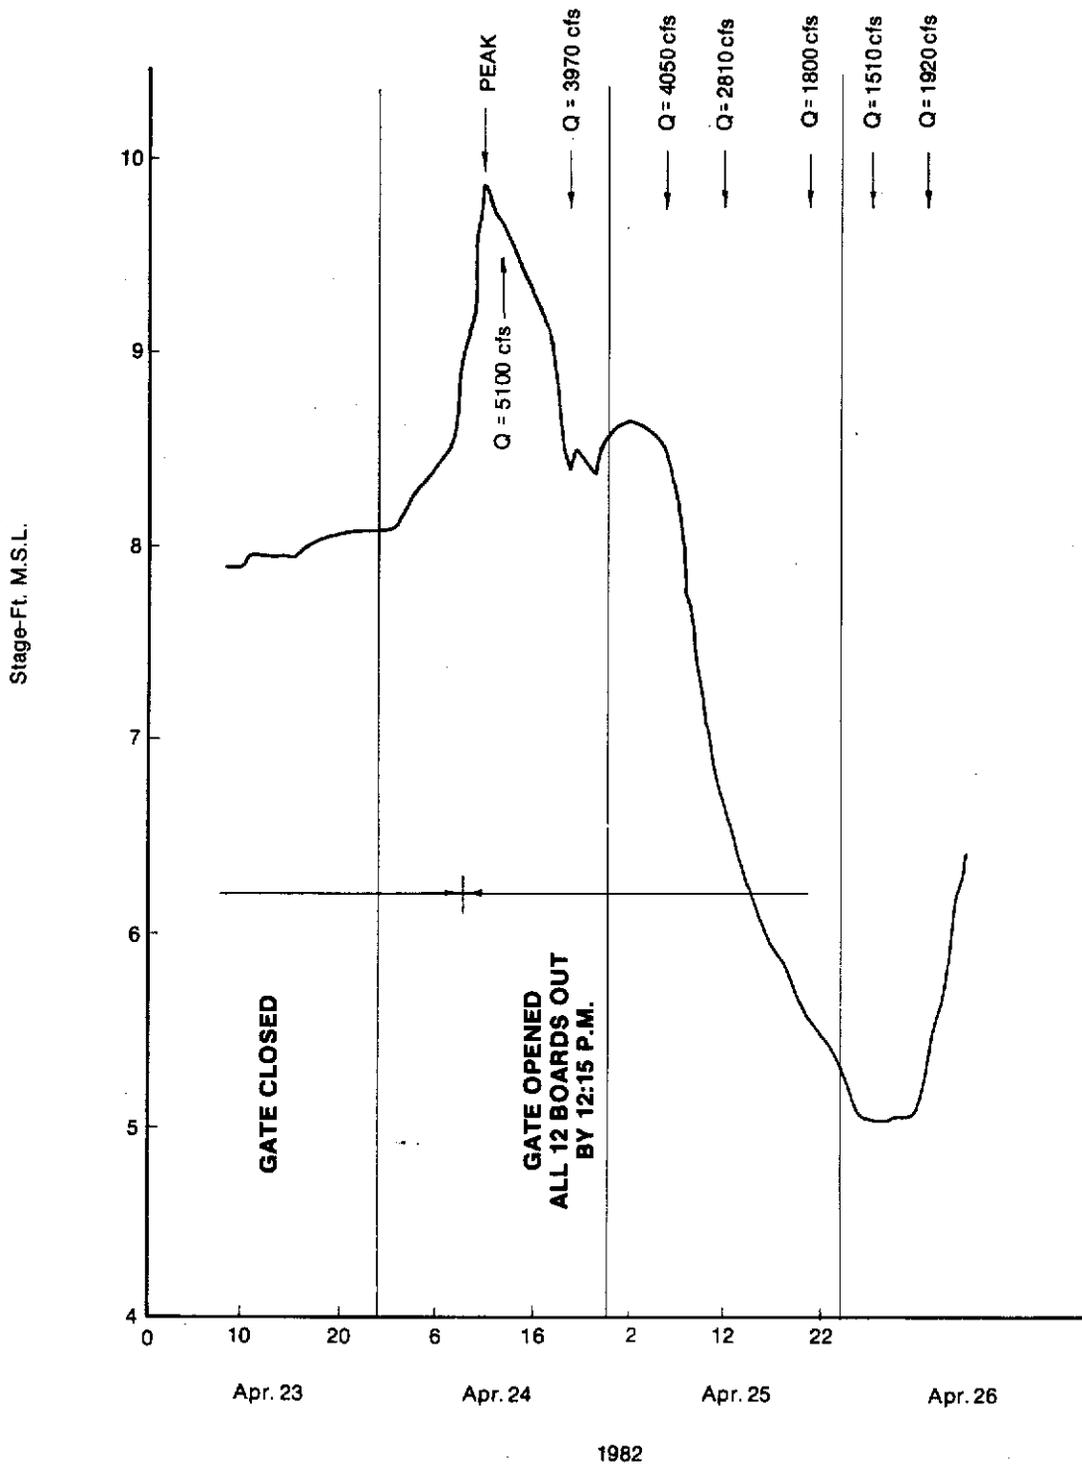
Figure 4 HOURLY STAGE HYDROGRAPH AT PALM BEACH LOCK DURING RAINSTORM OF APRIL 23-26, 1982

1. Palm Beach Lock - Figure 4 shows the hourly stage hydrograph during this rainstorm. The gate on the lock was closed until 9 AM April 24, 1982 and opened on automatic at 9:15 AM. The headwater stage was at 8.98 ft msl. At the same time, the service crew was on the way to pull the boards. The crew started pulling boards at ±11 AM and finished at ±12:15 PM. At 12:15 PM the structure was full open, all boards out, and the stage at the lock reached its peak (9.88 ft msl). The peak discharge at the lock was at 5100 cfs with an average flow, during April 24, 1982, at 4200 cfs. The peak stage was about 0.80 feet less than last month's rainstorm. The peak stage in the West Palm Beach Canal at the District's Field Station was 10.58 ft msl (at ±12 noon April 24, 1982). The high water mark at the Summit Boulevard crossing of the West Palm Beach Canal was 10.23 ft msl. In other words, due to the operation of the system and the rainfall from this event, stages in the system were about one foot below the high water mark during the March 28-29, 1982 rainstorm. The boards in the lock were pulled out more quickly than during the March storm, which took over five hours of effort during the night of March 28-29, 1982.

The boards in Palm Beach Lock were pulled out at 12:15 PM April 24, 1982. A peak stage of 9.88 ft msl at the lock was reached at 12 noon. This peak was the second highest stage since 1960 and also the second highest stage in this dry season. The return frequency of this stage is about one in 11 to 12 years. The peak stage at Summit Boulevard and the District's Field Station are 10.23 ft msl and 10.58 ft msl, respectively. These readings are about one foot lower than last month's readings (March 28-29, 1982 storm).

The events of March and April have vividly demonstrated the inadequacy of this antiquated structure, which is not responsive to the needs of an urban watershed. The replacement structure, S-155, is under contract by the Corps of Engineers.

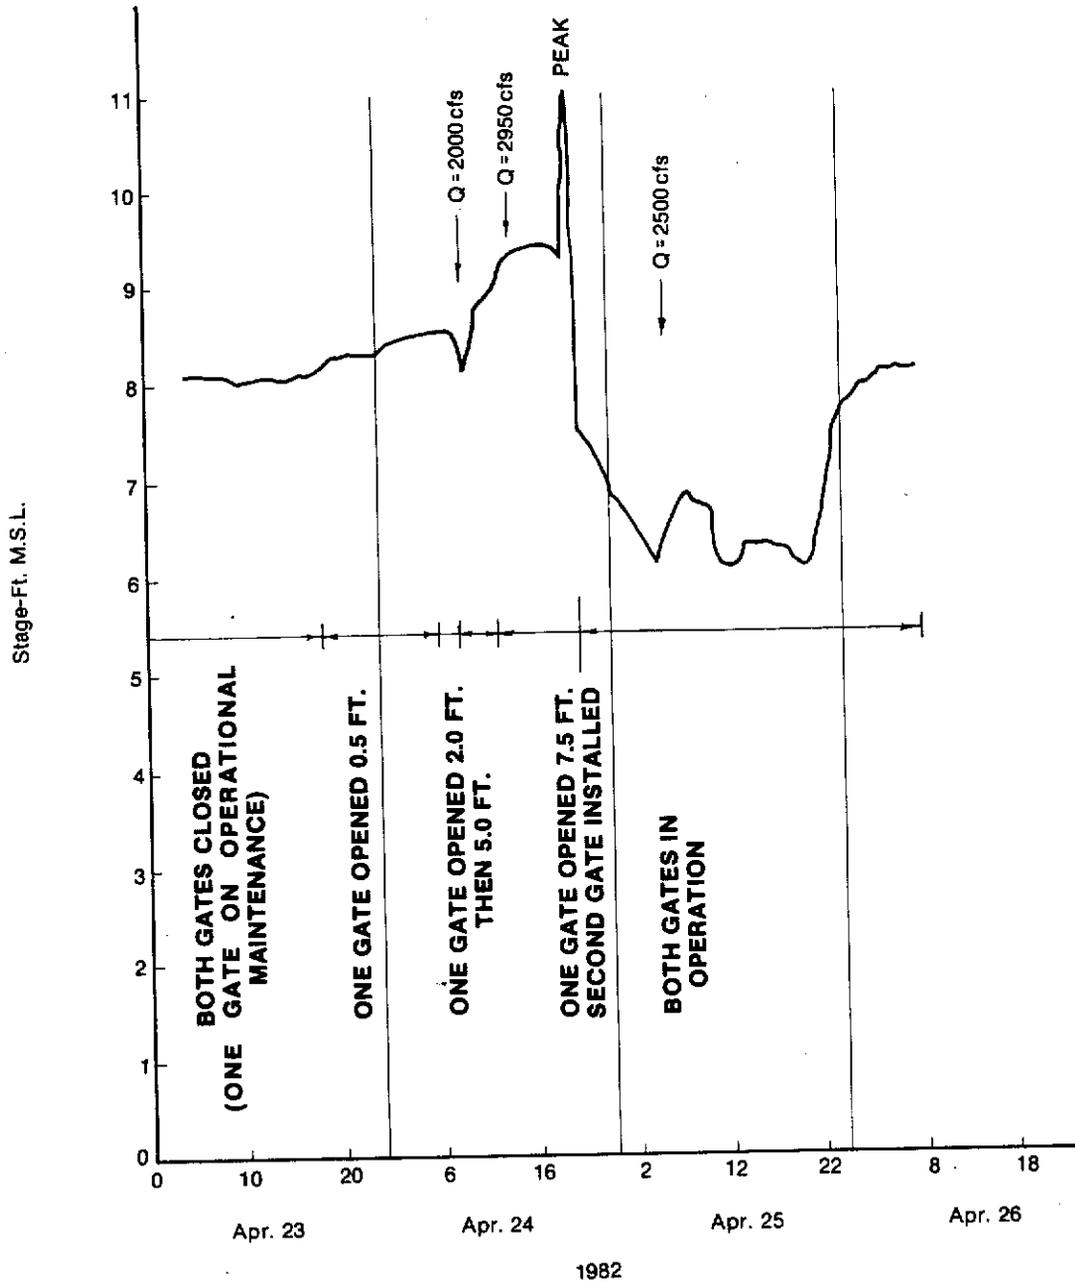
Figure 5 HOURLY STAGE HYDROGRAPH AT S-41 HEADWATER DURING RAINSTORM OF APRIL 23-26, 1982

Figure 5 shows the hourly stage hydrograph at S-41 headwater during this rainstorm. As briefly mentioned previously, one of the main gates on this structure was undergoing maintenance. Therefore only one gate was in operation until 8 PM April 24, 1982, when the second gate was put back in service. The stage reached a short term peak of 10.94 ft msl at 8 PM April 24, 1982. Reinstallation of the gate was prompted by a forecast of 80% chance of rainfall. The stage rose from 9.32 to 10.94 in 30 minutes, due to the need to close the gate on the structure to reinstall the second gate for service. The stage

dropped to 7.94 ft msl at 8:30 PM right after both gates on the structure were open full. The headwater stage was at 9.32 ft msl for several hours between 2 PM and 8 PM April 24, 1982 due to only one gate being in operation. This represents the actual storm peak. This may have provided less hydraulic head availability for the drainage from the secondary system in the area. However, the high water stage in John Prince Park at the Congress Avenue crossing of Lake Worth Drainage District Lateral Canal 14 was about 10.15 ft msl, which was about 2.20 feet below the high water mark caused by the March 28-29, 1982 storm. It is interesting to note that the discharge during the night and early morning of April 24-25, 1982 was 2500 to 3000 cfs, comparable to the 2500 cfs discharge later in the day with both gates in operation. The possible explanations are restriction of inflow from the secondary drainage system, and much less rainfall this time than last month.

One gate at S-41 was undergoing maintenance at the West Palm Beach Field Station and was out of service until 8 PM April 24, 1982. A forecast of 80% rainfall probability prompted reinstallation of the gate. The peak headwater stage resulting directly from the storm was 9.3 ft msl and occurred prior to the installation. During installation of the second gate, a short term peak stage of 10.94 ft msl resulted from the need to briefly close the remaining gate. The effects of the brief peak were not severe.

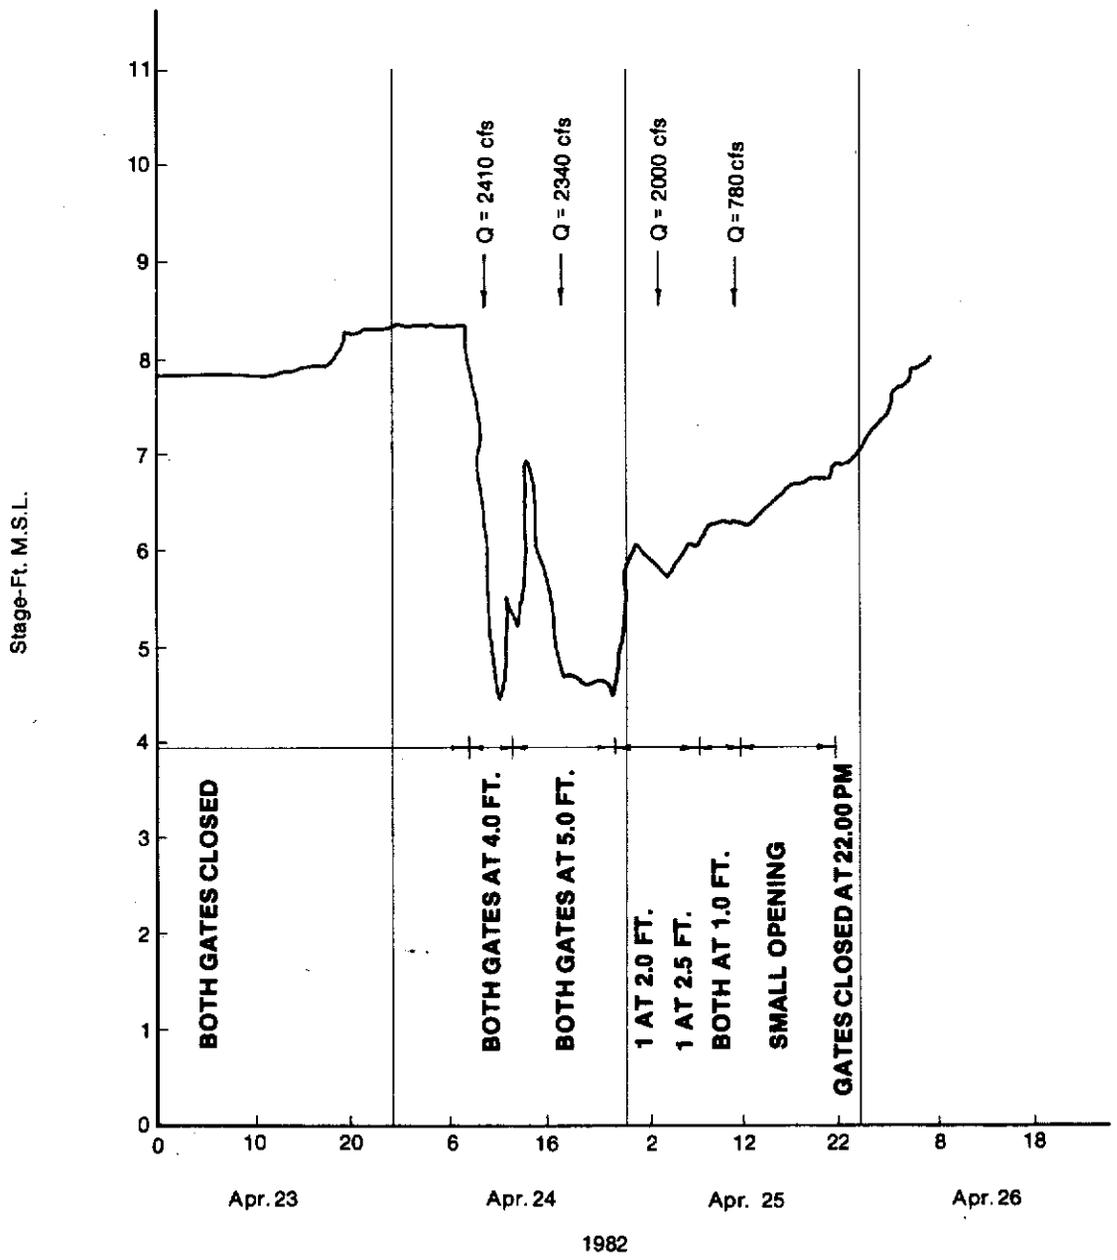
Figure 6 HOURLY STAGE HYDROGRAPH AT S-40 HEADWATER DURING RAINSTORM OF APRIL 23-26, 1982

3. S-40 - This structure maintains and drains the C-15 Basin which covers the City of Delray Beach. Figure 6 shows the hourly stage hydrograph at S-40 headwater during the rainstorm. Both gates were in operation during this rainstorm. The stage was maintained between 4.5 and 8.0 ft msl during this storm. The flooding in some streets and homes was due to inadequate secondary or tertiary drainage system capacity, maintenance, or operation.

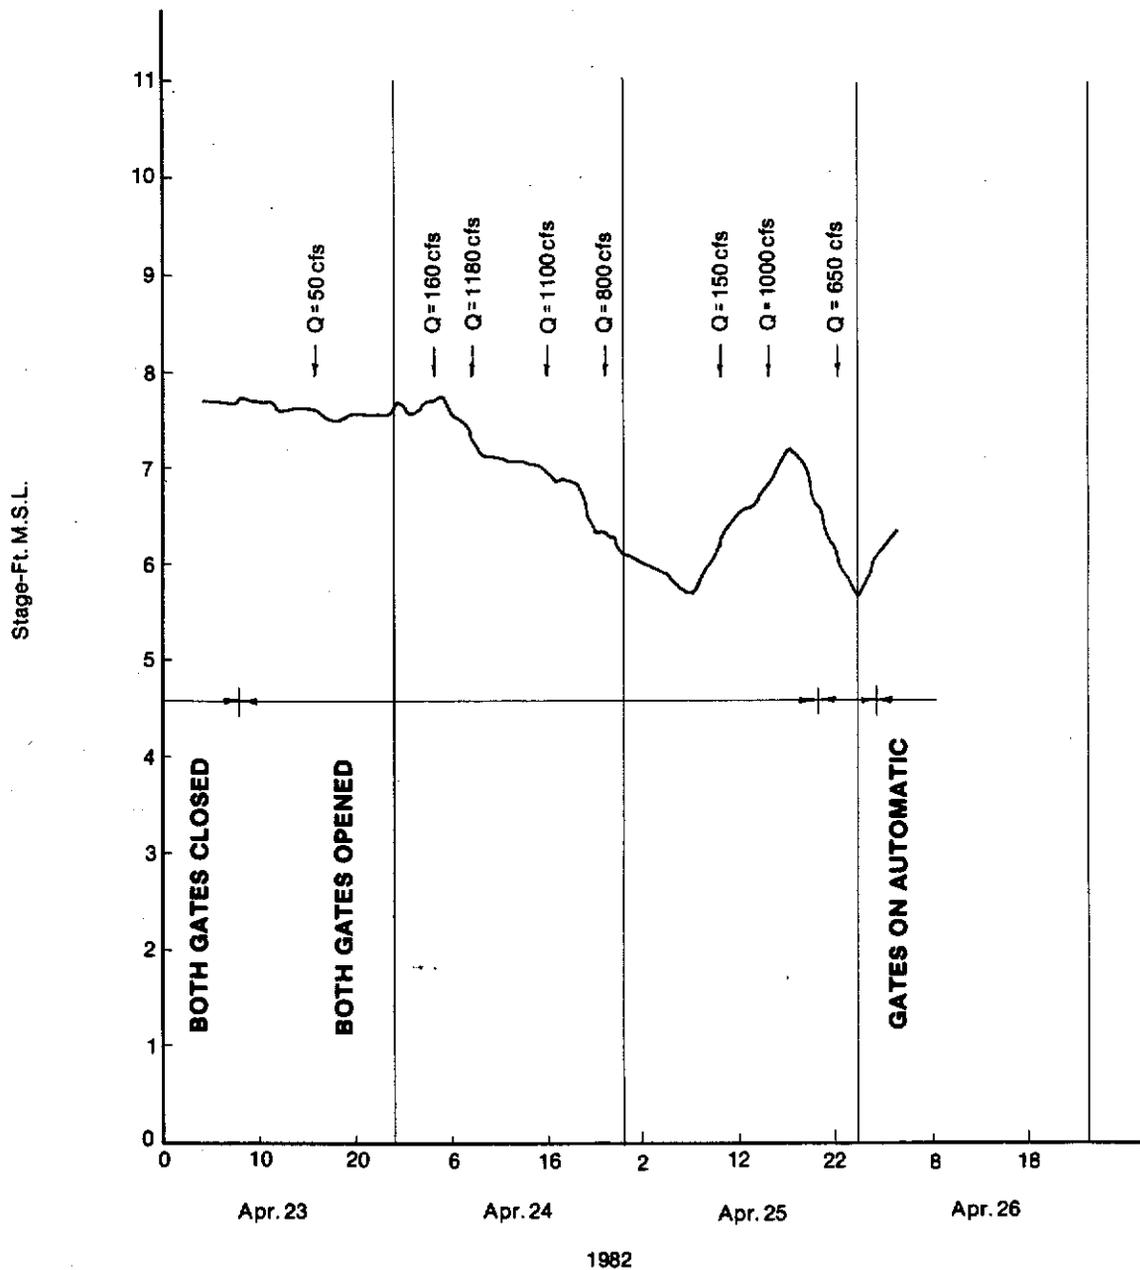
Figure 7 HOURLY STAGE HYDROGRAPH AT S-44 HEADWATER DURING RAINSTORM OF APRIL 23-26, 1982

4. S-44 - This structure maintains stages and drains the C-17 Basin. This basin received 5 to 8 inches of rainfall with intensive rainfall at the upstream portion of the basin. Figure 7 shows the hourly stage hydrograph during this rainstorm. The stage was maintained between 5.7 and 7.7 ft msl during the rainstorm. One death was reported to be the result of a flooded street and canal draining into C-17 across Palm Beach Lakes Boulevard. A sheetpile wier located downstream of 45th Street (West Palm Beach) in C-17 is suspected to have resulted in a backwater condition and is under investigation by the District.

This structure was able to handle the discharge from the C-17 Basin without difficulty. The intense rainfall in the southern portion of this basin resulted in significant flooding. An existing sheetpile weir, which maintains dry season waterlevels, may have caused a backwater condition and is under investigation by the District.

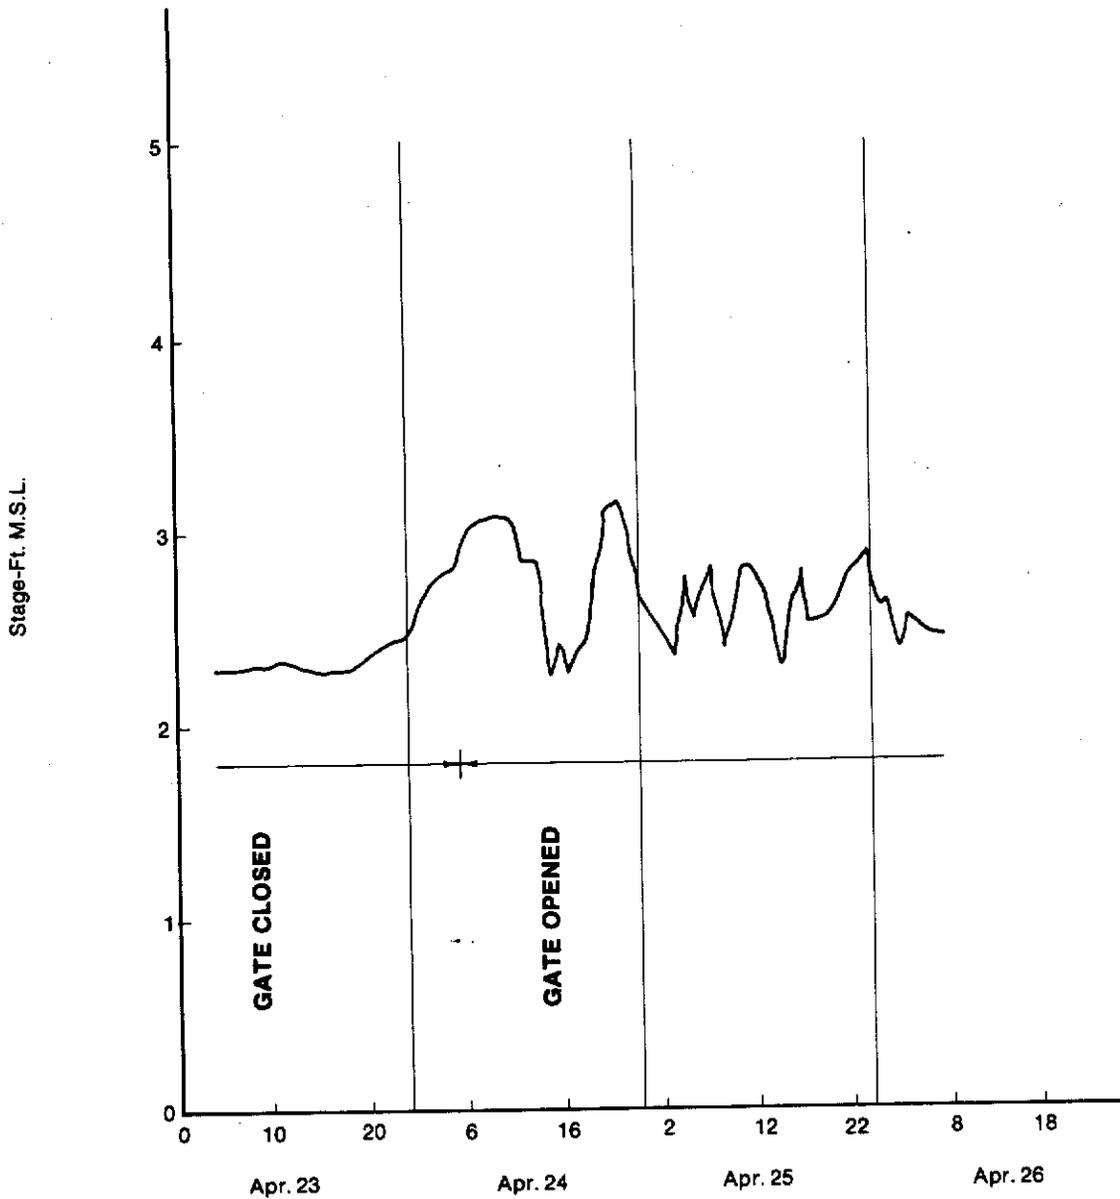
5. S-26 - This structure, located in the City of Miami at the 36th Street crossing of the Miami canal, is a reinforced concrete, gated spillway, with discharge controlled by two cable operated, vertical lift gates. Operation of the gates is automatically controlled to maintain the optimum headwater elevation of 2.50 ft msl. As mentioned previously, the rainfall in this area was reported to be 8.99 inches at Miami International Airport and 8.75 at the District's Miami Field Station. The operation of S-26 has a direct and indirect impact on the area's drainage. Figure 8 shows the hourly stage hydrograph at S-25 headwater during this rainstorm. The gates were operated at 5 AM April 24, 1982 when stage reached 2.80 ft msl. The stage at this structure was maintained between 2.25 and 3.12 ft msl. The stage reached slightly over 3.0 feet in two periods: one at 6 AM through 11 AM April 24, 1982 and one between 9 PM and 11 PM April 24, 1982. No severe flooding was reported in this basin, although golfball-size hail was observed.
