ANNEX G
HAZARDOUS, TOXIC, AND RADIOACTIVE WASTE

G.1 Project Area Investigations to Date

SUBJECT: Phase I Environmental Assessment
Collier (Tract No. 105-024); Peeples (Tract No. 105-022);
Comprehensive Review Study of the Central and Southern
Florida Project (Restudy); Glades County

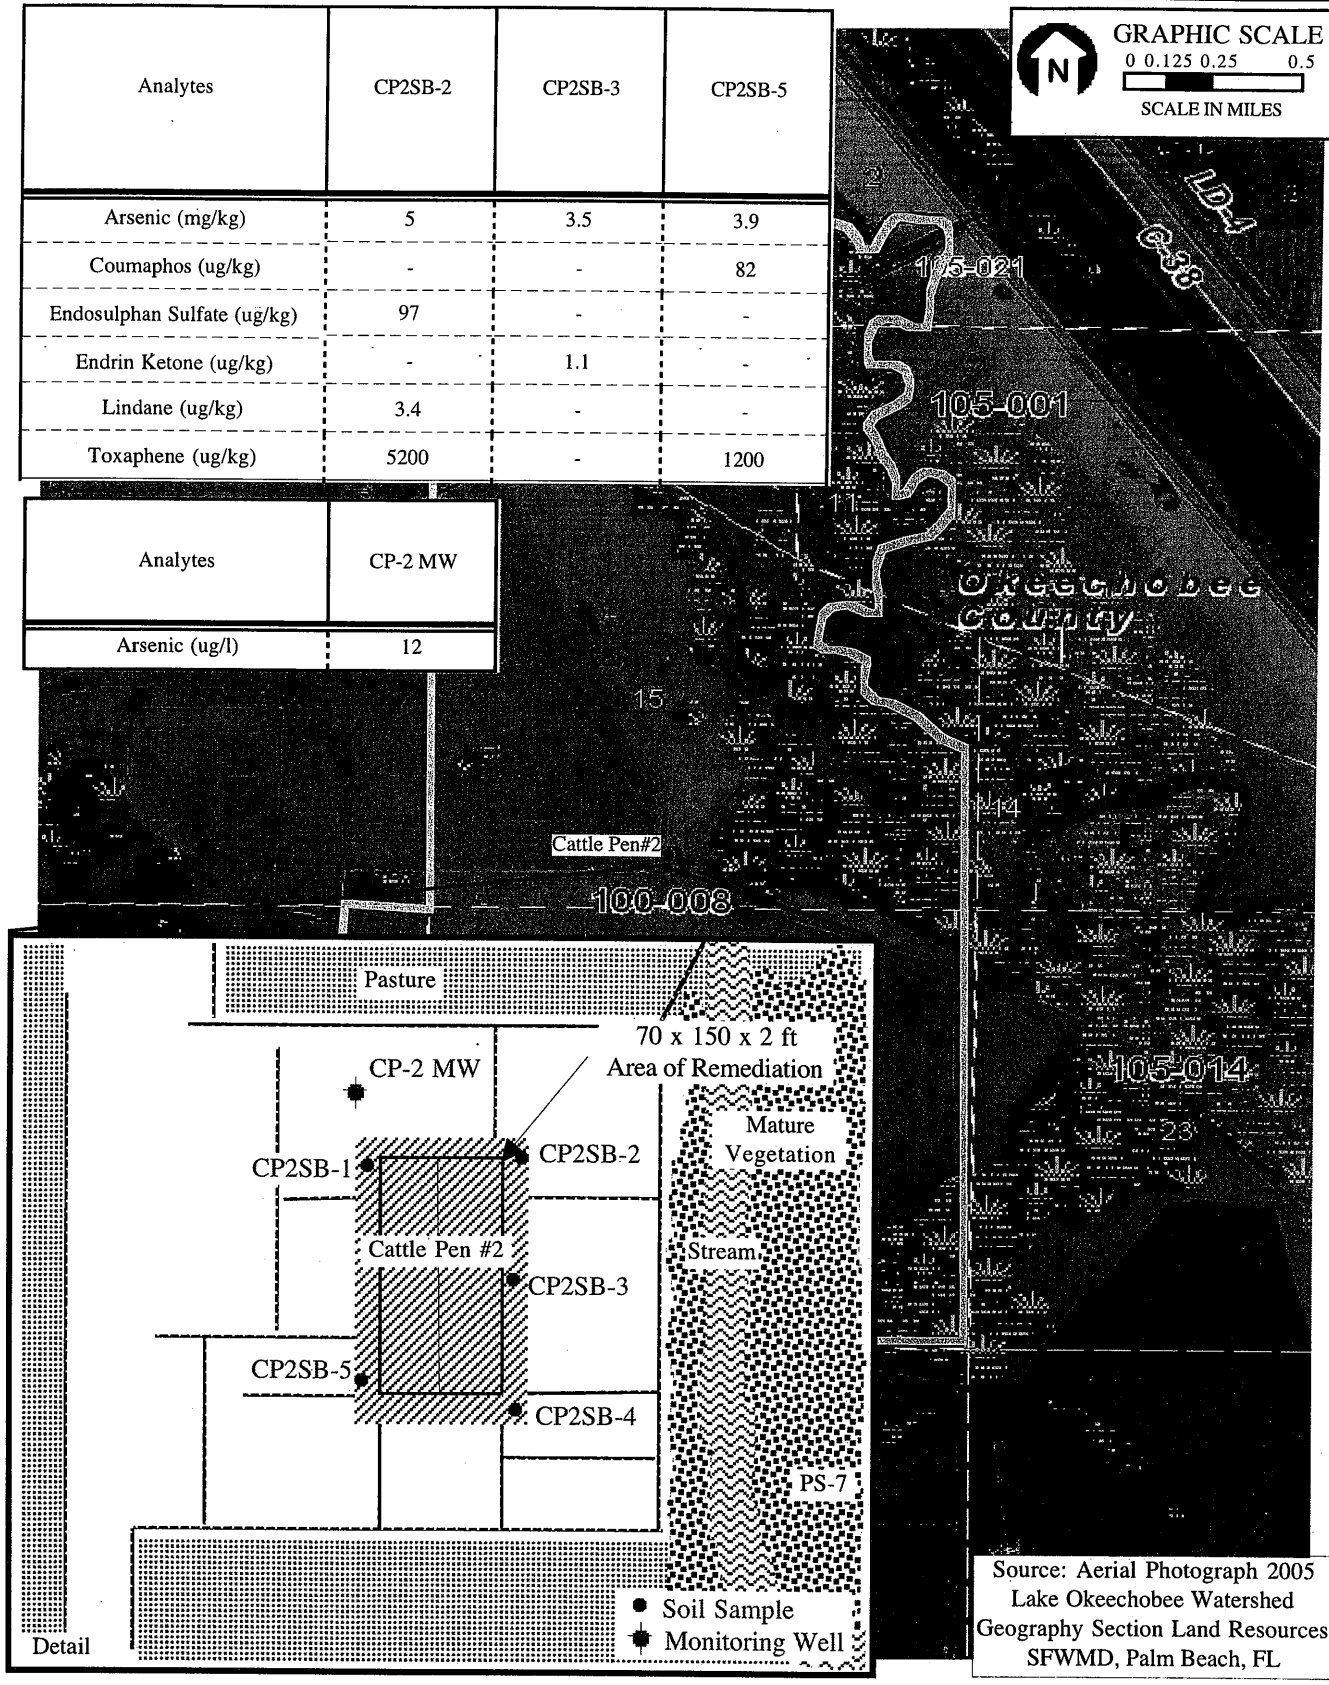
FIGURE 8-3.2
CATTLE PEN #2 EXTENT OF REMEDIATION
 PEARCE PROPERTIES, SR 78, BUCKHEAD RIDGE
 GLADES COUNTY, FLORIDA
 Source: ECT 2006

Analytes	CP-2 MW
Arsenic (ug/l)	12
