TECHNICAL PUBLICATION 80-7

PLANT COMMUNITIES OF THE KISSIMMEE RIVER VALLEY

Resource Planning Department  
South Florida Water Management District  
West Palm Beach, Florida 33402

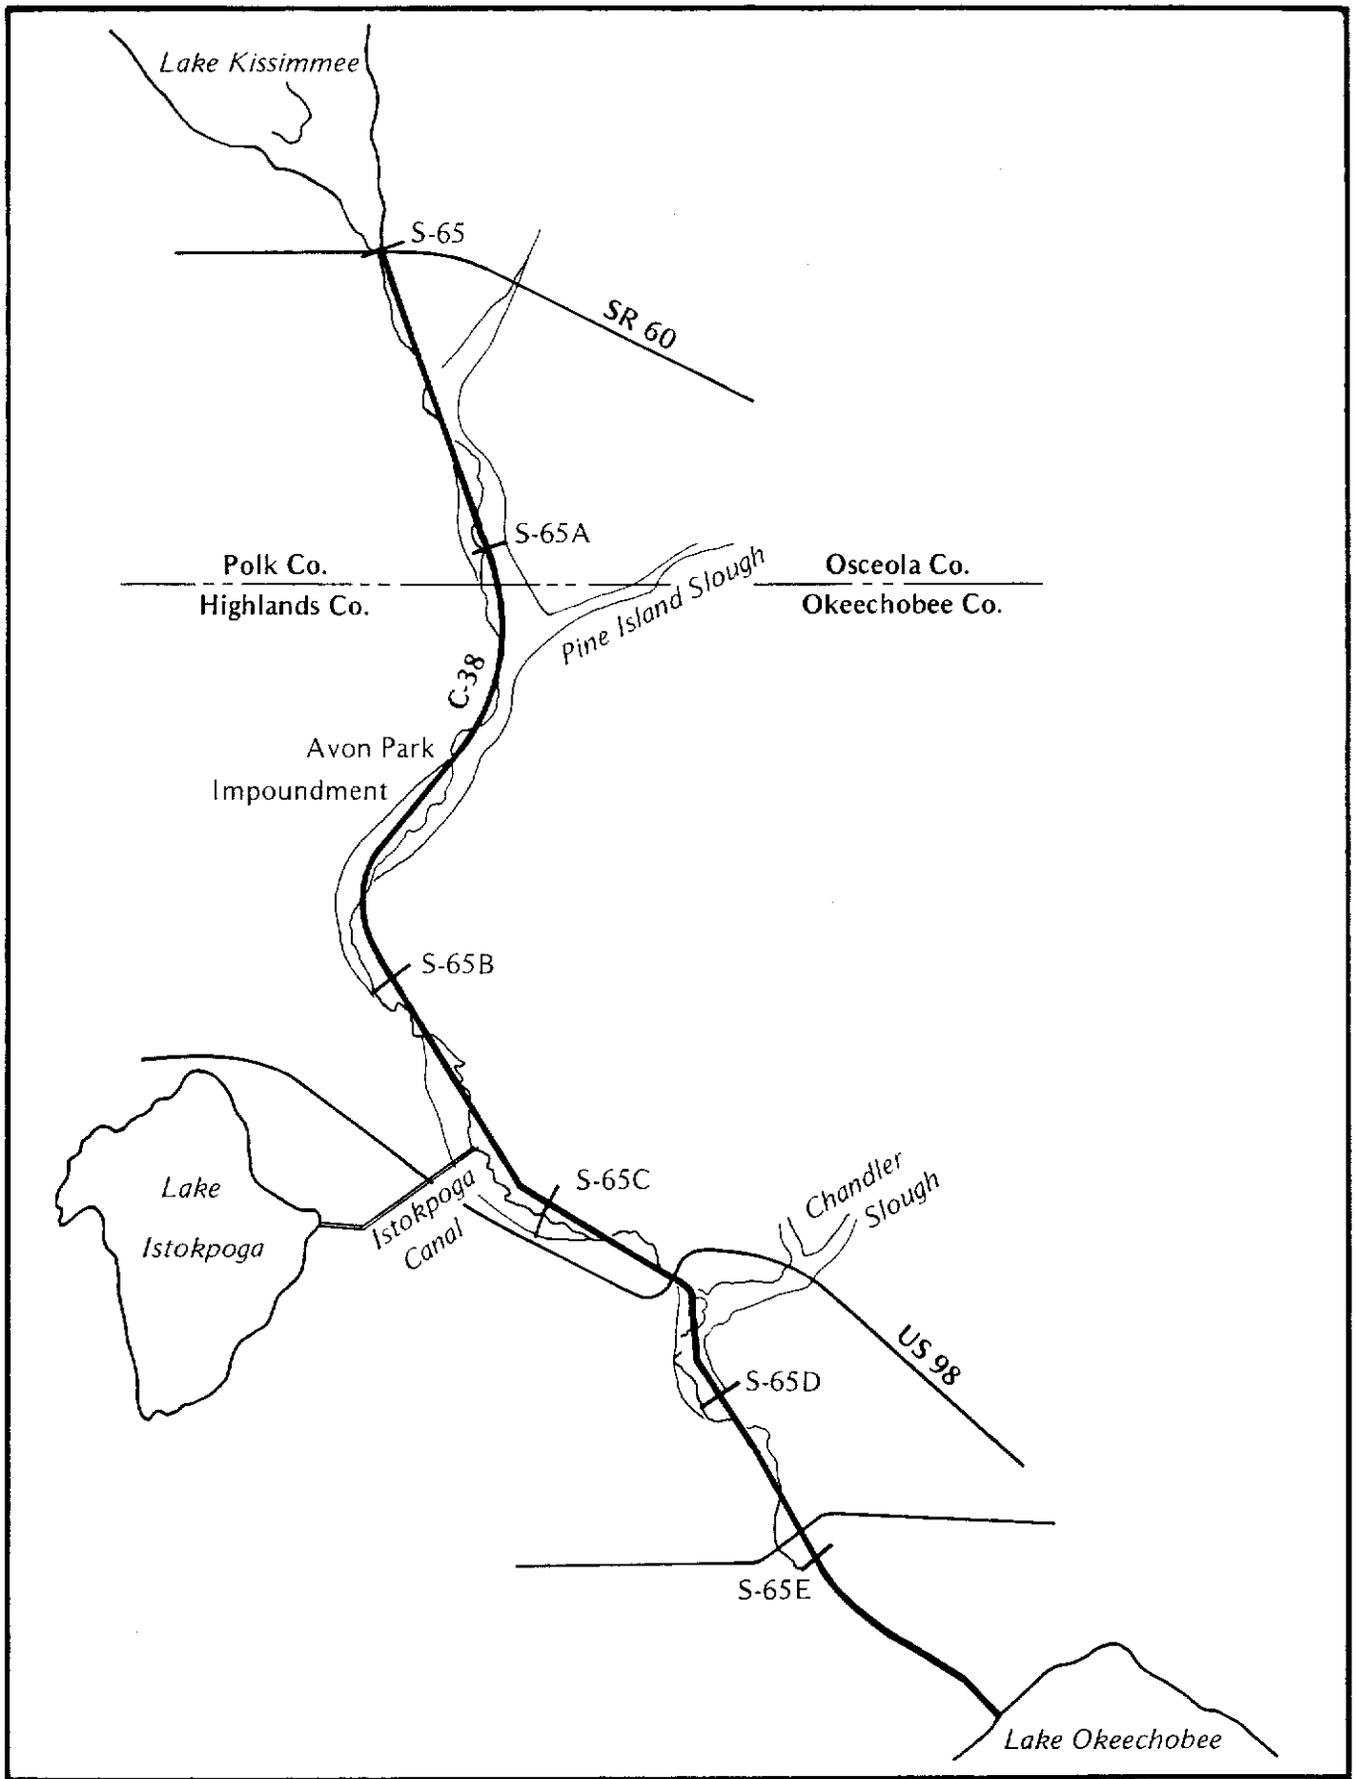
**FIGURE 1: LOCATION OF KISSIMMEE RIVER, WATER CONTROL STRUCTURES AND MAJOR TRIBUTARIES**

Six water control structures (S-65 series) in C-38 lowered the water levels between the canal segments in 6 or 7 foot increments, and created a series of impoundments, or pools, upstream of each water control structure (i.e., Pool A lies upstream of S-65A, Pool B is downstream of S-65A and upstream of S-65B, etc.). A tieback levee was built from each structure across the floodplain to higher ground to prevent water from flowing around the structure. Figure 1 shows the location of the Kissimmee River and C-38 in south-central Florida, the water control structures and the major tributaries.

The floodplain boundaries for mapping purposes were considered to be the more or less continuous tree lines of oaks or cabbage palms which parallel the river. Tributary sloughs, swamps and marshes were mapped to the first distinct upland feature, usually a road crossing. The north and south limits of the study area were S-65 at SR 60 and S-65E with its tieback levees, respectively (Figure 1).

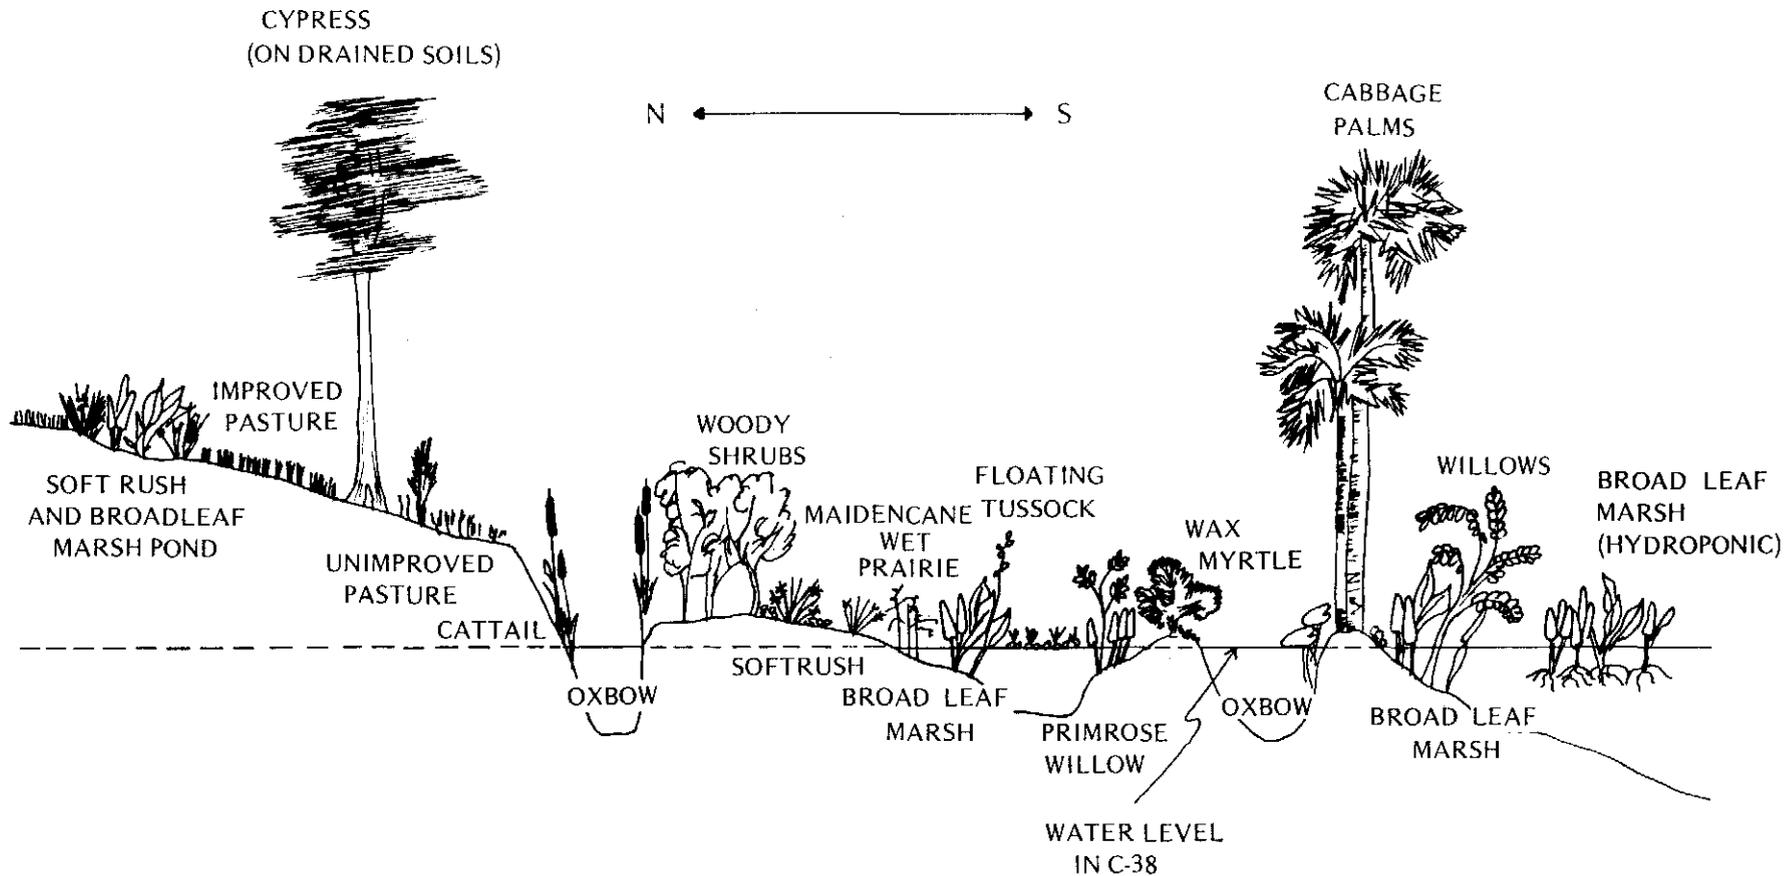
FIGURE 2: CONCEPTUAL CROSS-SECTION (NORTH TO SOUTH) THROUGH A KISSIMMEE RIVER IMPOUNDMENT (POOL), ILLUSTRATING GENERAL RELATIONSHIPS AMONG SOME OF THE PLANT COMMUNITIES AND COMMON SPECIES.

Figure 2 depicts a diagrammatic cross section from north to south through a Kissimmee River impoundment. Note that while the ground contours generally slope downward from north to south, impoundment of the water by the S-65 structures maintains a flat water level. Consequently, the southern portion of each pool is permanently flooded and the northern portion has been permanently drained.

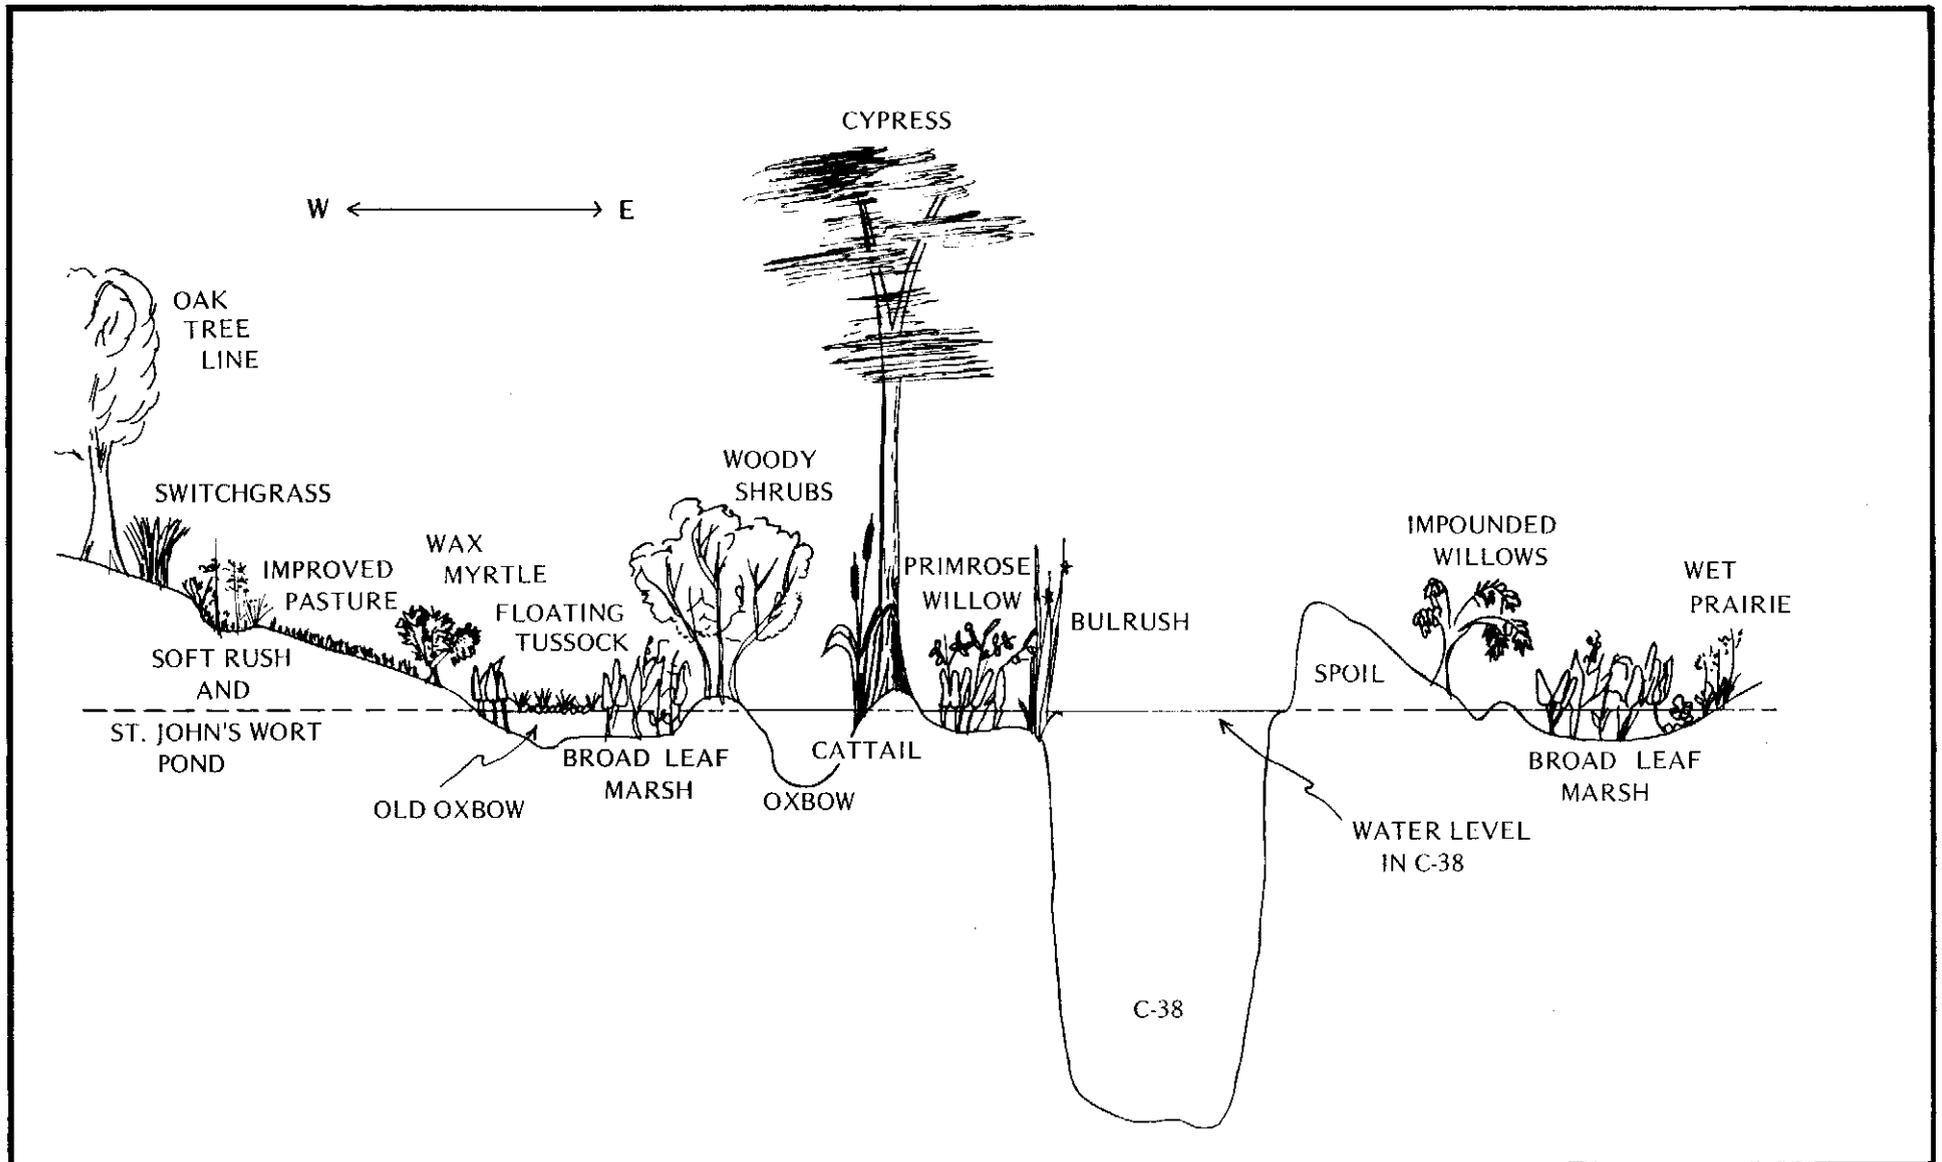
FIGURE 3: CONCEPTUAL CROSS-SECTION (WEST TO EAST) THROUGH THE KISSIMMEE RIVER FLOODPLAIN ILLUSTRATING GENERAL RELATIONSHIPS AMONG SOME OF THE PLANT COMMUNITIES AND COMMON SPECIES.

The spoil mounds which parallel C-38 reach their maximum height immediately adjacent to the canal and slope downward towards the floodplain (Figure 3). Vegetation is more likely to exist along the lower, back edges of the spoil piles, probably because soil moisture is higher than at the top of the mound.

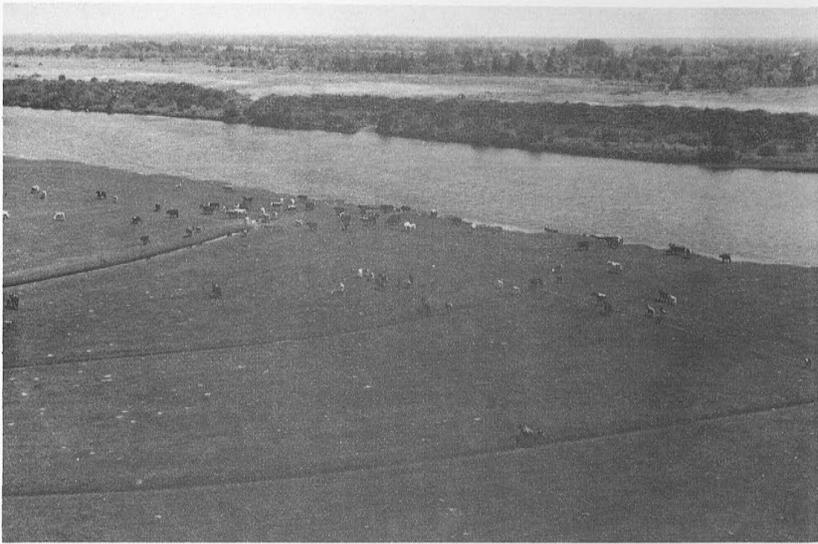
PLATE 1

IMPROVED PASTURES often contain grassed swale systems for irrigation and drainage. The pastures may be planted with forage grasses and maintained. Cattle density is generally high.

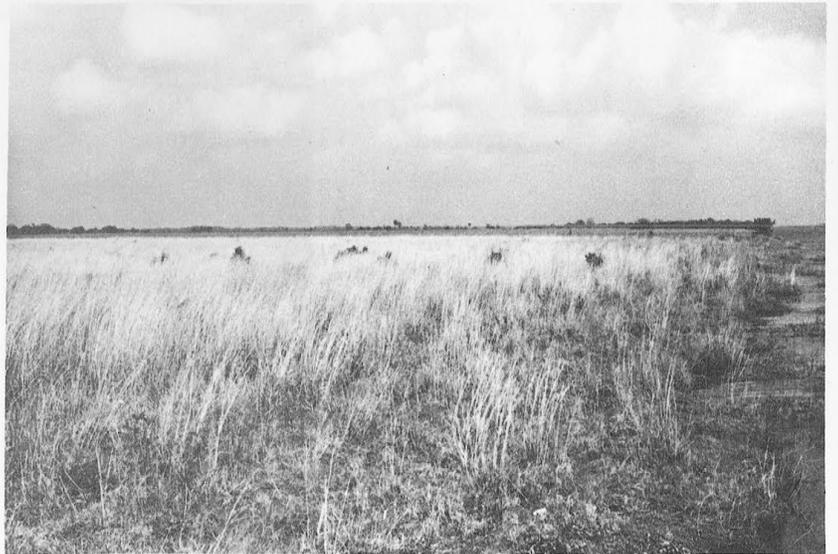
PLATE 2

UNIMPROVED PASTURES often result from permanently lowered water levels and generally occur in the central and northern portions of each pool. Broomsedges (*Andropogon sp.*) and scattered wax myrtles (*Myrica cerifera*) are common.

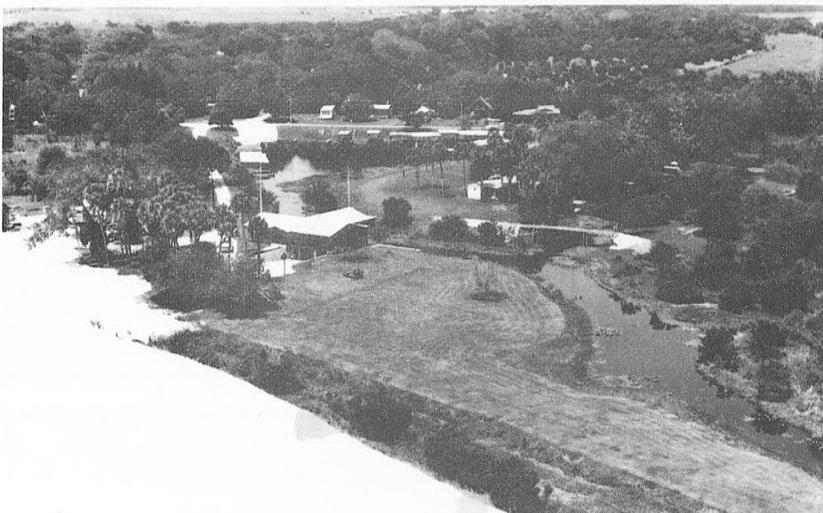
PLATE 3

Small residential areas, fish camps and buildings associated with water control structures are typical of URBAN land use categories found in the floodplain.

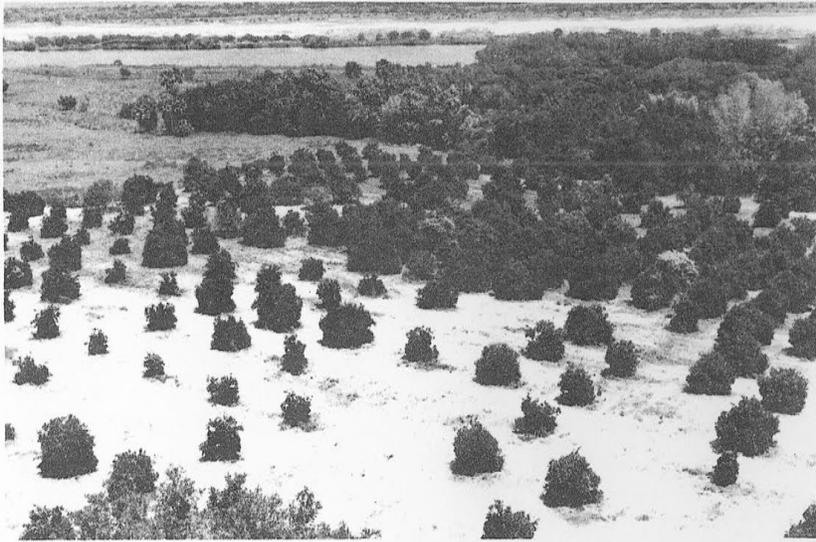
PLATE 4

A few groves of CITRUS trees are located near the edge of the historic river floodplain in pools D and E.

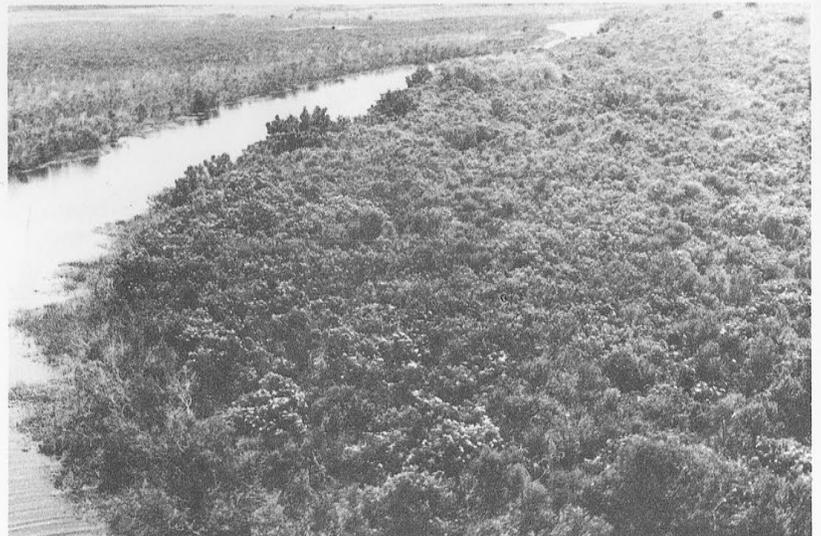
PLATE 5

WOODY SHRUBS such as elderberry (*Sambucus simpsonii*), salt bush (*Baccharis halimifolia*) and wax myrtles (*Myrica cerifera*) have become dense in areas where the stabilization of water levels in the impoundments has exposed the ground in the north and central portions of each pool and in disturbed areas throughout the pools.

The woody shrub community generally occurs on drained soils, although it is sometimes found in transition zones and may contain some aquatic species such as Panicum repens, P. hemitomon, water primrose (Ludwigia peruviana), and arrowhead (Sagittaria lancifolia).

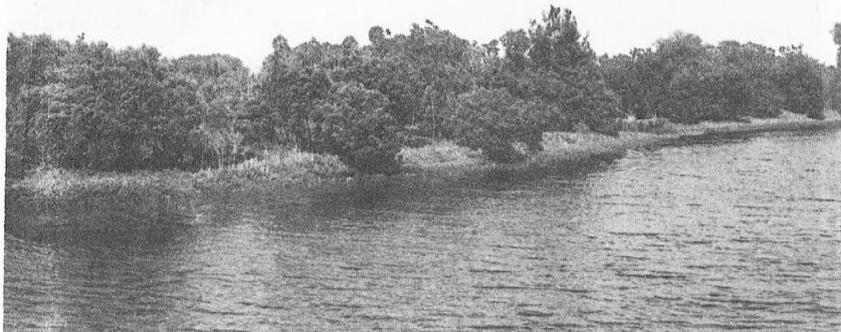
PLATE 6

WAX MYRTLE (*Myrica cerifera*) has colonized river banks that were left permanently exposed by the stabilization of water levels. Scattered broomsedge (*Andropogon sp.*) and bladderpods (*Glottidium vesicaria*) are evident in the photo.

Wax myrtle prefers dry sites with adequate soil moisture. Established plants can tolerate seasonal flooding to some degree, and in some cases they have even been observed growing on floating tussocks of Scirpus cubensis.

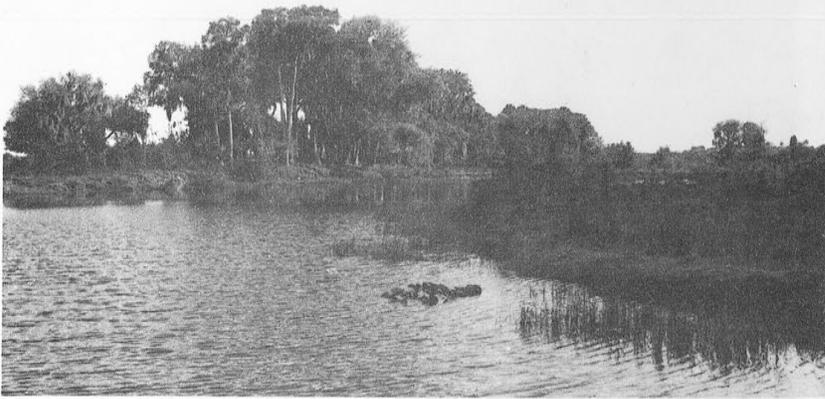
## PLATE 7

OAKS (*Quercus* spp.) and CABBAGE PALMS (*Sabal palmetto*) occupy some natural ridges and riverbanks alongside the original river channels.

Oaks and cabbage palms are found on elevated ridges and knolls and on high river banks within the limits of the floodplain.

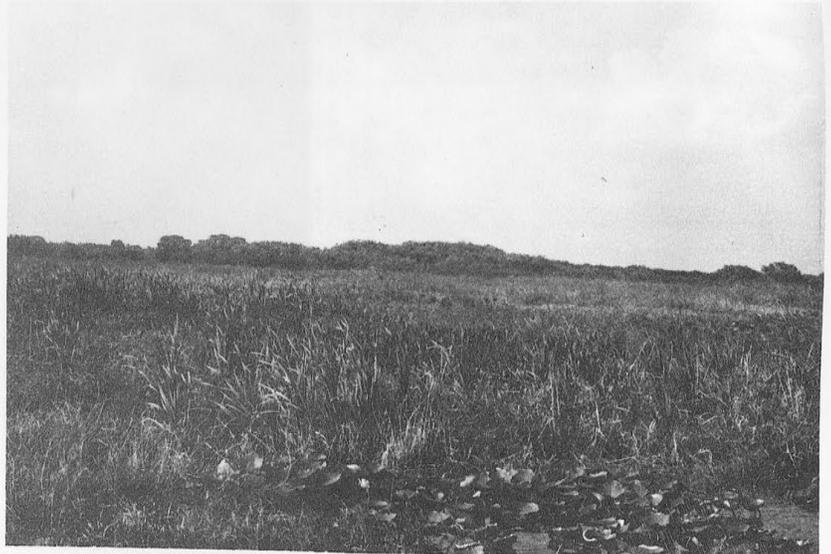
## PLATE 8

WILLOW (*Salix caroliniana*) heads occur within various wetland communities, such as this broadleaf marsh.

Willows are found scattered throughout broadleaf marsh areas and may form willow heads of several acres in size. Two of the largest concentrations of willows occur in the southwest portion of Pools C and D. Understory vegetation includes most of the common broadleaf marsh plants.

The willows encountered in the inundated portions of each pool have been flooded for several years. These trees are stunted and have spindly trunks and few leaves. It was observed that experimental water level drawdowns in Pool C stimulated growth of the willows and increased their size and foliage.

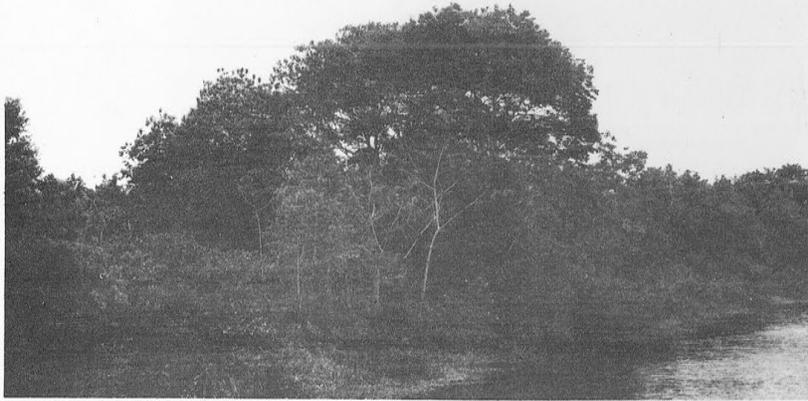
PLATE 10

Maples (***Acer rubrum***) are common swamp HARDWOOD trees and are usually found in small heads or strands along Kissimmee River banks or tributaries.

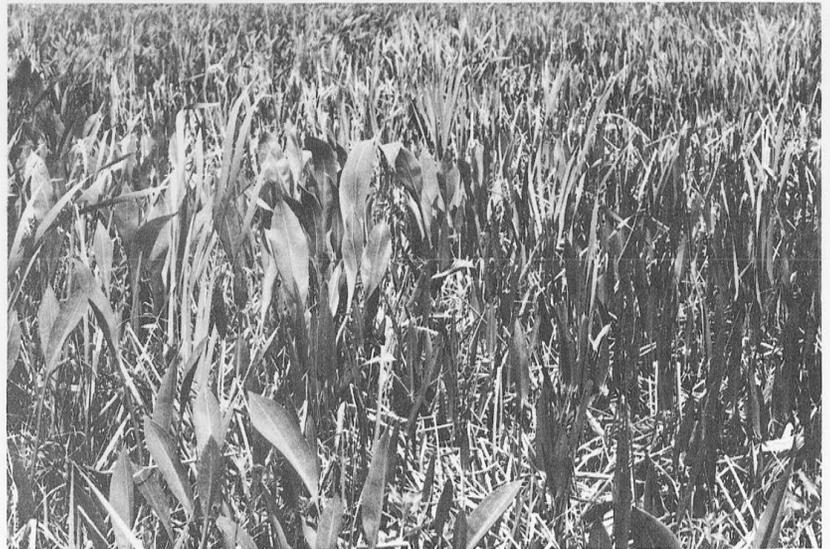
PLATE 11

Pickerelweed (***Pontederia lanceolata***), arrowhead (***Sagittaria lancifolia***) and cattail (***Typha latifolia***) are dominant species in this BROADLEAF MARSH. Due to stabilization of water levels in C-38 impoundments, excessive plant litter often accumulates.

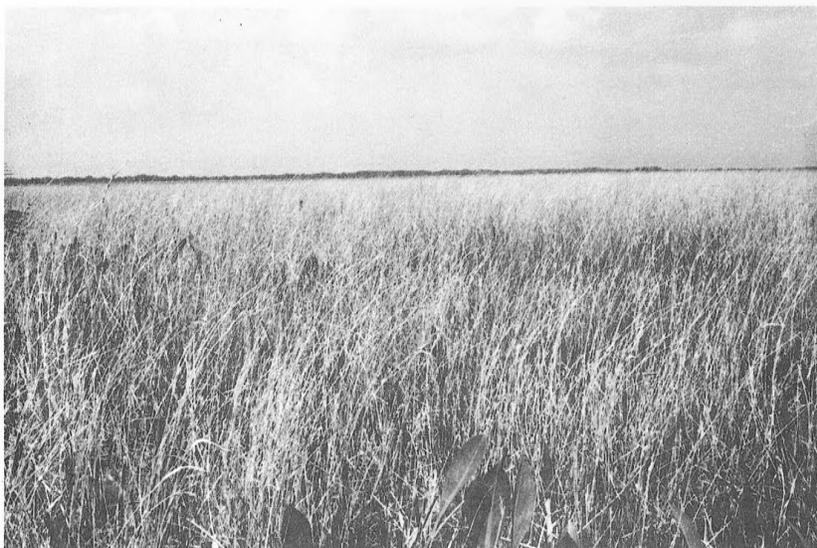
PLATE 12

MAIDENCANE WET PRAIRIE is comprised of a vast, uniform growth of ***Panicum hemitomon***. Some associated species are arrowhead (***Sagittaria lancifolia***) and pickerelweed (***Pontederia lanceolata***).

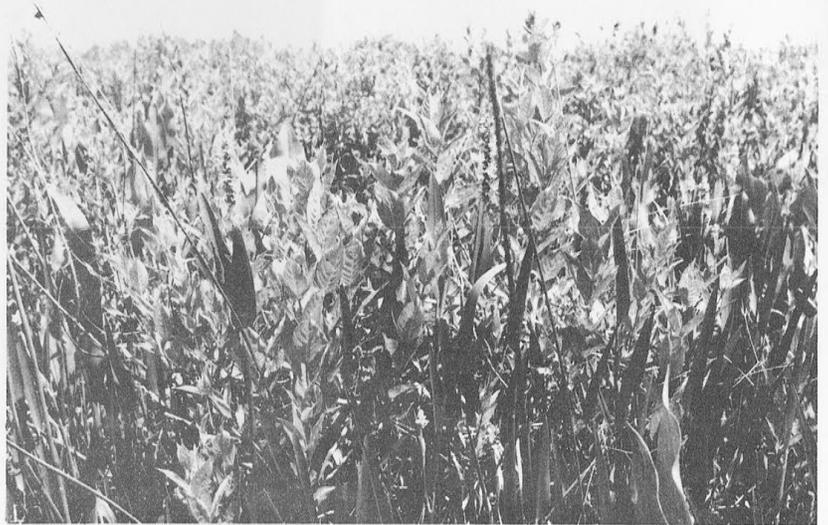
## PLATE 14

BUTTONBUSH (***Cephalanthus occidentalis***) shrubs grow to 12 feet in height. The understory includes broadleaf marsh plants such as pickerelweed (***Pontederia lanceolata***) pictured here.

Climbing hempweed (Mikania scandens) is also frequently found growing on the buttonbush shrubs.

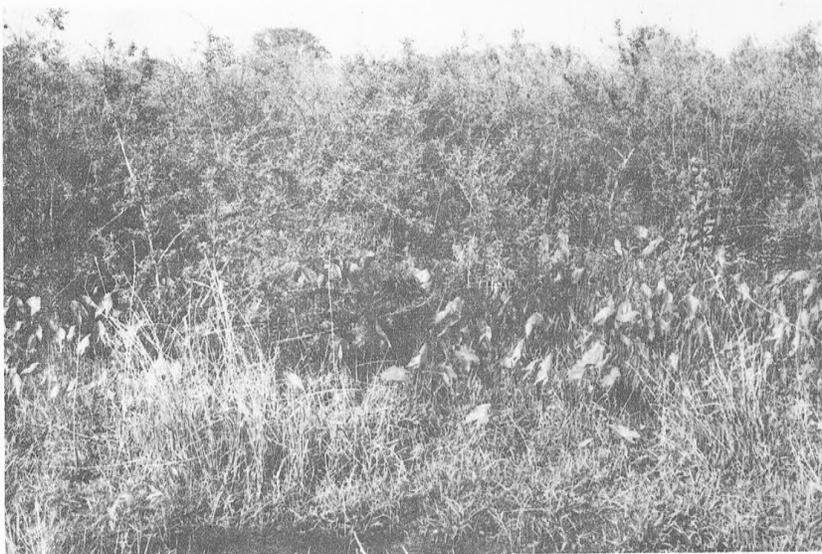
## PLATE 15

Thickets of PRIMROSE WILLOW (***Ludwigia peruviana***) often form a complete canopy over broadleaf marsh species such as ***Sagittaria latifolia*** and ***Pontederia lanceolata***.

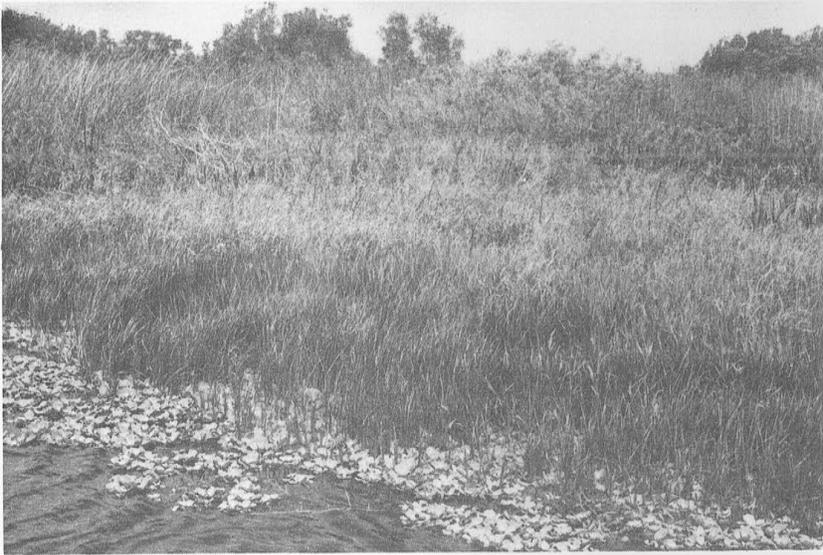
PLATE 16

Old river runs or oxbows sometimes become colonized by FLOATING TUSSOCKS composed primarily of *Scirpus cubensis* and water hyacinth (*Eichhornia crassipes*). Other species which have colonized the mats include *Ludwigia leptocarpa* and *Pontederia lanceolata*. Water lettuce (*Pistia stratiotes*) is accumulating along the edge of the tussock.

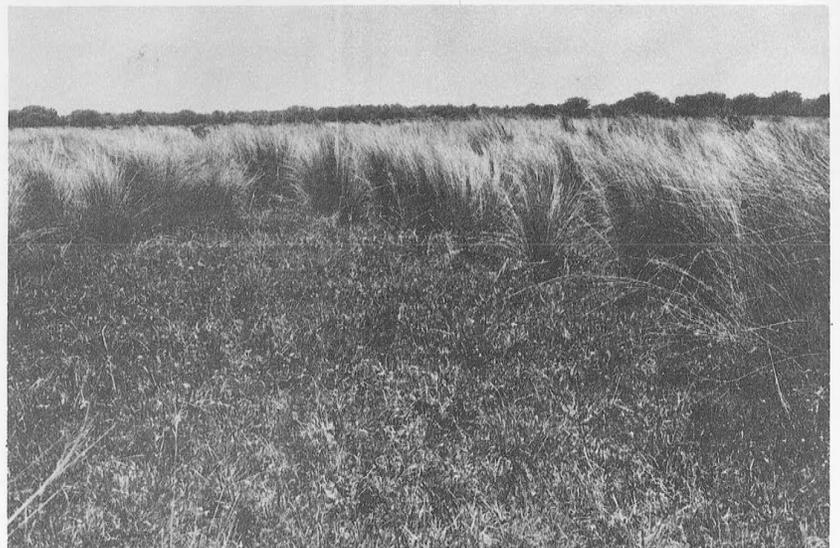
PLATE 17

SWITCHGRASS (*Spartina bakerii*) forms a distinctive community slightly downgradient from the oak tree line along the floodplain edge. Ground cover in the foreground of the switchgrass tufts includes torpedo grass (*Panicum repens*), coinwort (*Centella asiatica*) and pennywort (*Hydrocotyle umbellata*).

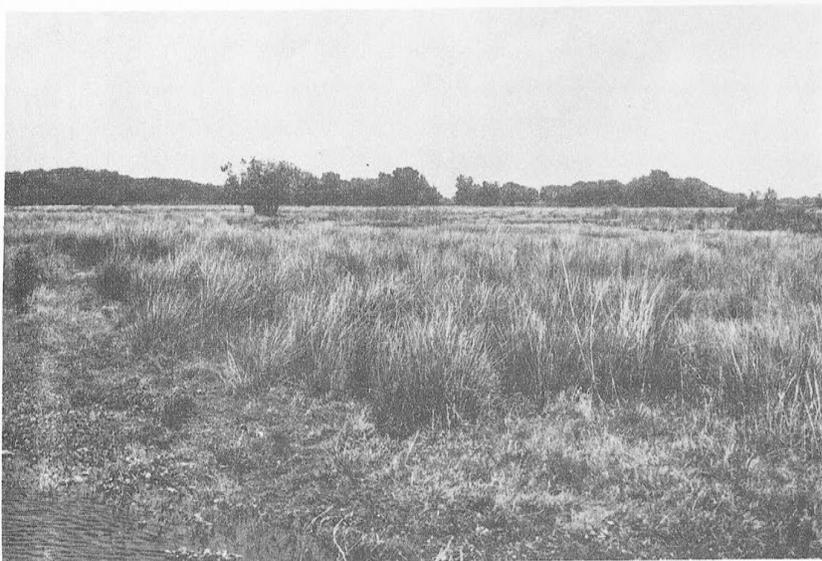
PLATE 18

SOFT RUSH (*Juncus effusus*) is usually found at elevations slightly above the stabilized water levels in the Kissimmee River impoundments. The oak tree-line in the background marks the historical limits of the floodplain.

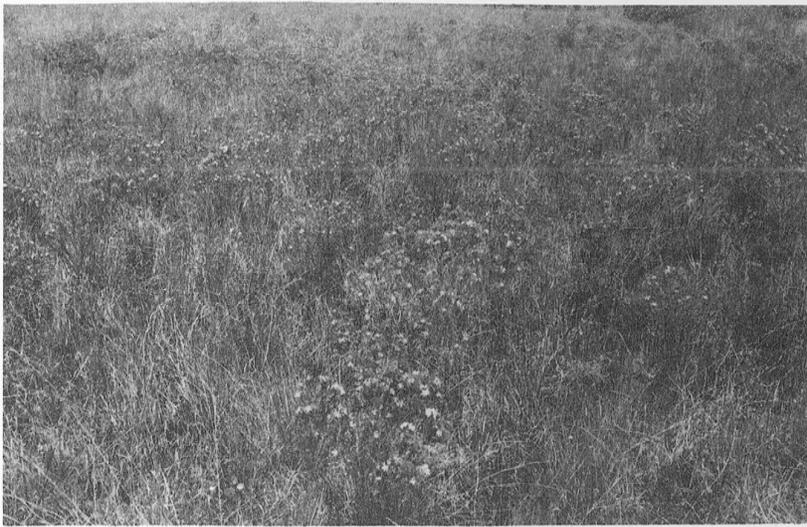
PLATE 19

ST. JOHNS WORT (*Hypericum fasciculatum*) grows in shallow, sandy ponds near the upland edge of the floodplain.

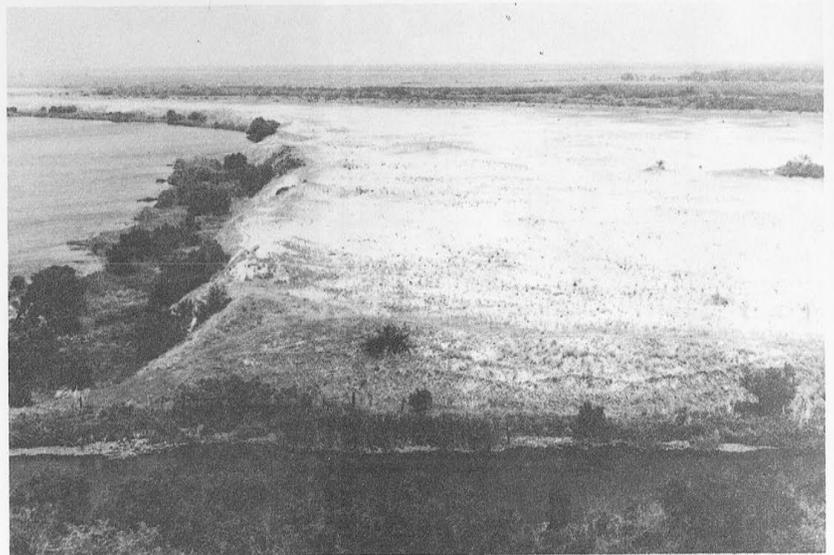
PLATE 20

Excavated sand, shell and limerock typify SPOIL PILES which occur along the edges of C-38. These spoil areas are a prominent feature of the Kissimmee River floodplain, and have displaced over 4900 acres of marsh.

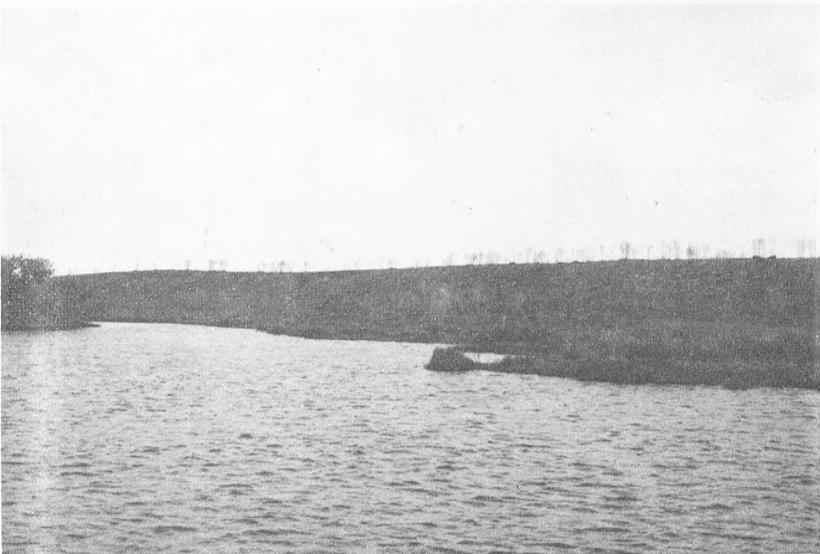
PLATE 21

VEGETATED SPOIL piles alongside C-38 have primarily become colonized with terrestrial species, such as grasses and dogfennel (*Eupatorium sp.*).
