TRACT NO. D0100-004 SURPLUS MATERIALS

Former Fort Pierce Field Station
St. Lucie County

Tetra Tech Building Inspection Checklist
SFWMD Fort Pierce Field Station
Fort Pierce, St. Lucie County, Florida 33451
May 18, 2016

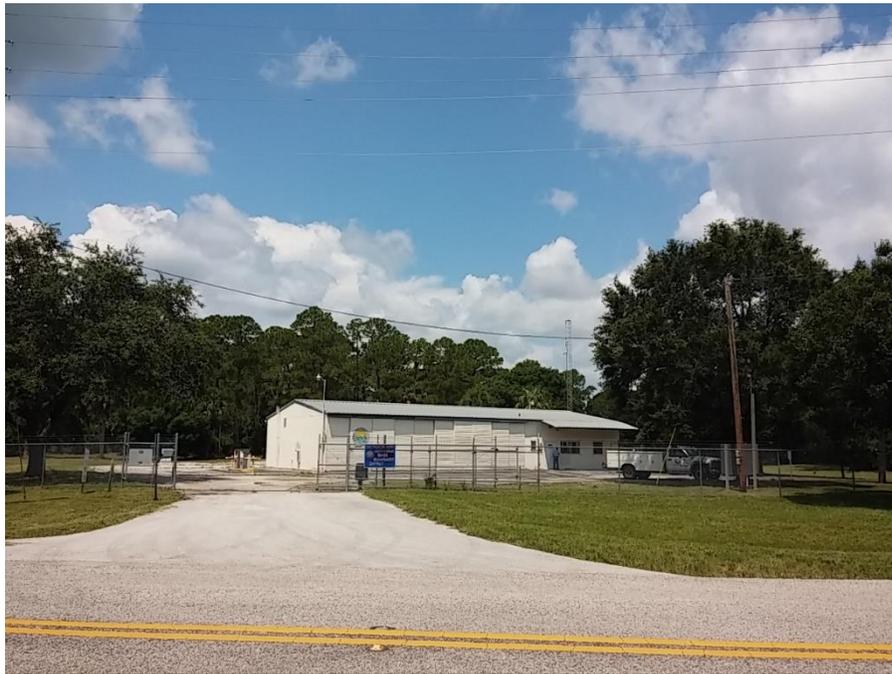
Property view from Ideal Holding Rd.

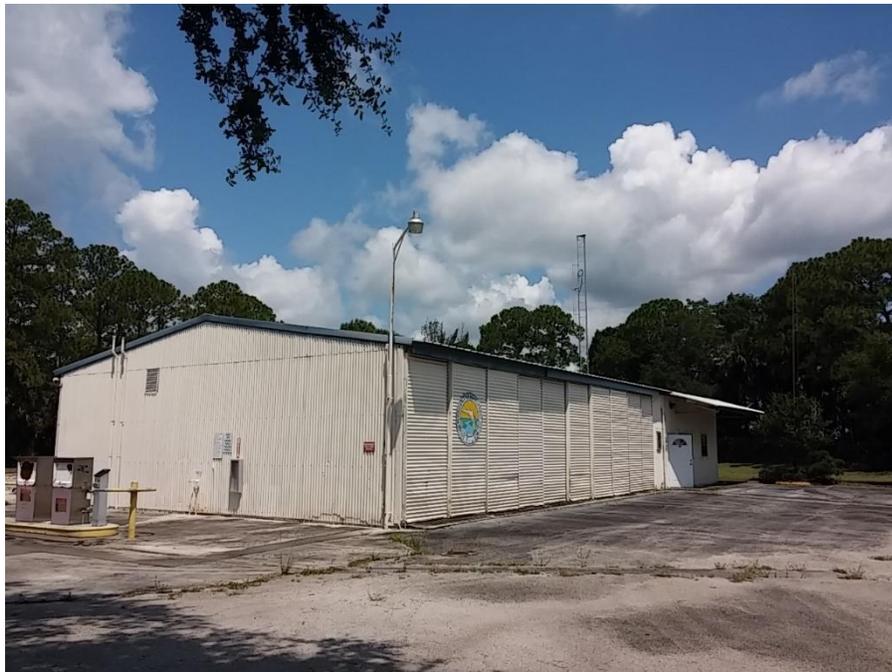
Front & south building elevations

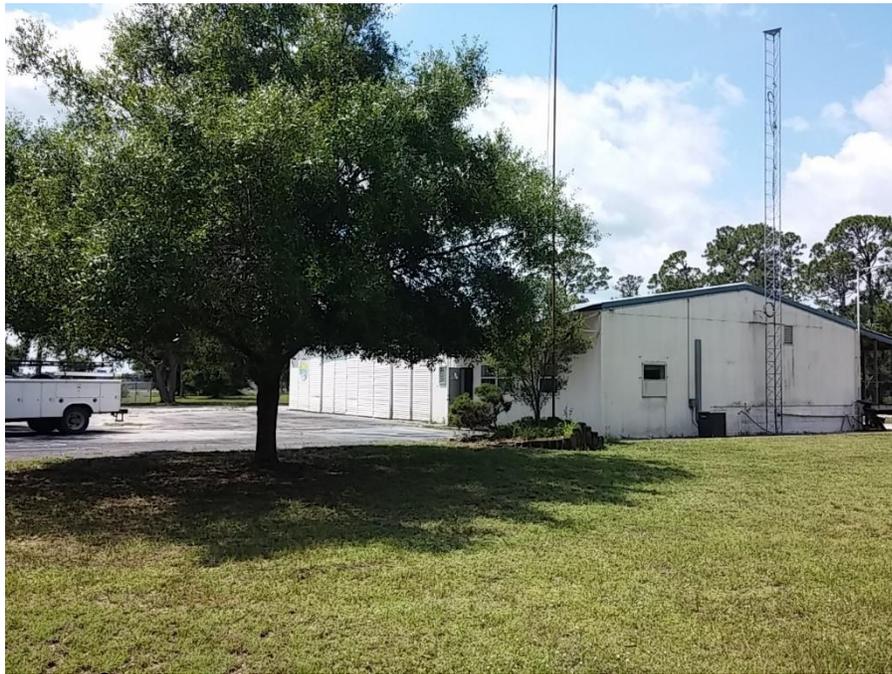
Front & north building elevations

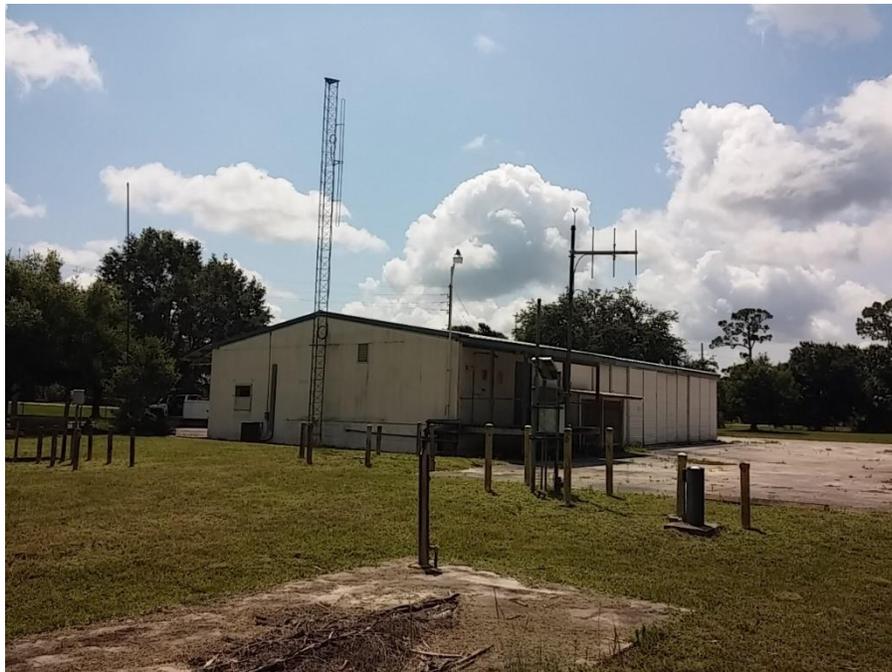
North & west (back) building elevations

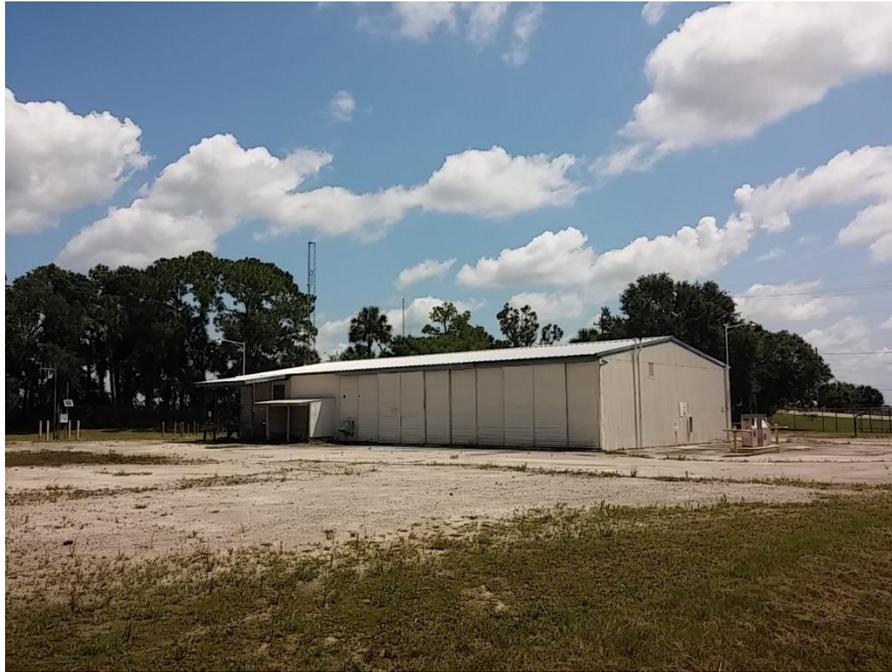
West & south building elevations

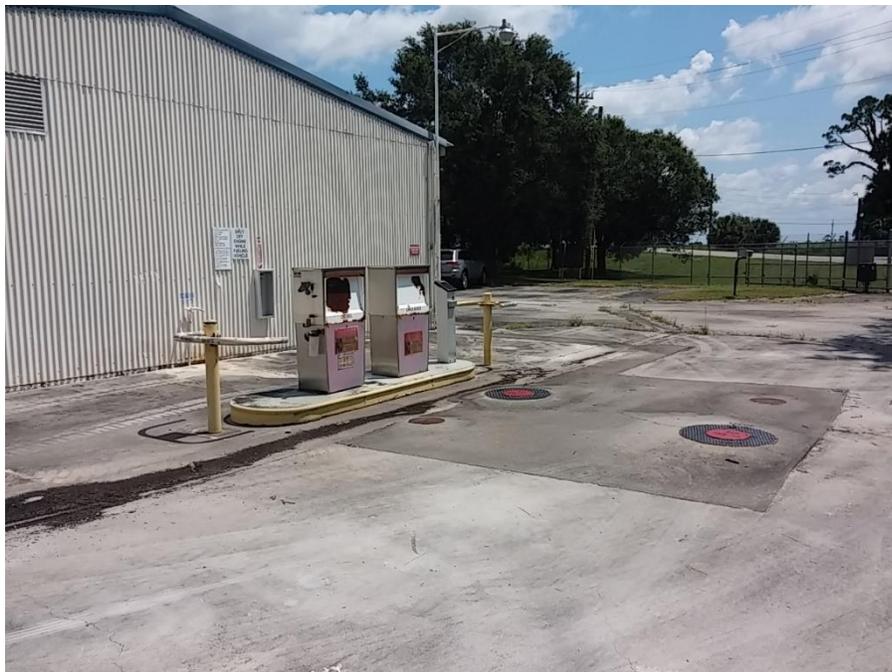
Fuel dispensing area & location of buried fuel tanks

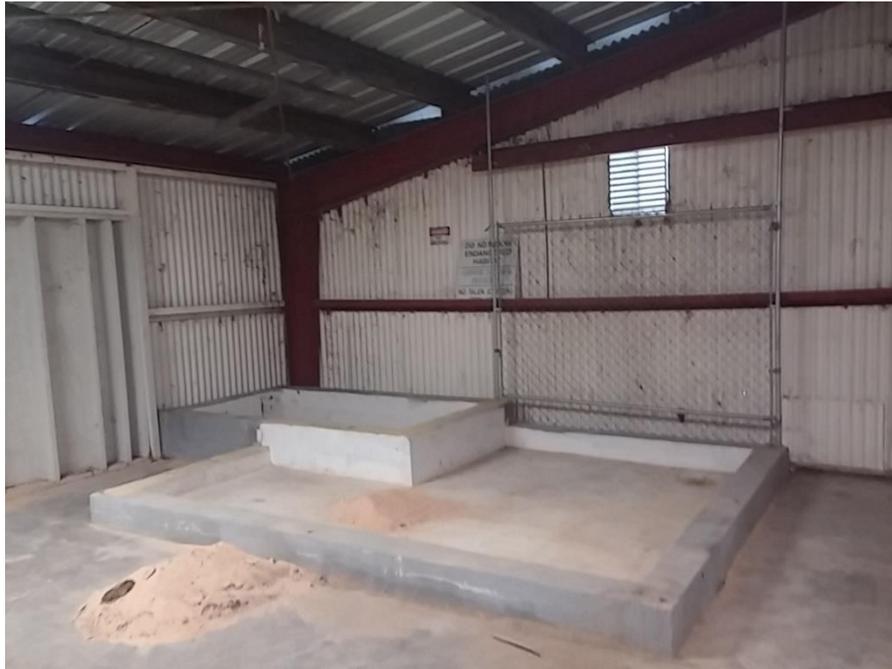
Former chemical storage containment area on north side of dock height floor

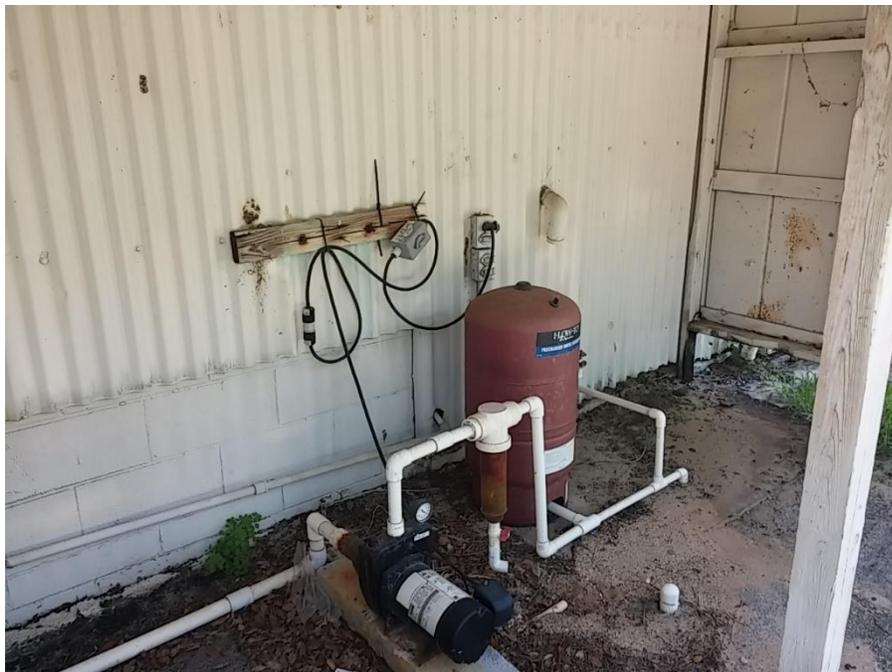
Water pump/pressure tank

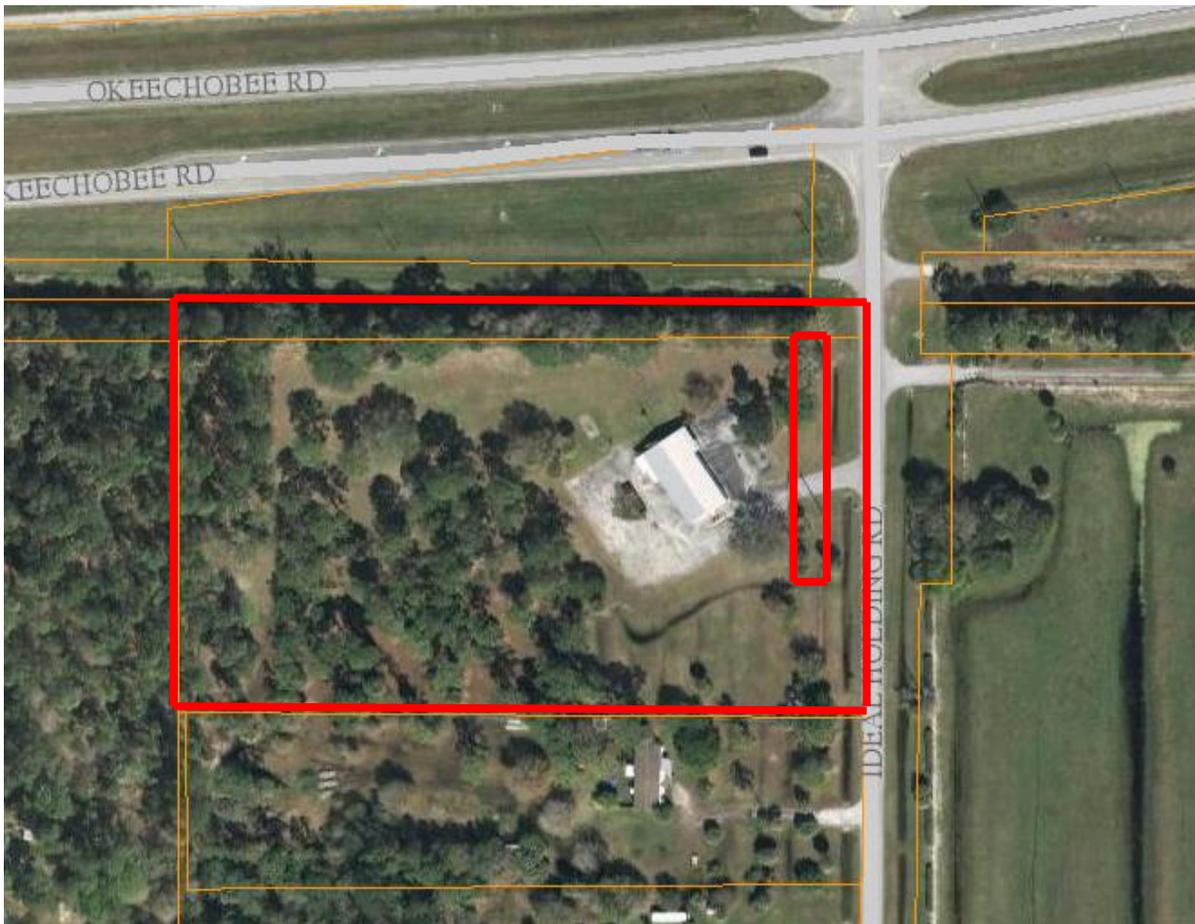
AERIAL SITE MAP

- Drainage – there are three drainage catch basins within the area of the building improvement, one in the approximate middle for the front drive/parking lot, one in the approximate middle of the rear drive/parking lot and one in the lawn area north of the building improvement. It appears underground piping directs water flow to the NSLRWCD canal 75 lying along the subject's north property line.
- NSLRWCD canal 75 provides drainage for the neighborhood, and along subject's north property line there is a berm which appears to be on the canal right of way, thus the only drainage the canal affords the subject is via the mentioned catch basins and engineered piping to the canal.

- There is also a swale ditch within the property, beginning back of the rear drive/parking area and then turning east south of the southerly driveway eventually connecting the swale drainage ditch within the right of way of Ideal Holding Road.
- There is a 15 feet wide easement for drainage along the subject's west property line but it does not appear this is an active drainage area.
- Otherwise drainage in the undeveloped portion of the site is by percolation.

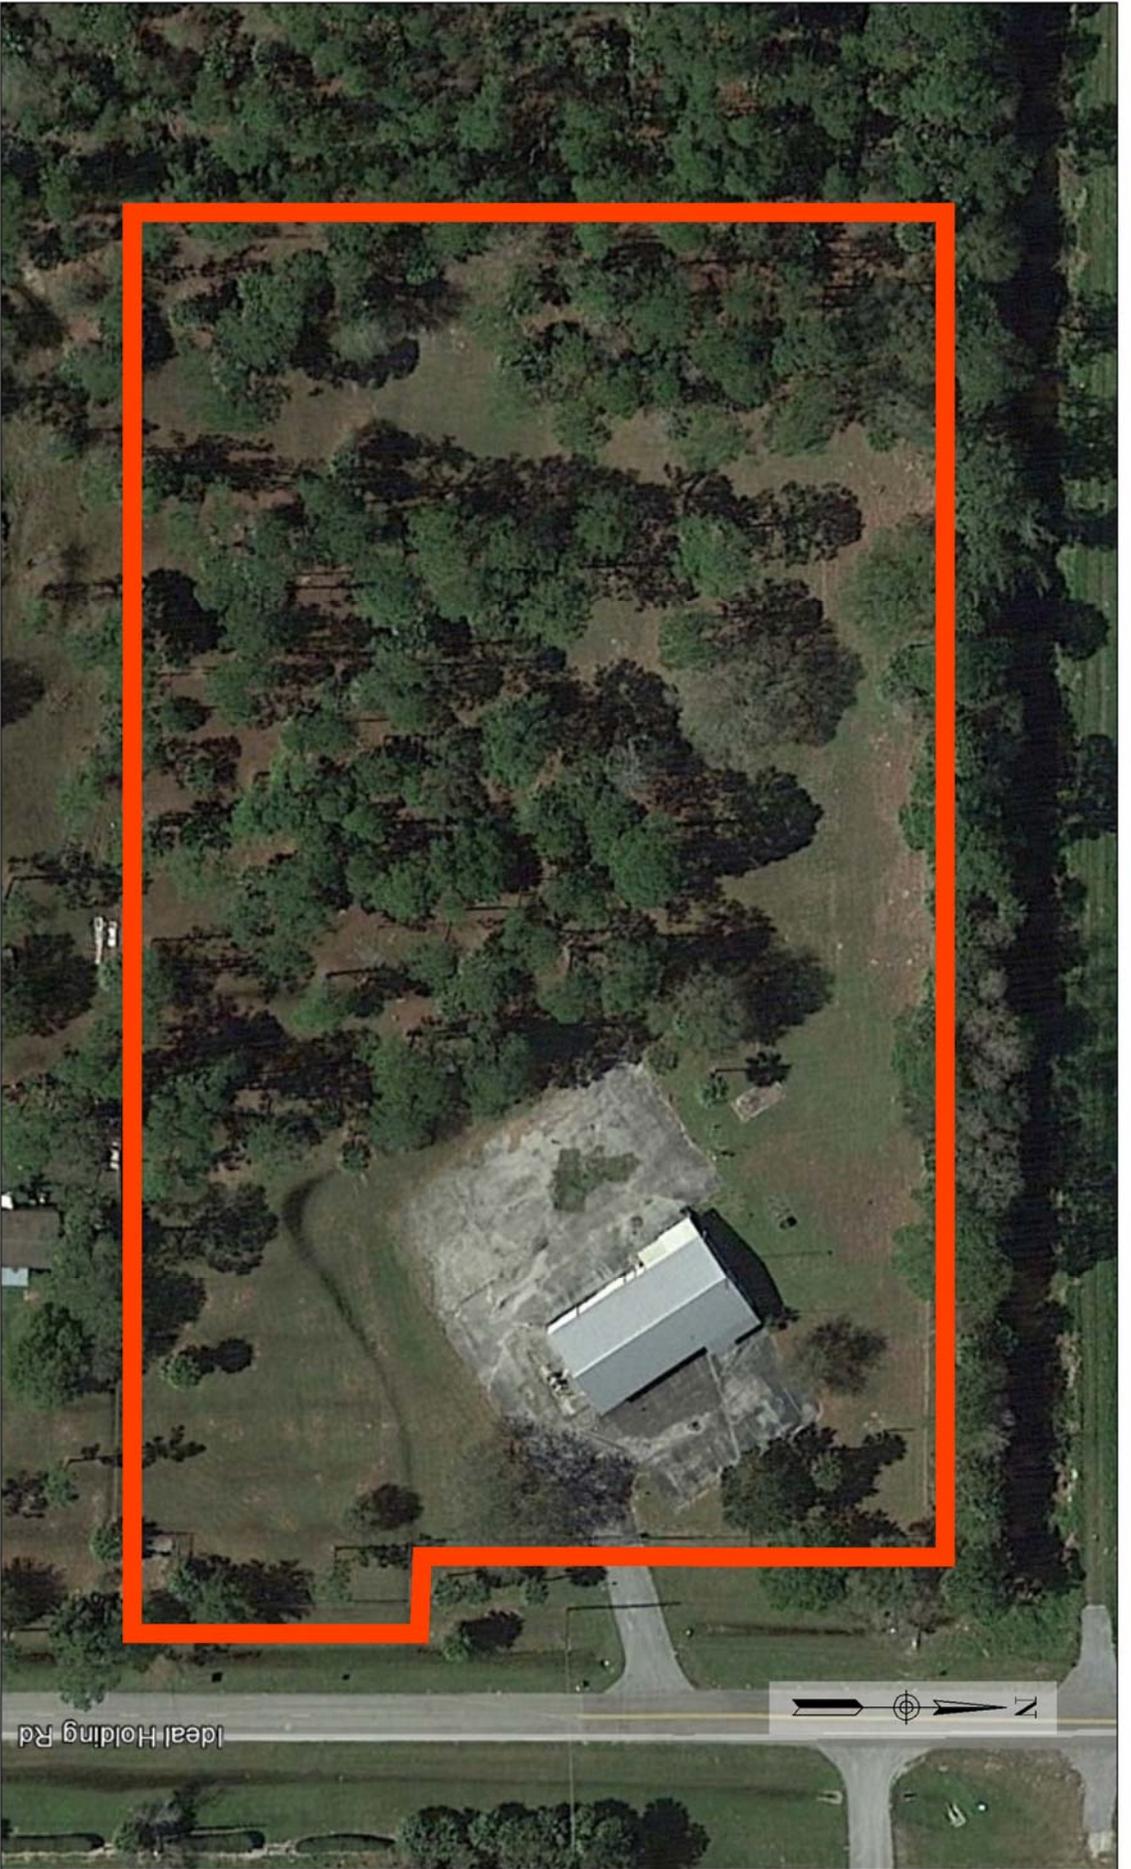
CAD FILE NO.
WMD_FPPS
FIGURE No.
2

- Figure 1 – Site Vicinity Map
- Figure 2 – Target Property Map
- Figure 3 – Site Plan

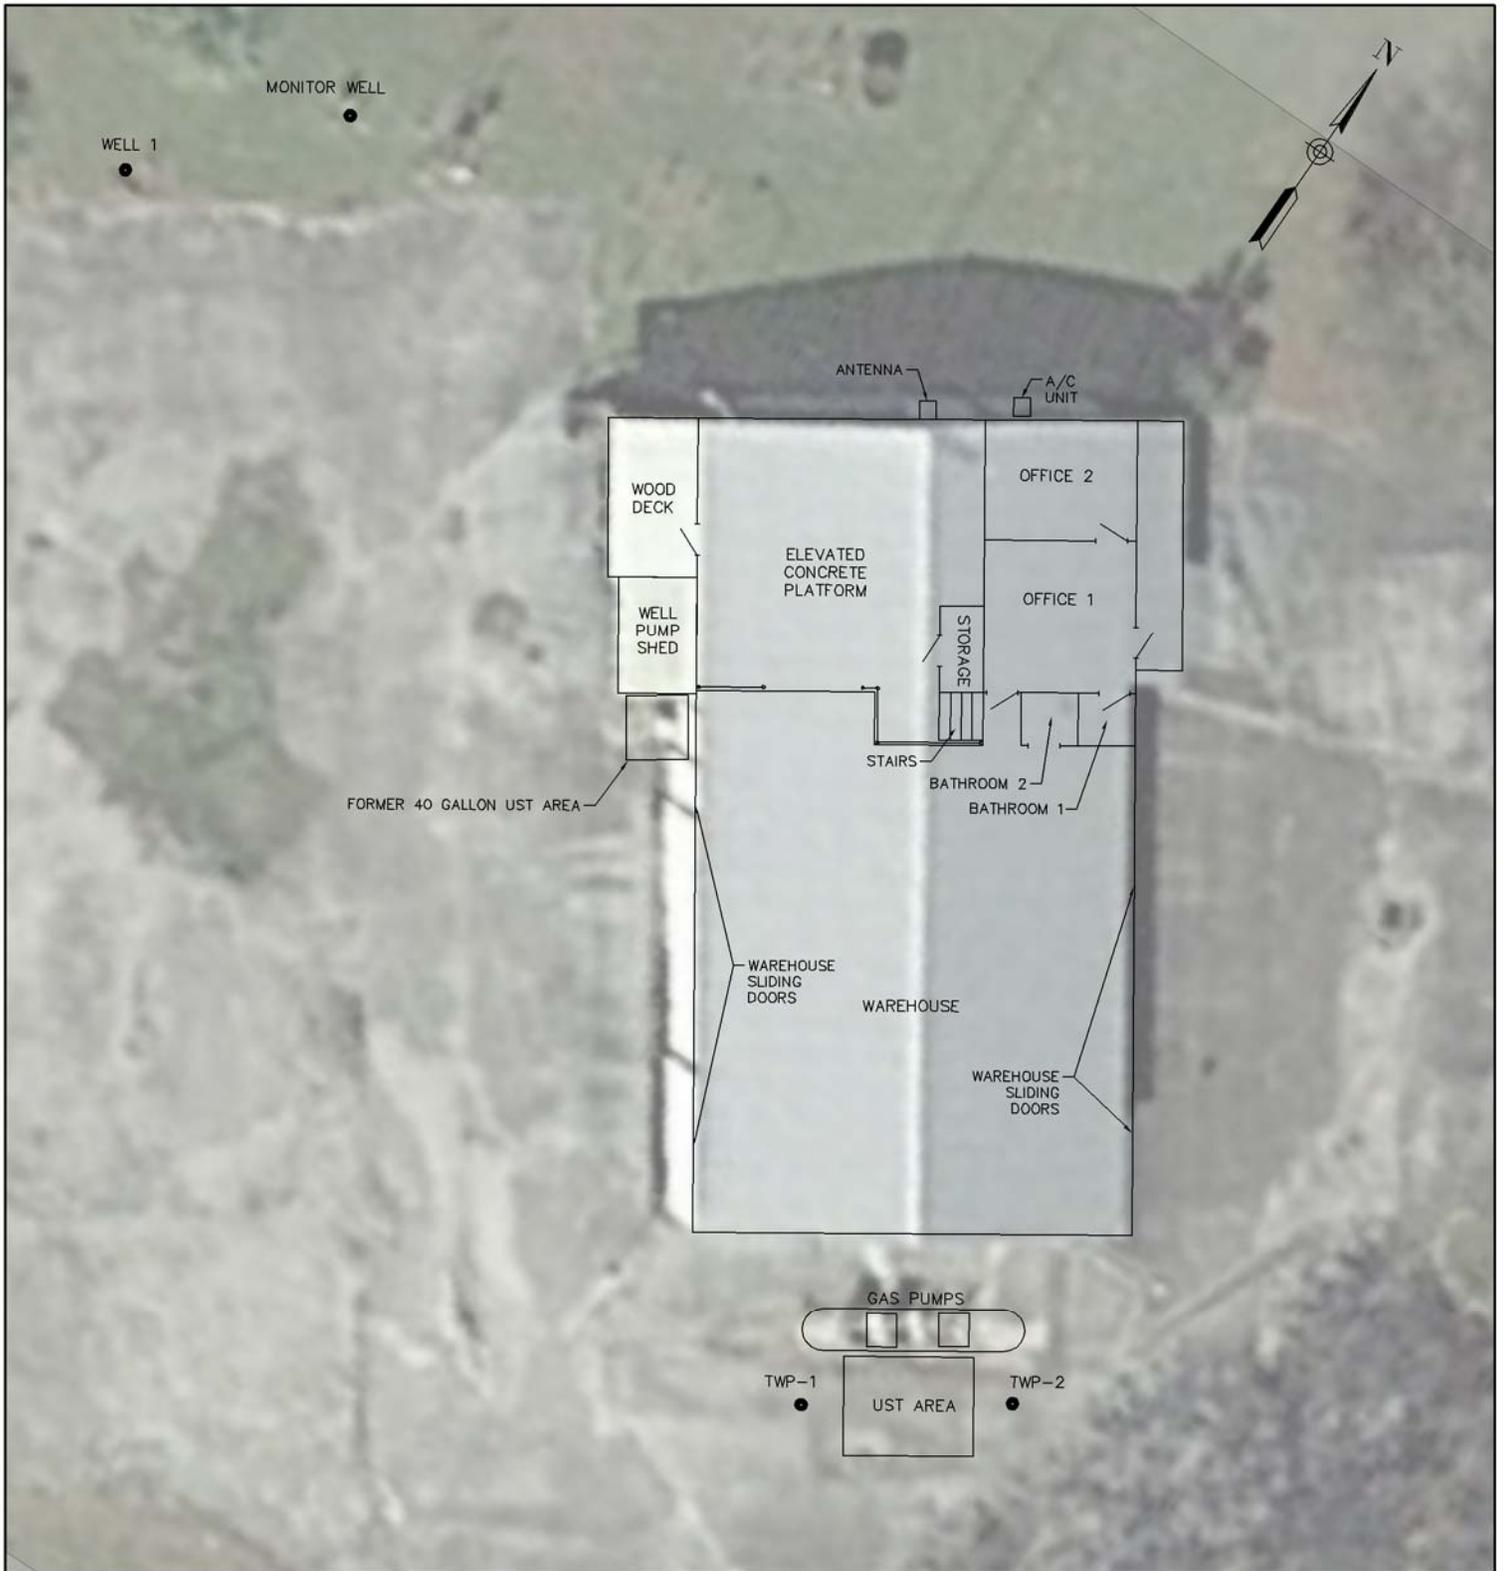
NOTE: THE INTERIOR BUILDING LAYOUT SHOWN IS AN APPROXIMATE REPRESENTATION FOR INFORMATIONAL PURPOSES ONLY, AND IS NOT INTENDED TO DEPICT THE TRUE CONDITIONS OF THE BUILDING INTERIOR.

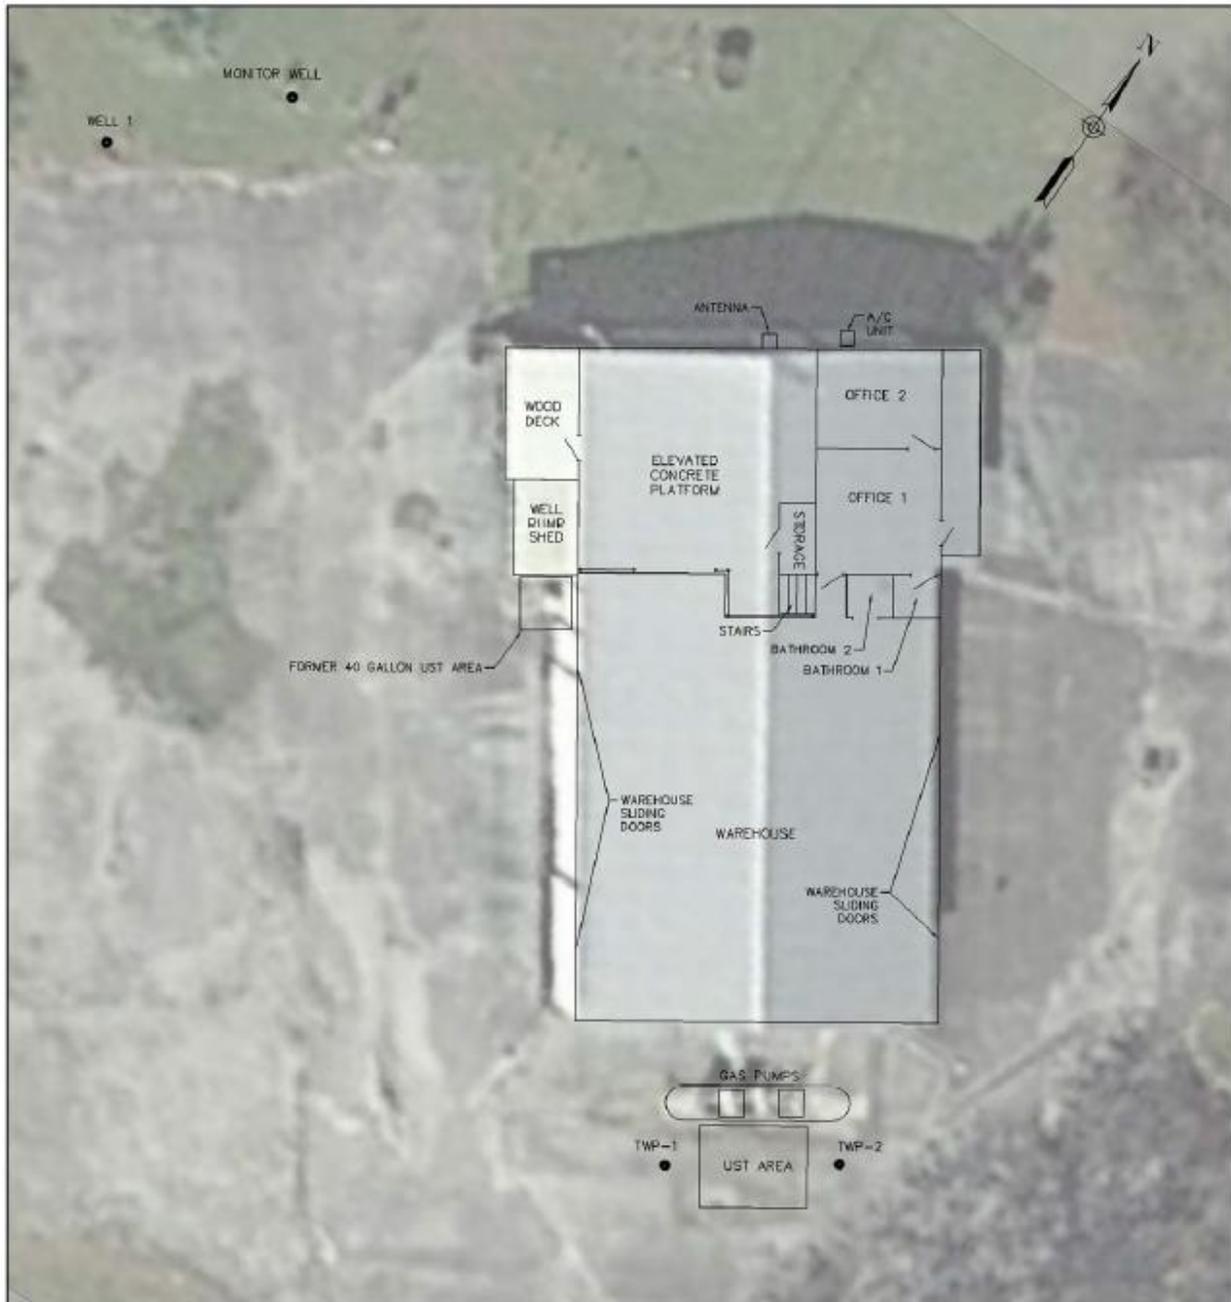
**SOUTH FLORIDA WATER
 MANAGEMENT DISTRICT**
 FORT PIERCE FIELD STATION
 FORT PIERCE, FL
 SITE LAYOUT

NOTE: THE INTERIOR BUILDING LAYOUT SHOWN IS AN APPROXIMATE REPRESENTATION FOR INFORMATIONAL PURPOSES ONLY, AND IS NOT INTENDED TO DEPICT THE TRUE CONDITIONS OF THE BUILDING INTERIOR.
 ALL LOCATIONS DEPICTED ARE APPROXIMATE

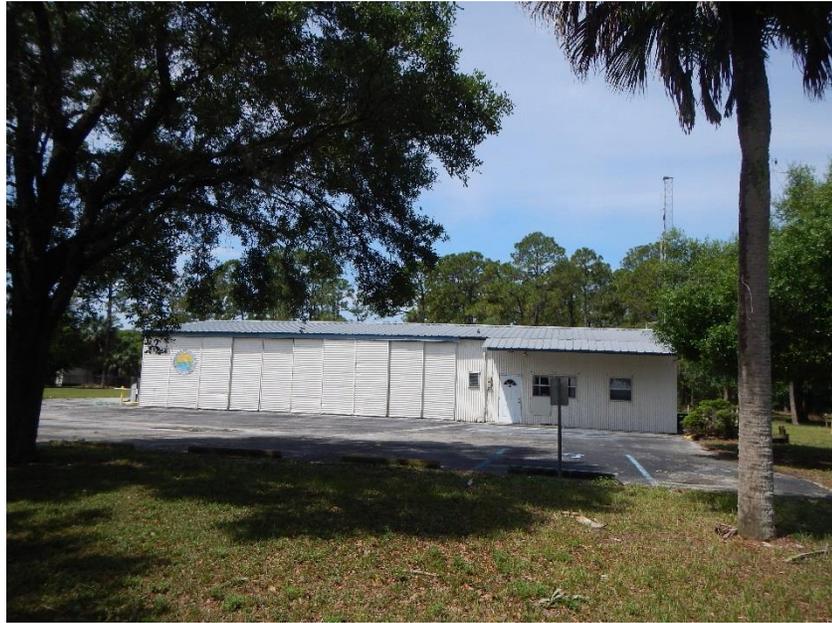
Photo: 2

General view of the building front, from the East side. Roof appears to be in good condition. The pavement along the front parking area is in good condition.

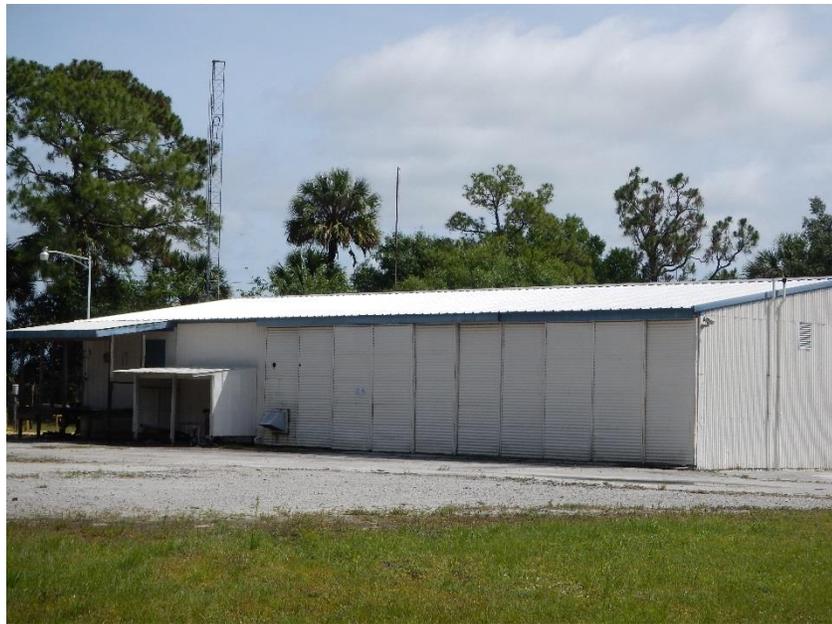
General view of the back of the building, from the West side. Roof appears to be in good condition. The pavement along the back is cracked, with exposed dirt and gravel areas.

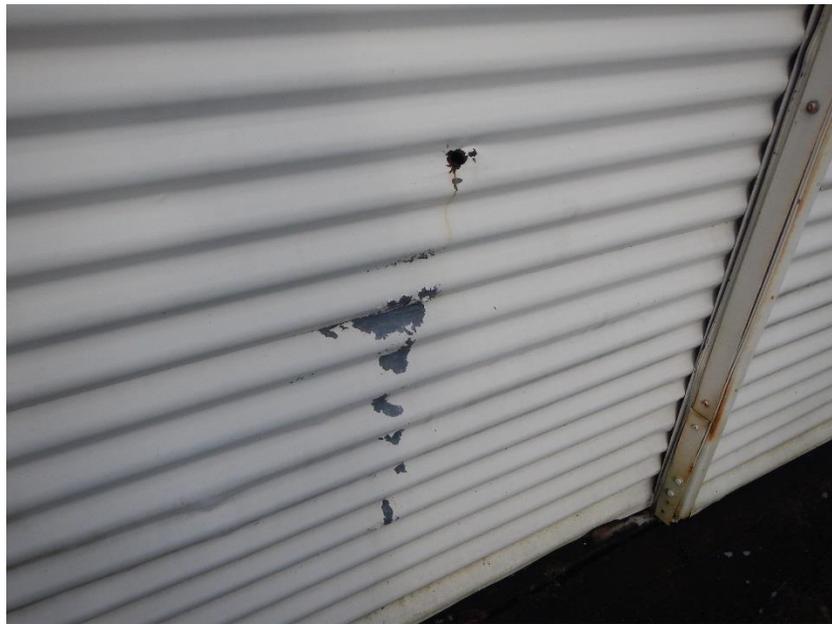
Photo: 4

View of first sliding warehouse door at the Southeast corner of the building. Typical paint peeling from some of the metal warehouse doors. There are also some small punched holes occasionally seen throughout the metal sheets and doors.

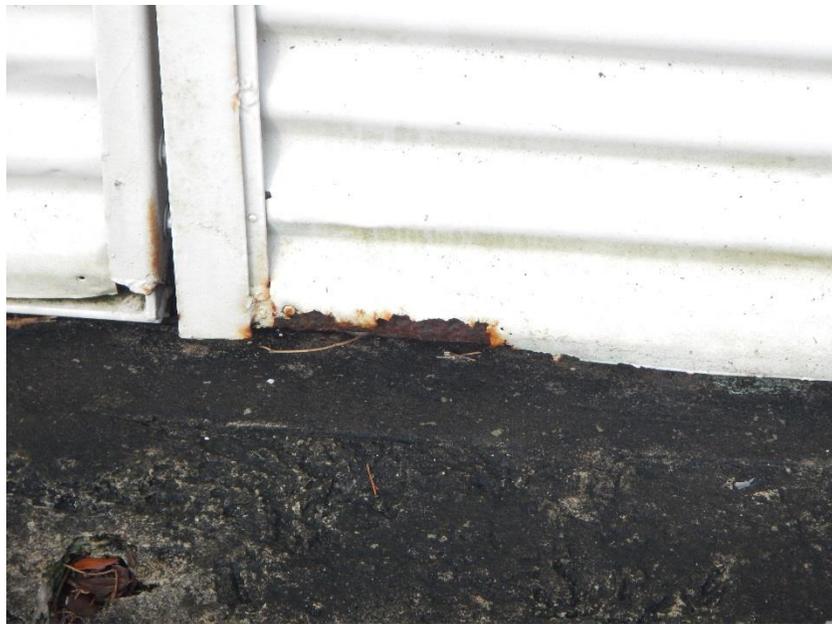
View of warehouse door on East side of the building. Typical peeled paint and rusting along the bottom of various warehouse doors.

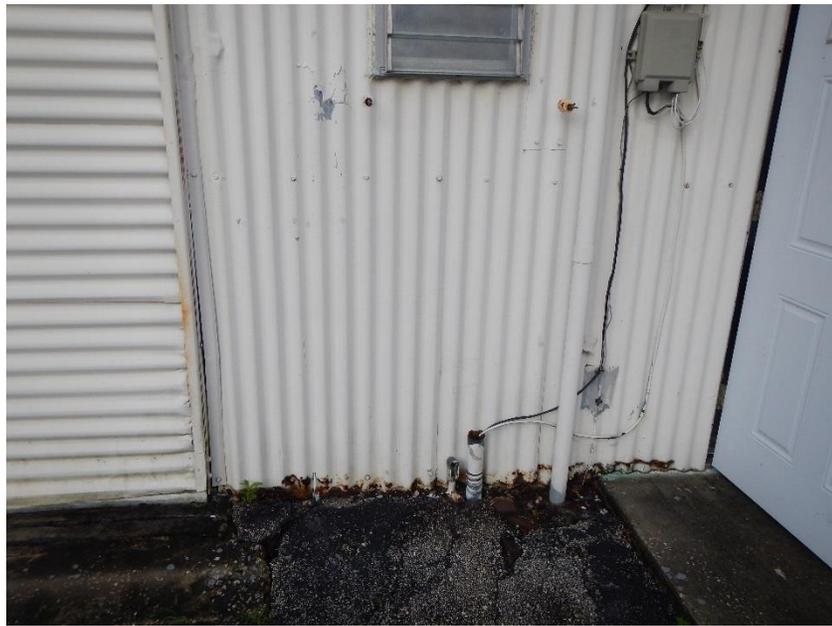
Photo: 6

View of building wall next to front entrance on East side of building. The metal sheeting outside of the office area has various spots of peeled paint and rust staining and rusting/corrosion along the bottom.

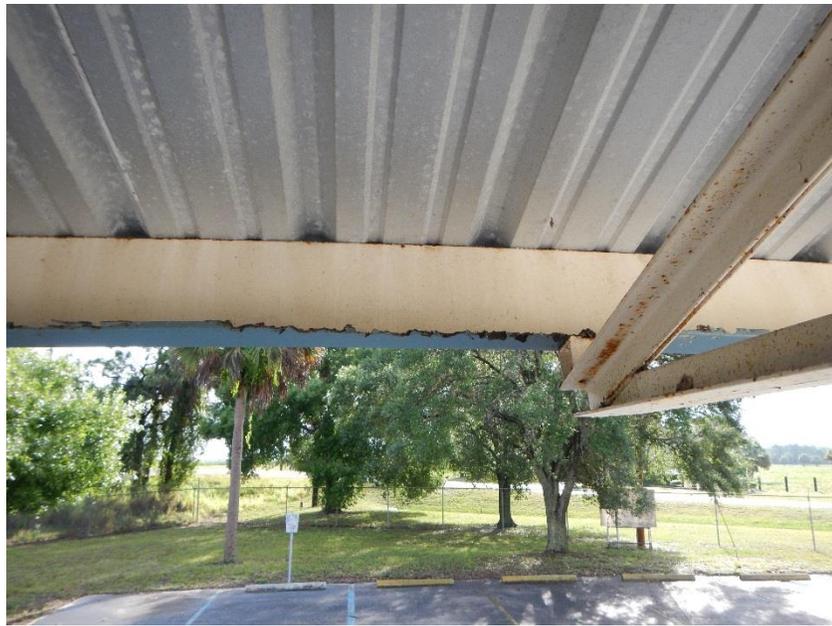
The support beams under the roof overhang by the front door are showing signs of rusting/corrosion along the edges, with some support beams showing rust/corrosion throughout.

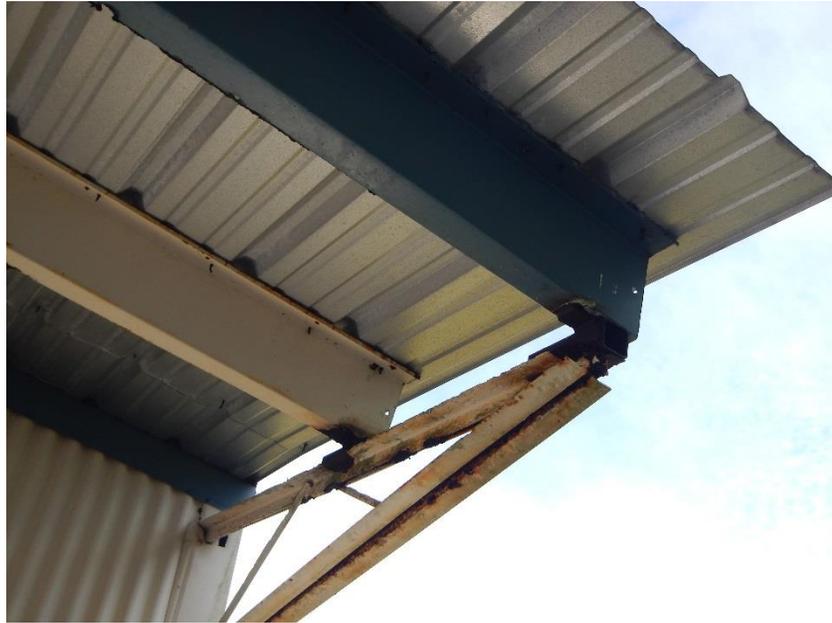
Photo: 8

The roof overhang by the front door with corrosion along the edges of the supporting angle beams.

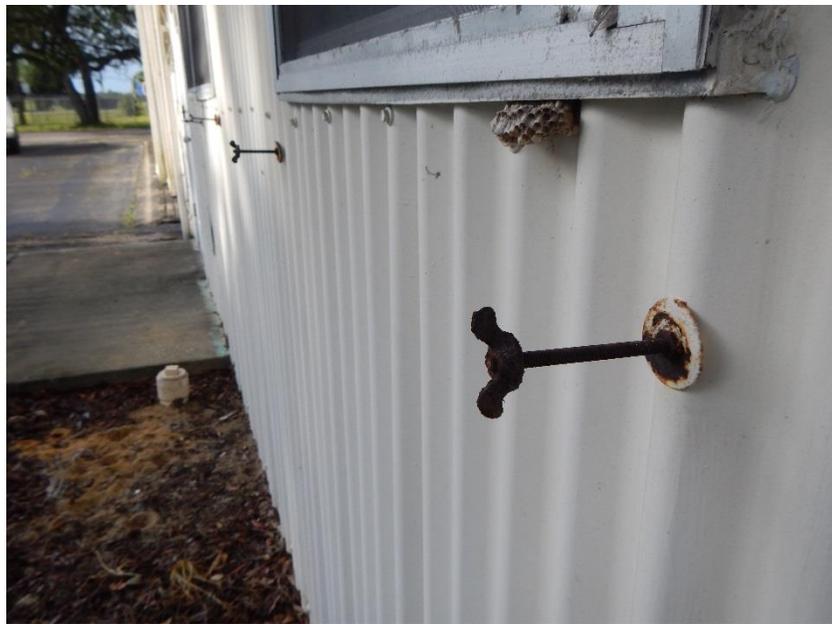
View under second window from front door on East side of building. The hurricane shutter bolts around the windows are rusting/corroding.

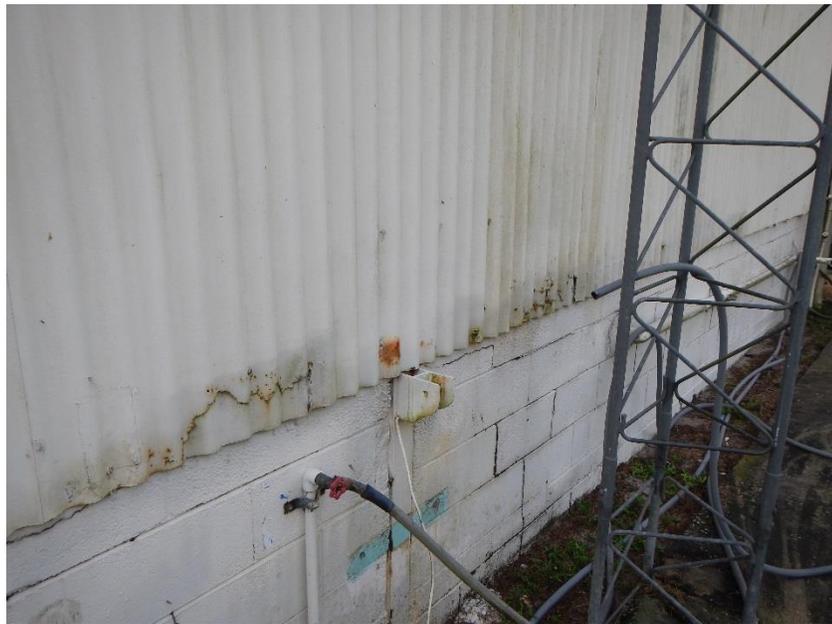
Photo: 10

Exterior metal sheeting and coating are rusting/corroding along the bottom on the North side of the building. Water is available/running at the hose bib on this side of the building.

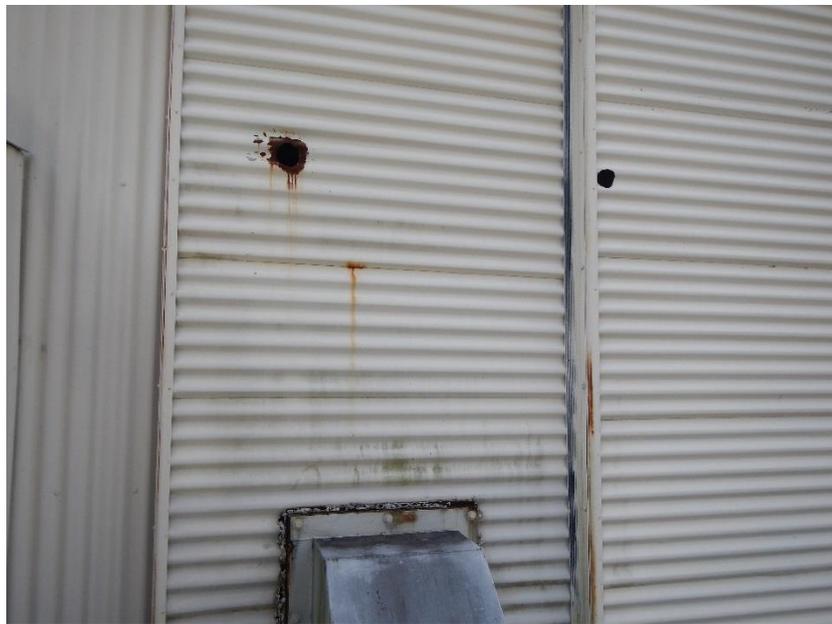
Two large punched holes exist on the warehouse doors on the West side of the building. There is loss of coating and rust/corrosion developing along one of the holes, with some rust staining on the edges of the doors.

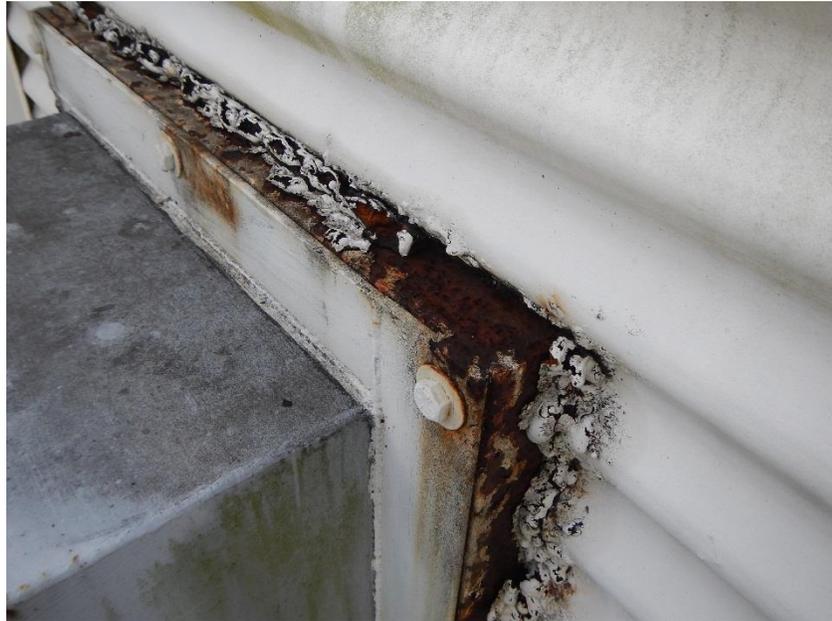
Photo: 12

A vent was installed through one of the warehouse doors on the West side of the building – the doors do not appear to open/close here. The joint between the vent and metal door is rusting/corroding.

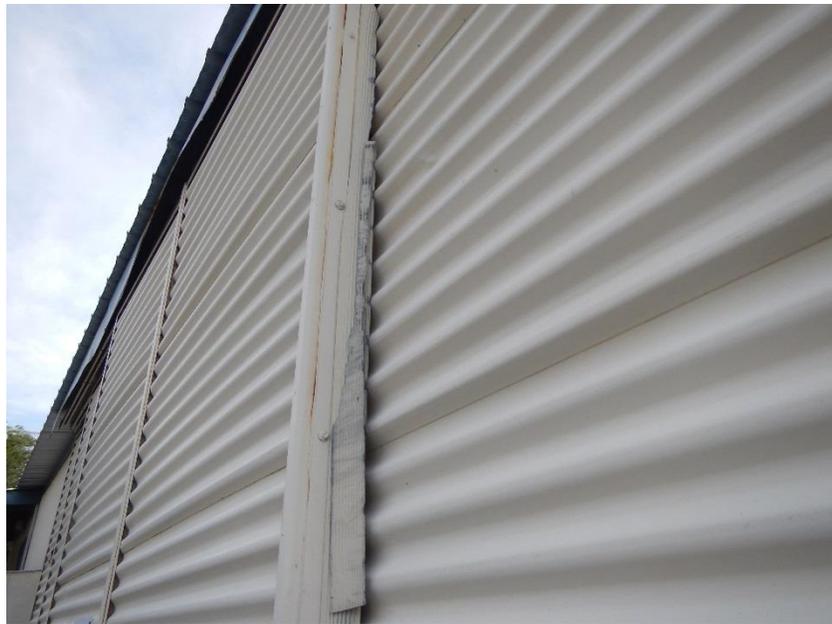
View of warehouse door on West side of building. Plastic flashing along the edges of the warehouse doors is worn and breaking.

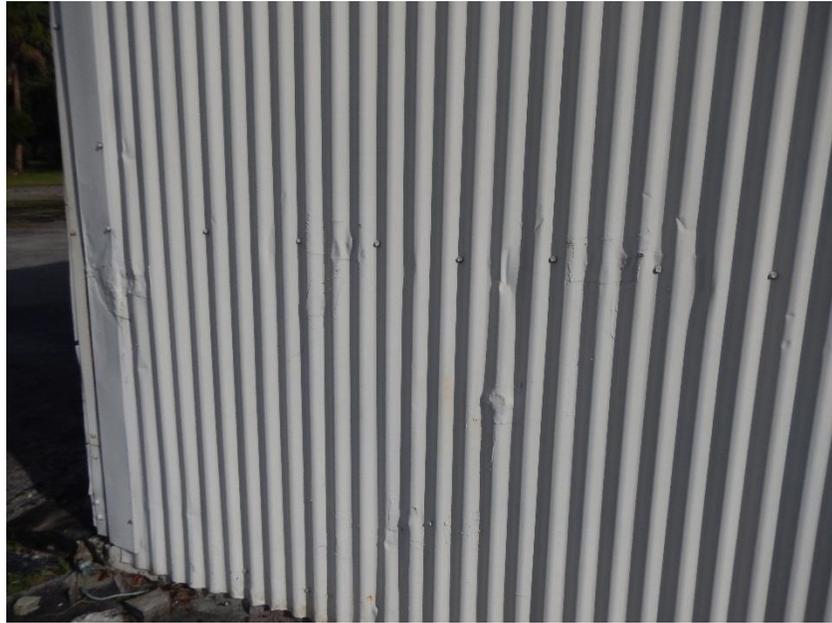
Photo: 14

View of the metal sheeting on the South side of the building. Various patched holes were seen along this wall.

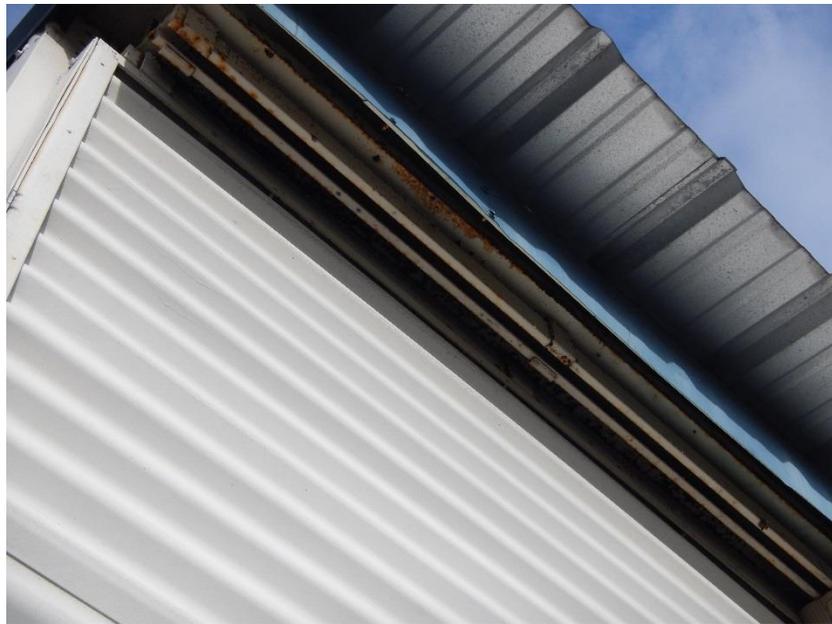
Typical rust staining along the top warehouse door tracks. (NOTE: The ability for doors to open/close could not be tested as the keys were not provided for these doors)

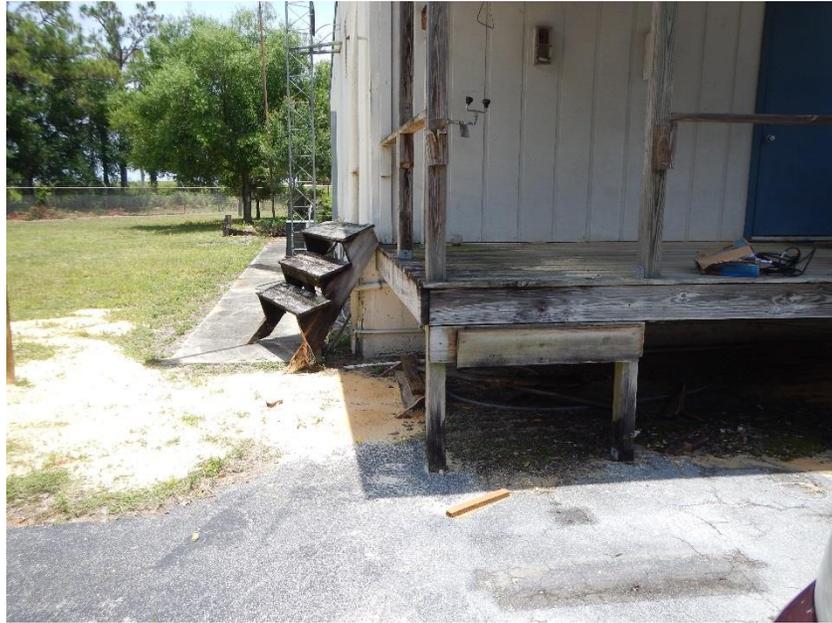
Photo: 16

View of the wood deck/platform on the Northwest side of the building. The wood deck is in good condition. The steps that used to lead up to the deck are deteriorating and/or broken and have been moved aside.

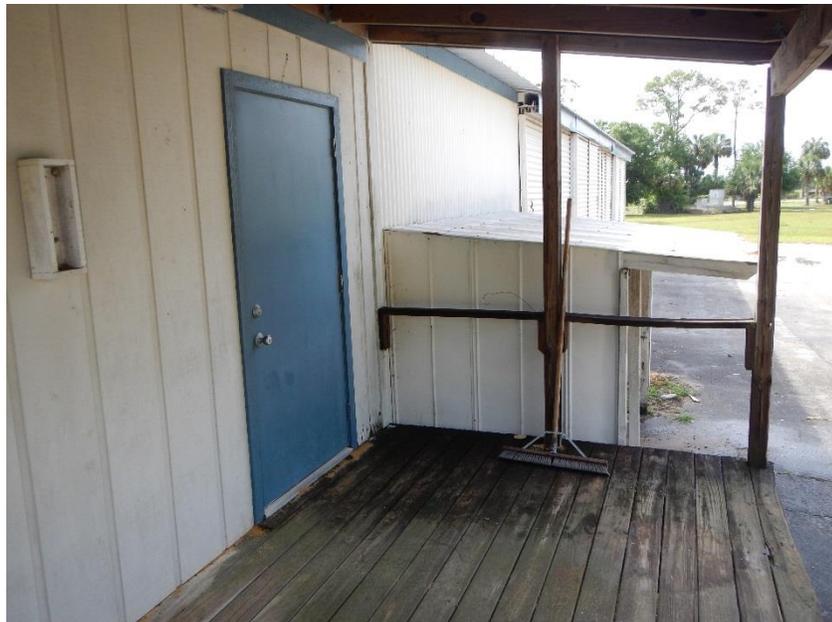
View of the door from the exterior wood deck. The overall condition of the wood planks and the wood overhang are in good condition. The operational status of an emergency shower/eyewash station on this platform could not be determined.

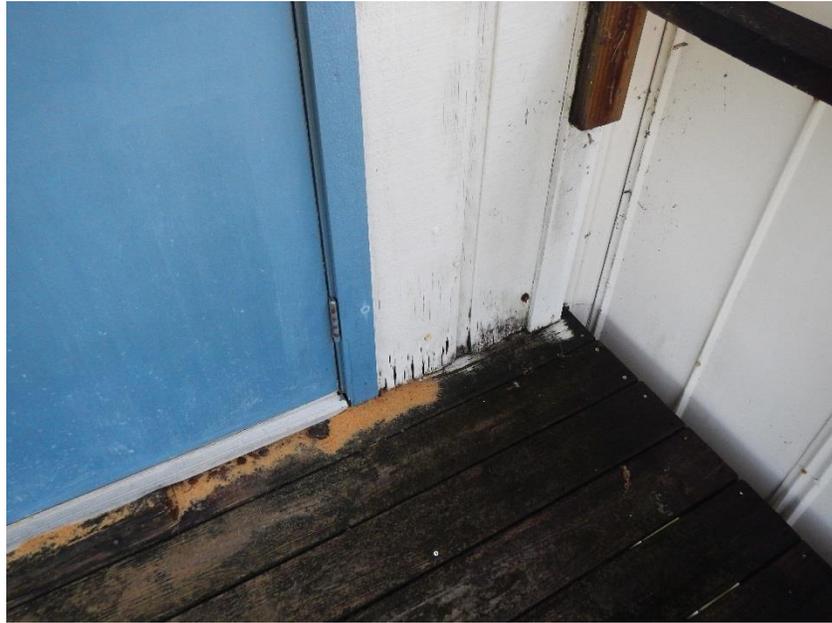
Photo: 18

View of wood panels next to the back door on the exterior wood deck. The wood panels next to the door leading out to the wood deck are peeling/deteriorating from water damage along the bottom.

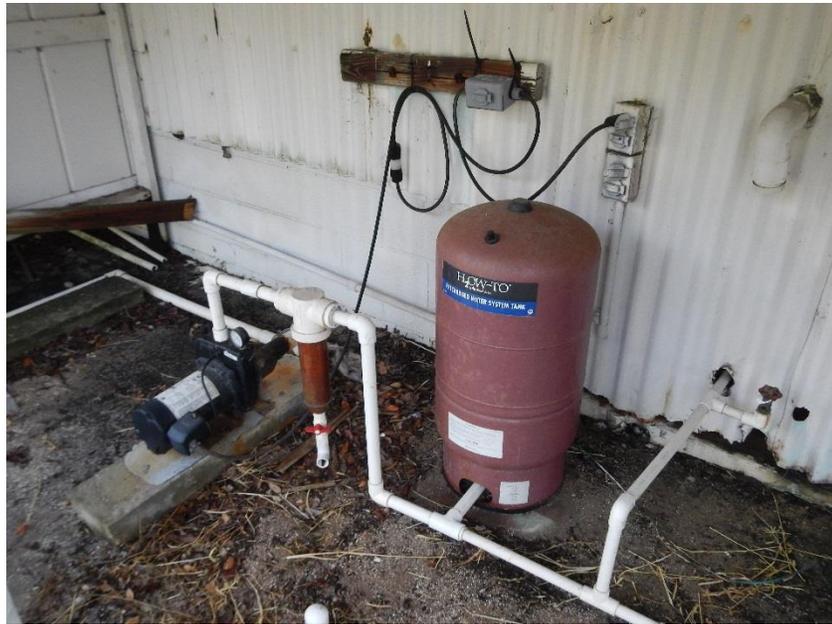
Well pump and associated pressure tank filter and plumbing located at the West side of the building. The pump is in good condition supplying water throughout the building.
