TRACT NO. D0100-004 SURPLUS MATERIALS

Former Fort Pierce Field Station
St. Lucie County

Tetra Tech Building Inspection Checklist
SFWMD Fort Pierce Field Station
Fort Pierce, St. Lucie County, Florida 33451
May 18, 2016

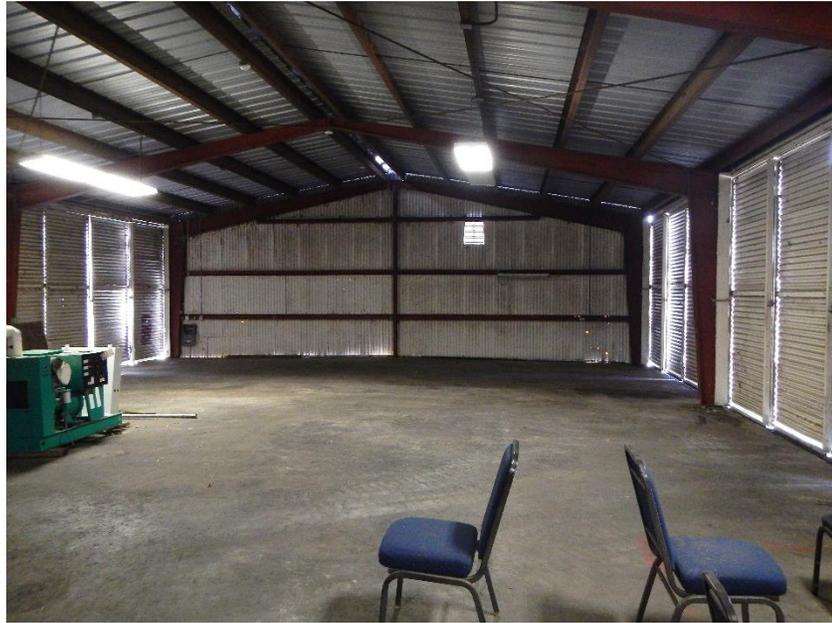
Photo: 20

View of the warehouse portion of the building interior, facing South. The side walls consist of numerous sliding metal doors (NOTE: The ability for doors to open/close could not be tested as the keys were not provided for these doors). All electrical sockets were in working condition.

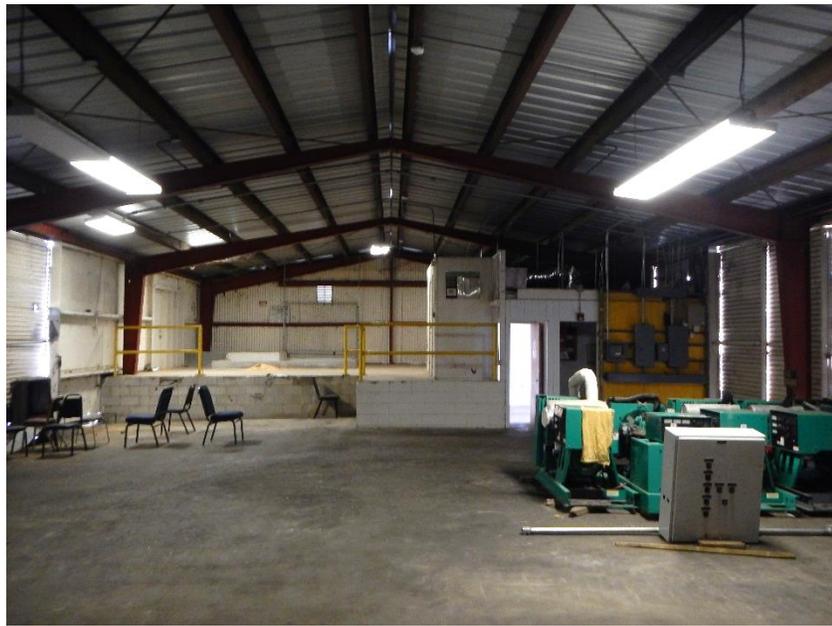
Photo: 22

View of the warehouse portion of the building interior, facing North. There is an elevated concrete platform (left), and access to the offices (right). Bathroom 2 is accessible from here, and circuit breakers are located along the wall (right). There is also equipment still in the warehouse.

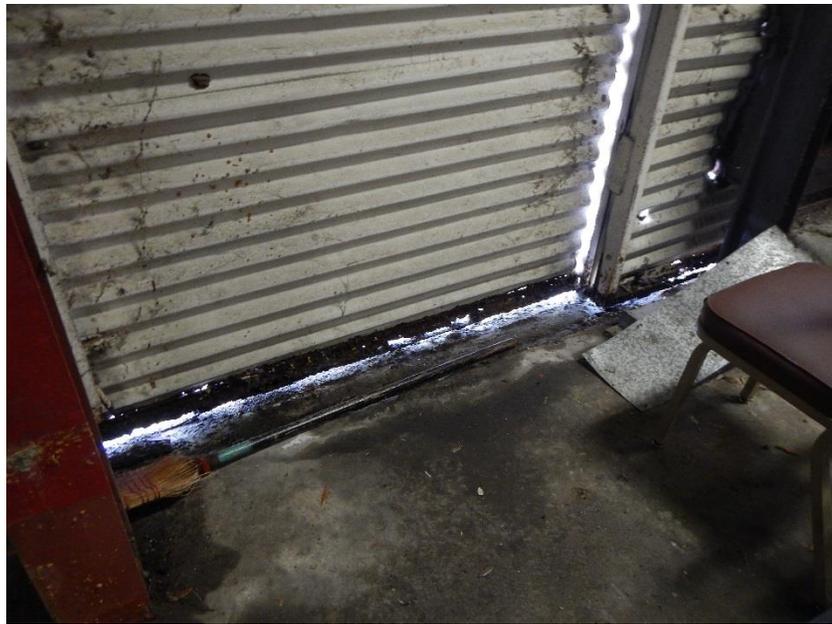
View of warehouse doors on West side of building. Typical signs of rusting/corrosion along the bottom edge of the warehouse sliding doors.

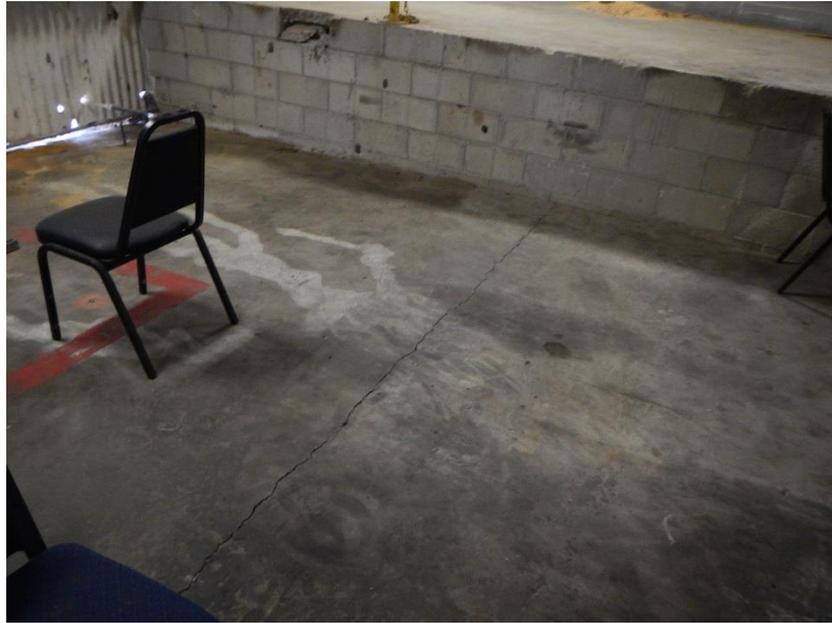
Photo: 24

View of warehouse floor by the elevated concrete platform. The concrete floor along the warehouse is in good condition, with some typical concrete cracking throughout.

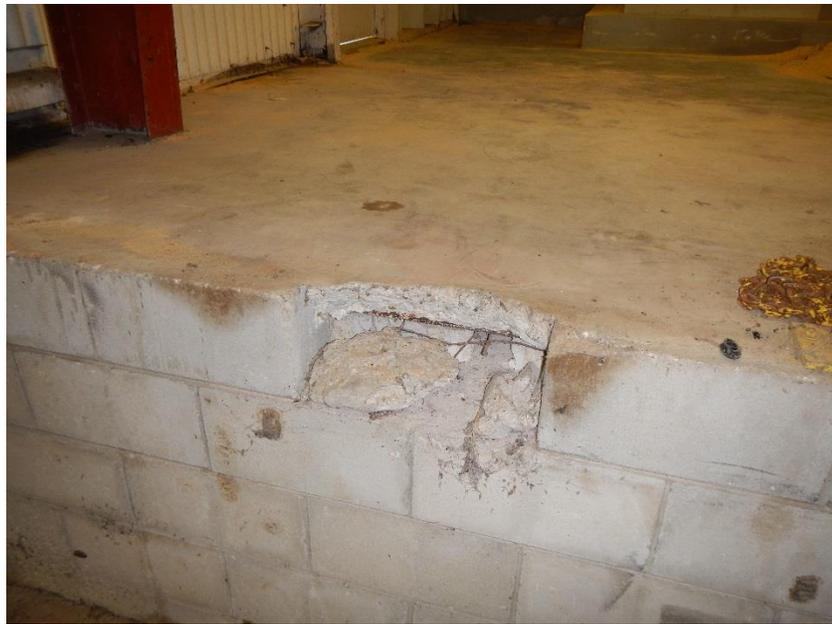
One concrete block on the elevated platform is damaged, exposing reinforcement.

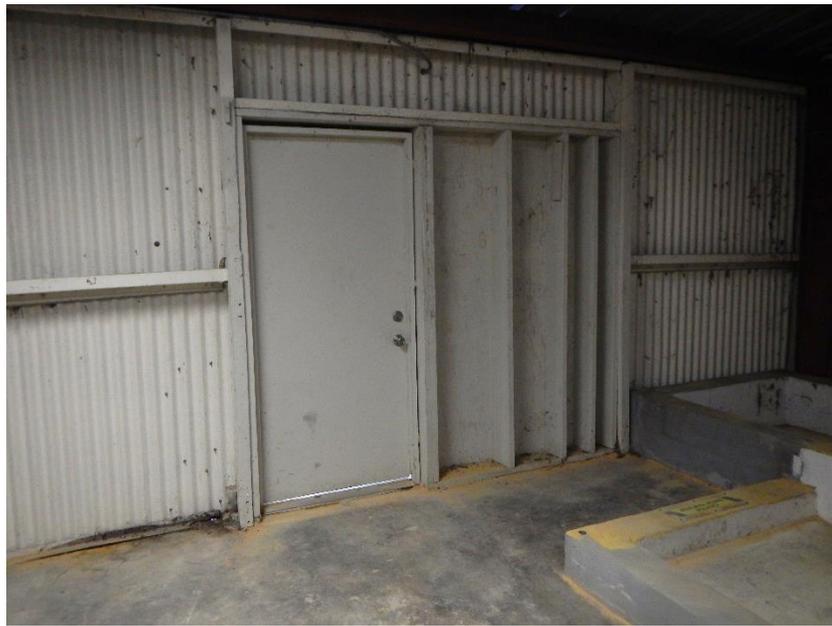
Photo: 26

On the elevated concrete platform there is access to the exterior wood deck. Door is in good working condition.

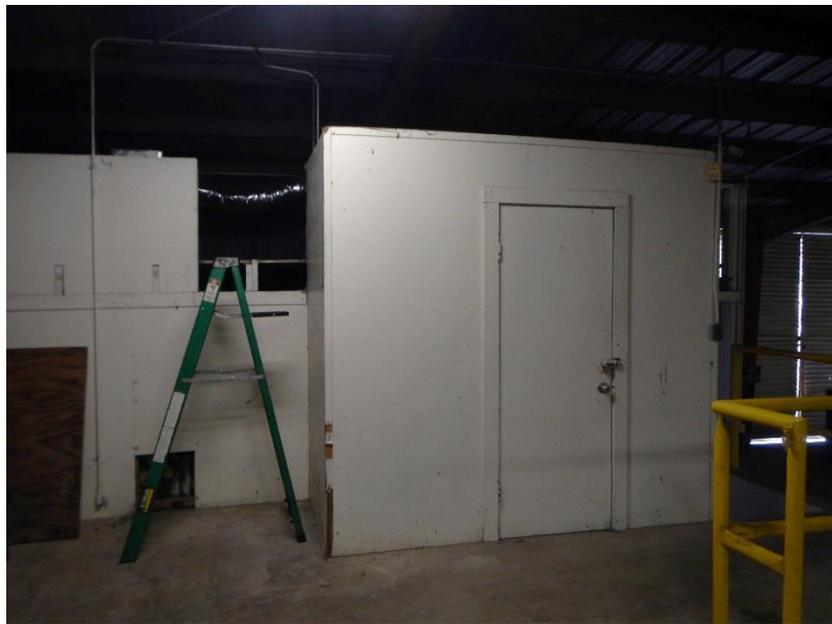
There is a small storage closet located on the elevated platform, with door and interior in good condition. Behind/next to the storage closet is access to the air handling unit for the office air conditioning.

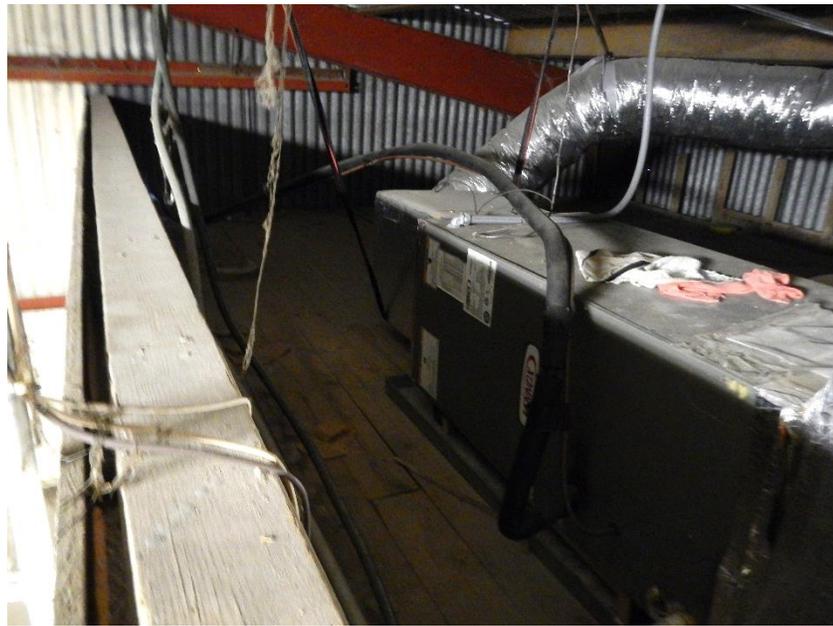
Photo: 28

The air handling unit and ducts/ventilation appear in good condition above the office spaces.

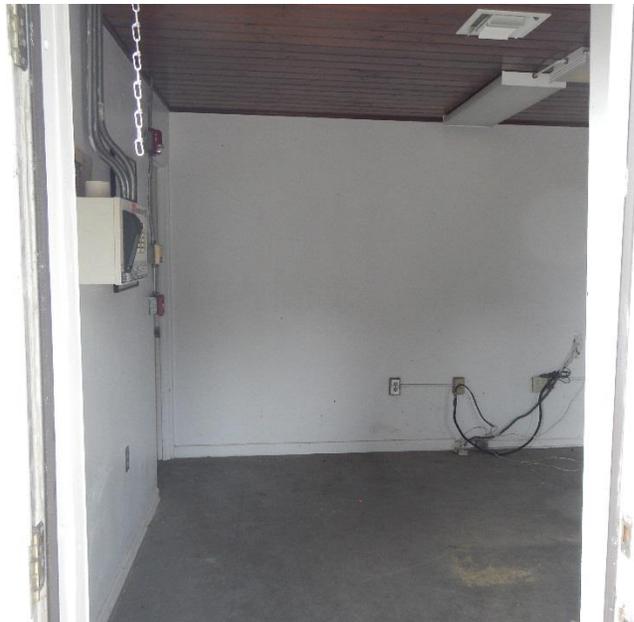
View of Office 1 from the front entrance. The ceiling is in good condition, but the floor tiling is lifted and breaking in various places. All lighting and electrical sockets are in working condition throughout all offices.

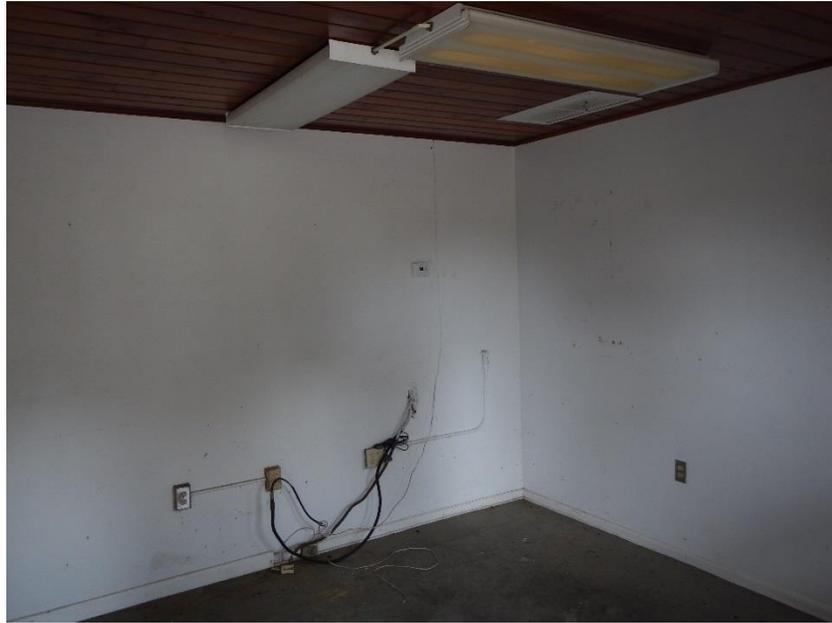
Photo: 30

General view in Office 1. Various cables are protruding from the wall. The thermostat is accessible on the wall here. The fan setting on the thermostat was operating, and there was no issue with air traveling to both offices, however the cooling/heating aspects could not be tested, possibly due to an unresponsive thermostat.

Because keys to the locks on the warehouse doors were not provided, they could not be tested to confirm whether they opened and closed properly.
Due to the inability to operate the air conditioner unit, it could not be confirmed whether it was in good working order. The thermostat should be checked to see if that will allow the air conditioner system to work (all breaker switches were checked and turned on to ensure this was not the issue).

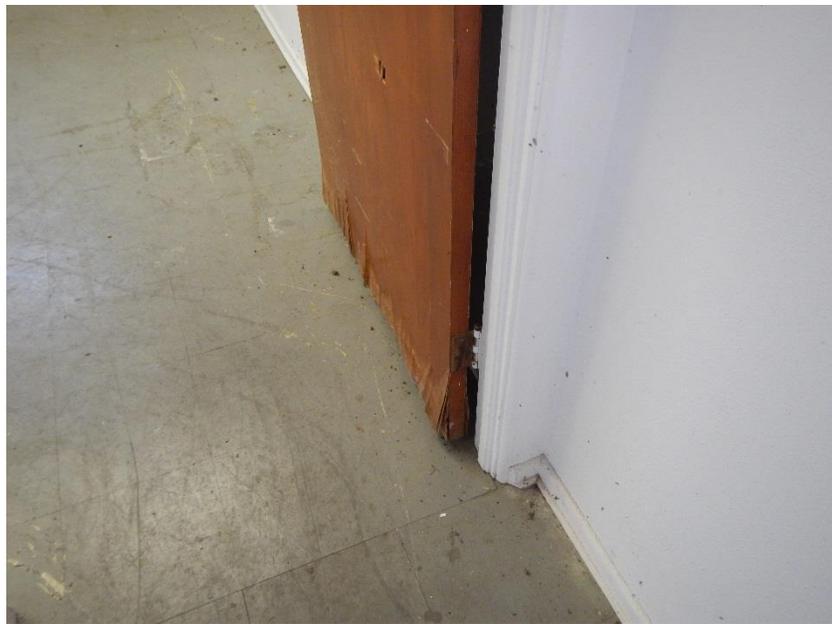
The door to Office 2 has severe water damage along the bottom. The door will no longer close.

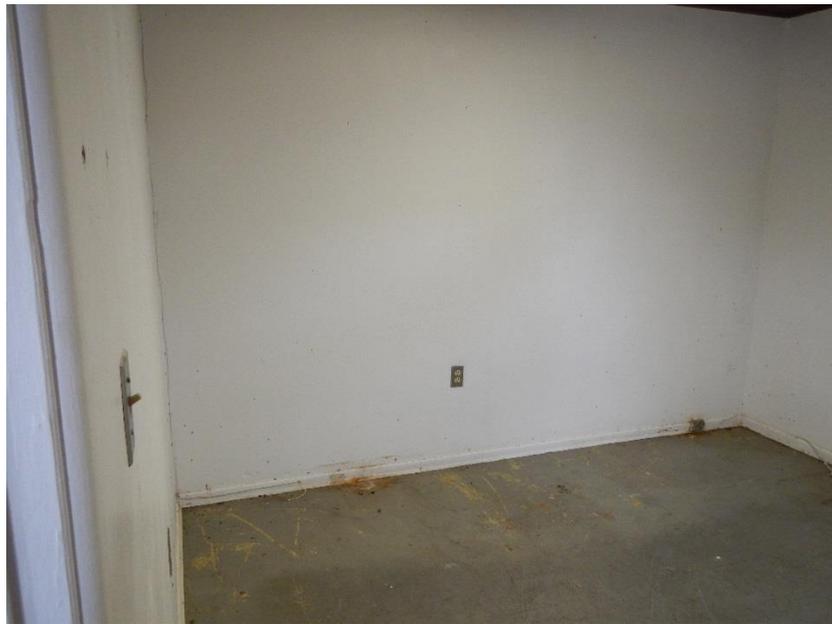
Photo: 32

General view of Office 2. The floor tiling is not in good condition, and there is staining on the floor and along the walls.

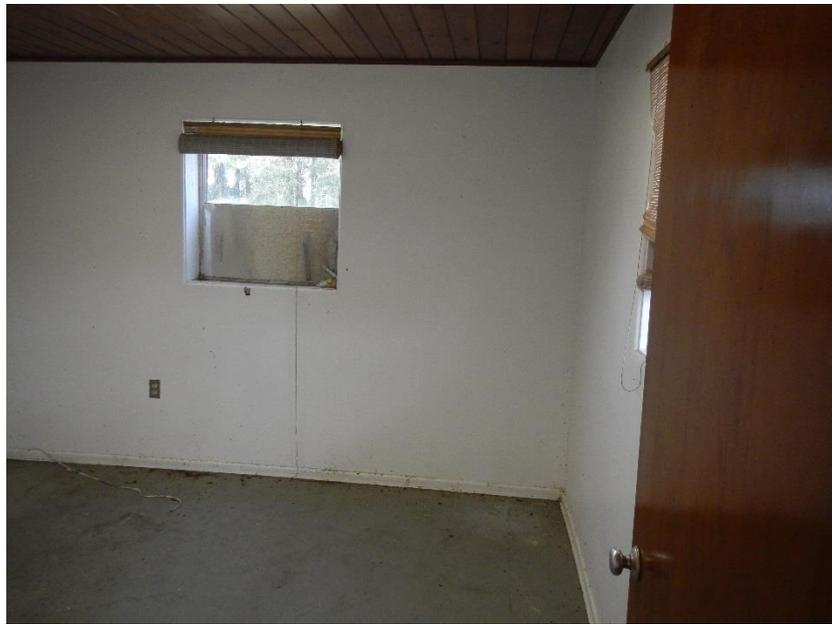
General view of Office 2. The ceiling is in good condition, and one of the windows has a metal sheet panel on the inside and outside along the North wall.

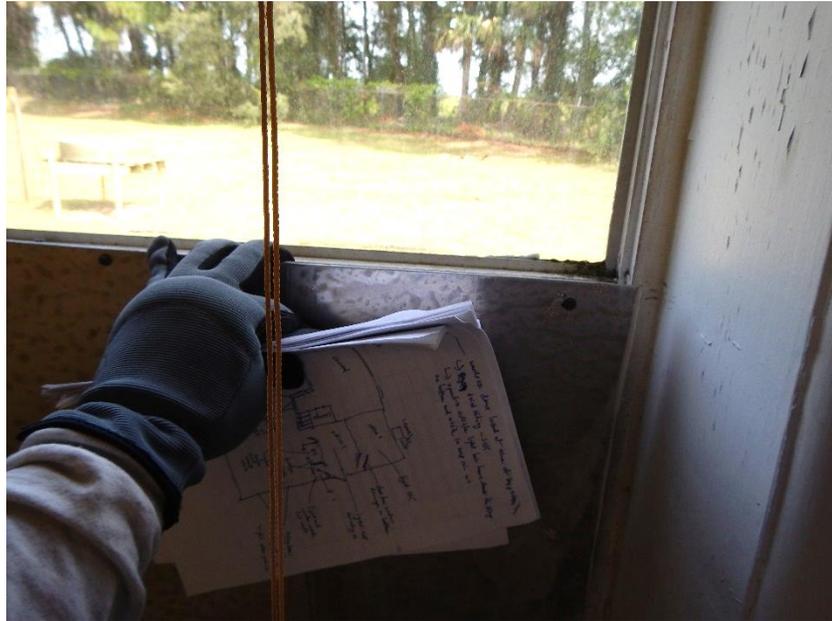
Photo: 34

The window panel in Office 2 is loose on the inside. The exterior panel appeared in good condition.

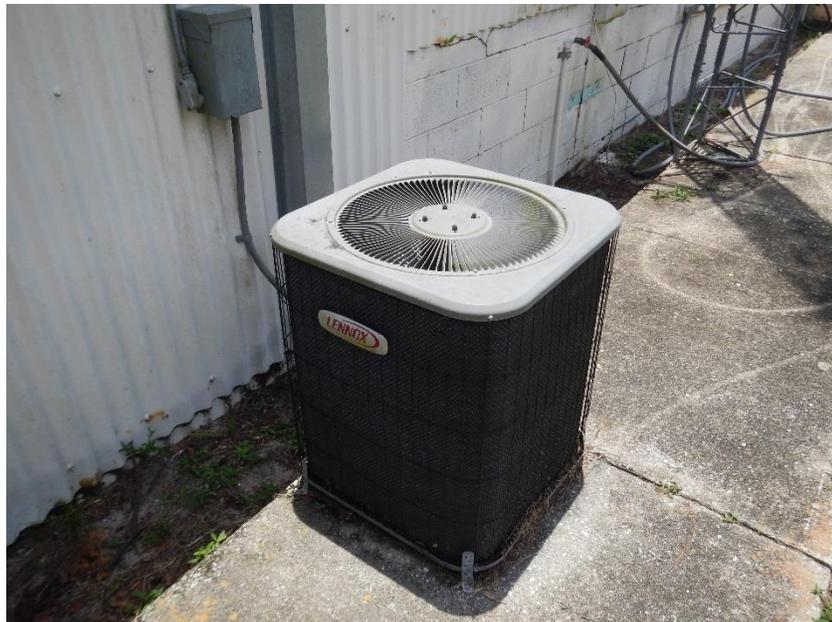
The exterior air conditioner unit would not operate when turned on, reason unknown, although the thermostat may not have been working correctly.

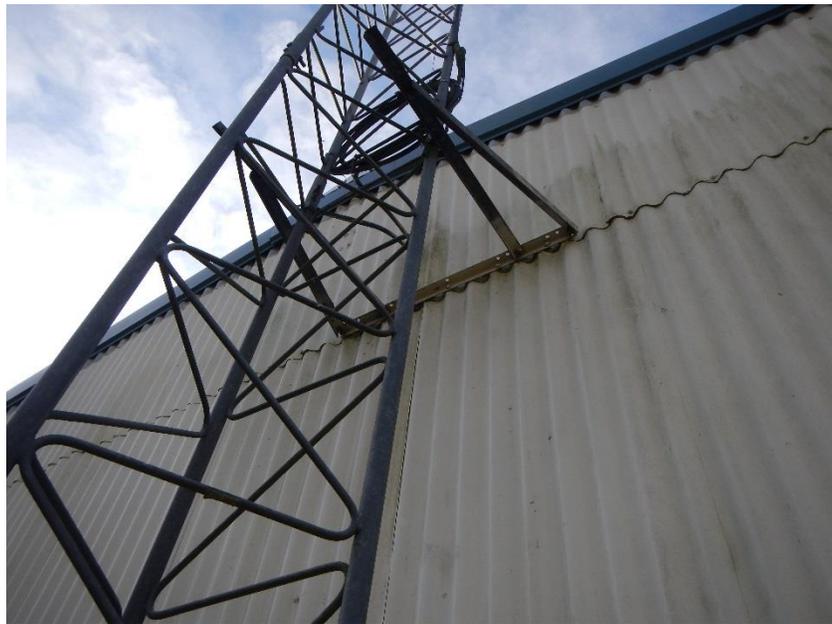
Photo: 36

The antenna on the North side of the building appears to be in good condition, with no loose or missing hardware connections observed.

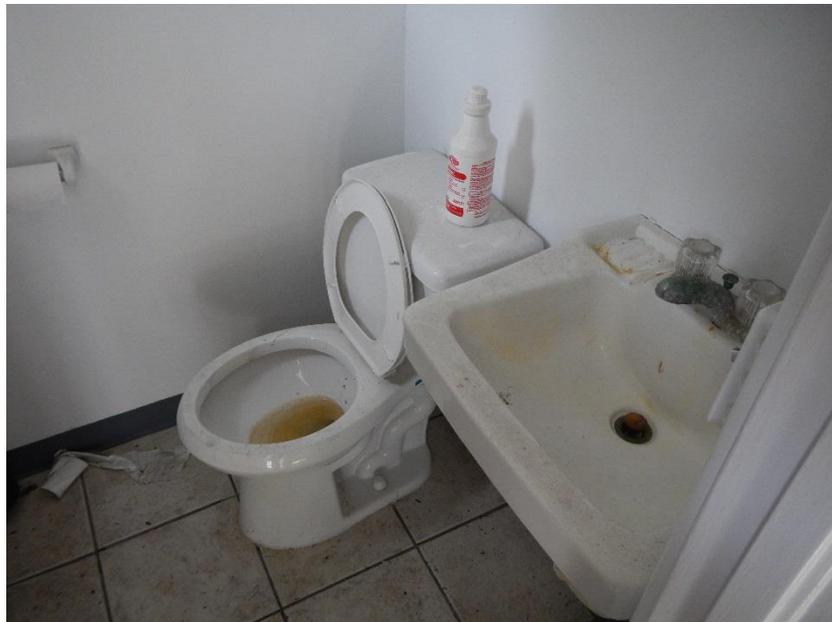
Bathroom 1, accessible from Office 1. There is water running to the bathroom fixtures, however the toilet did not seem to have enough pressure to flush.

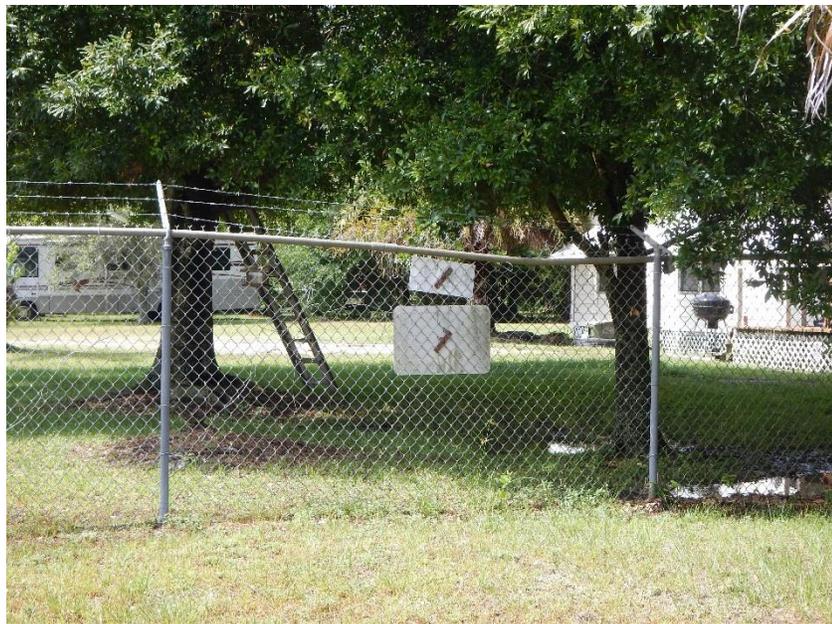
The overall condition of the perimeter fence is good. One problem area was found along the South portion of the fence where the top bar was bent down along with the bottom piece of barbed wire.

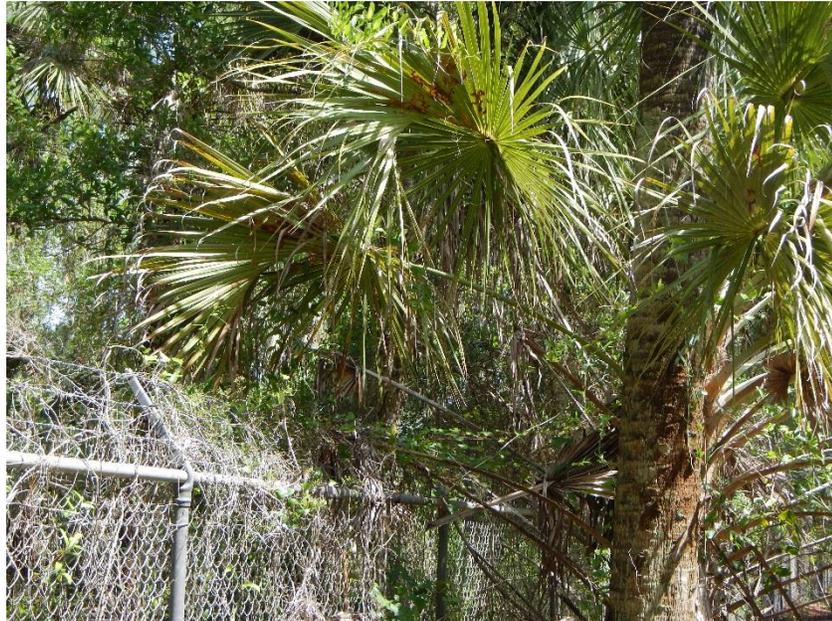
Photo: 40

Along the West portion of the fence plants are starting to grow over the fence, but the fence and barbed wire itself are in good condition.

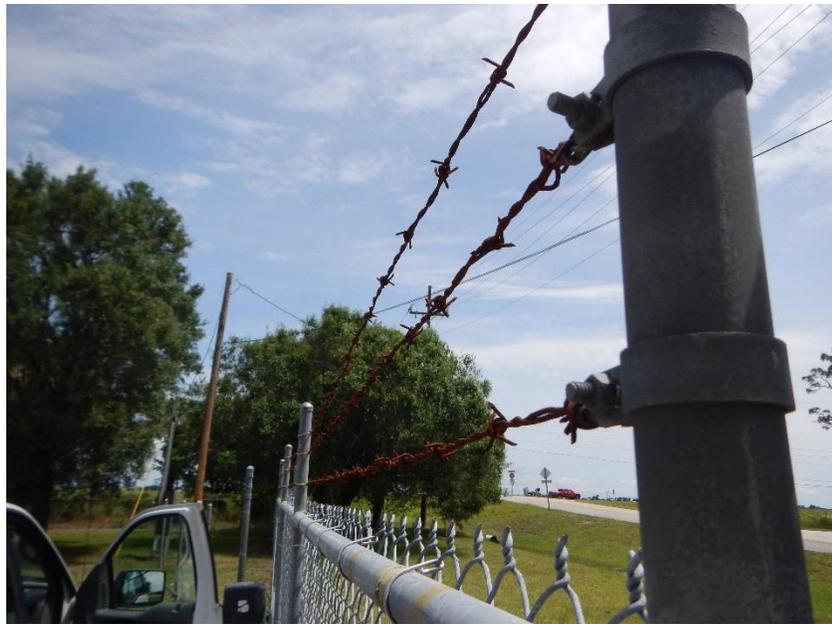
The only barbed wire that is rusting is the barbed wire located over the entrance gate.

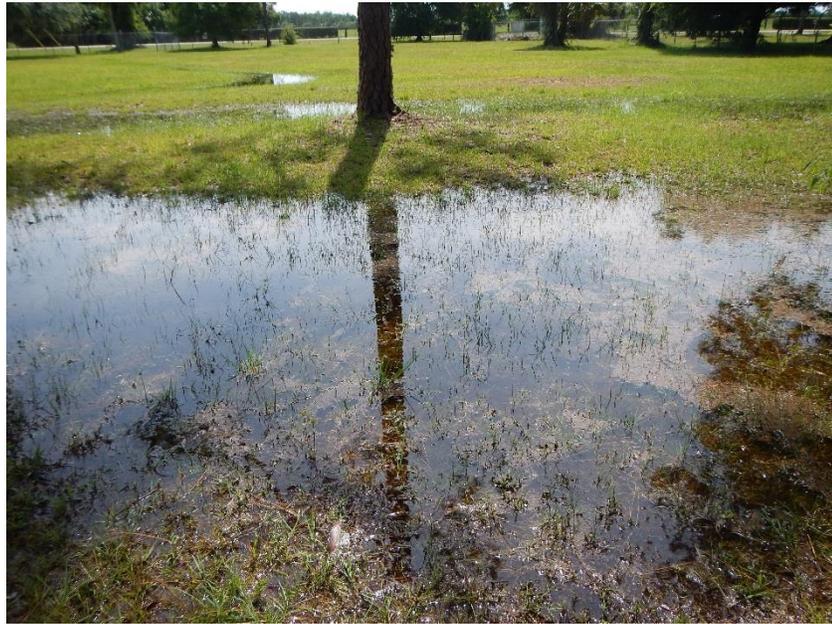
Photo: 42

There is standing water throughout most of the grass area around the property (it had rained the day and possibly the night before the inspection).

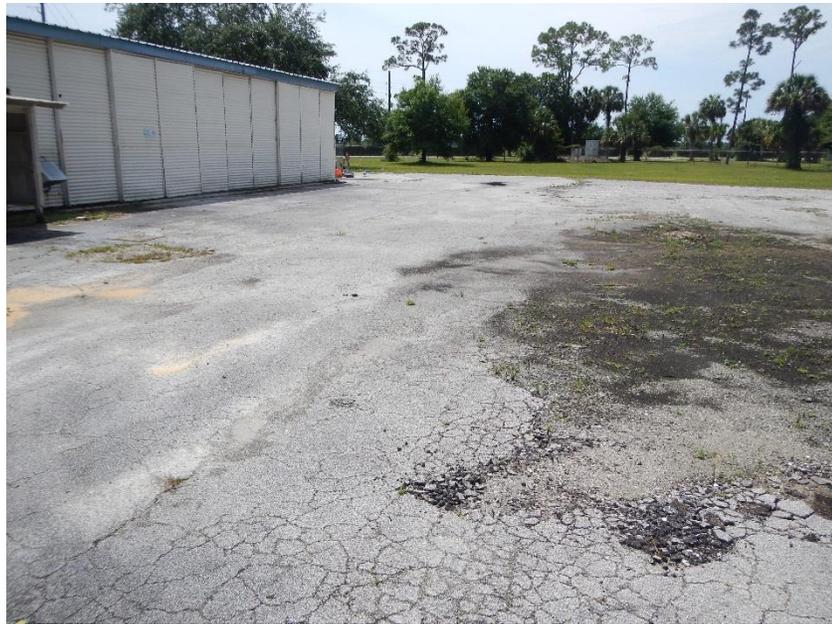
The pavement behind the building on the West side is cracked and broken with dirt and gravel exposed.

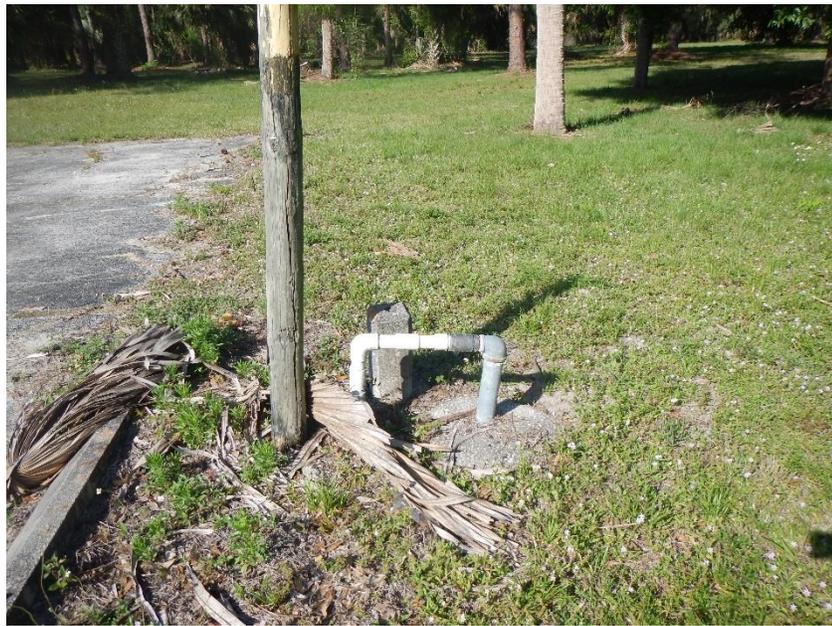
Photo: 44

View facing Westward from onsite, West of the building. Photo depicts well casing and check valve.

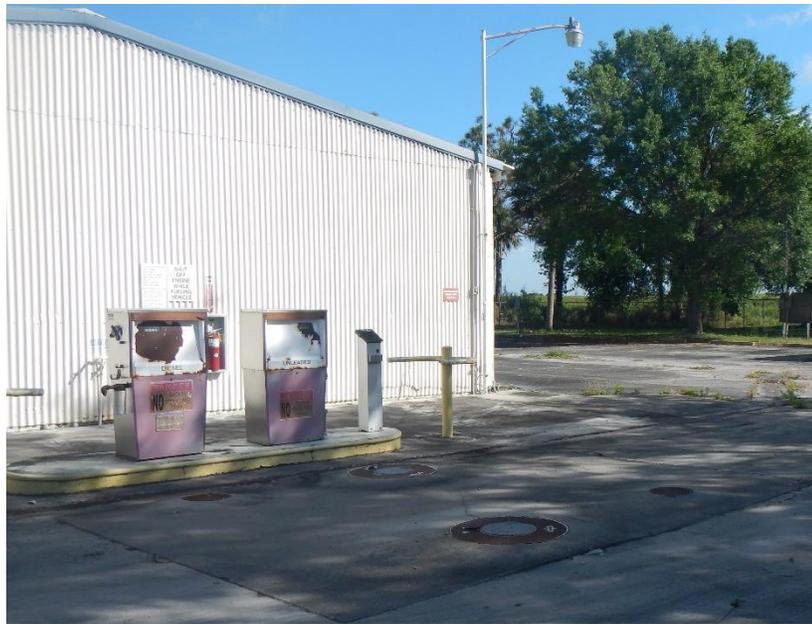
View of Southeast corner of building with fuel dispensers. Photo depicts UST area and associated fill ports.

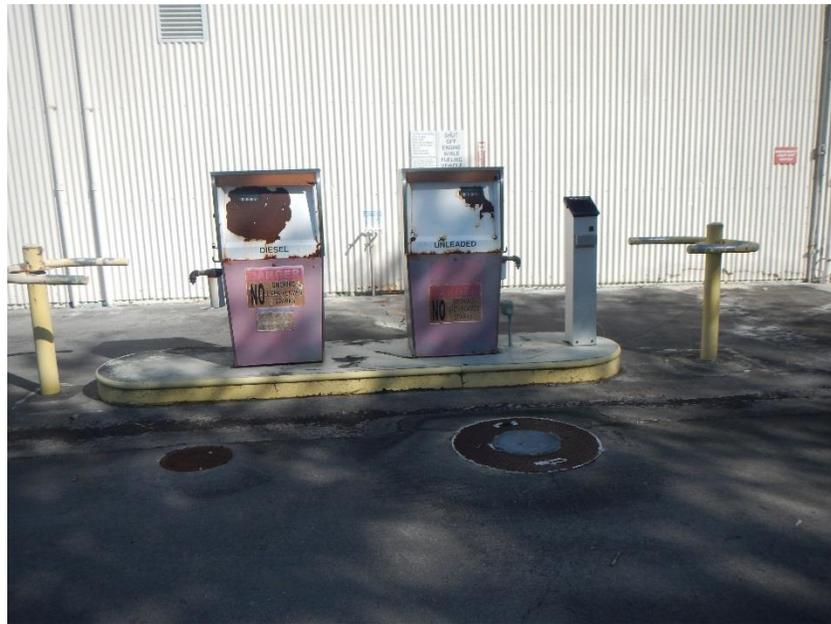
View of South side of building with fuel dispensers. Photo depicts inactive dispenser island.

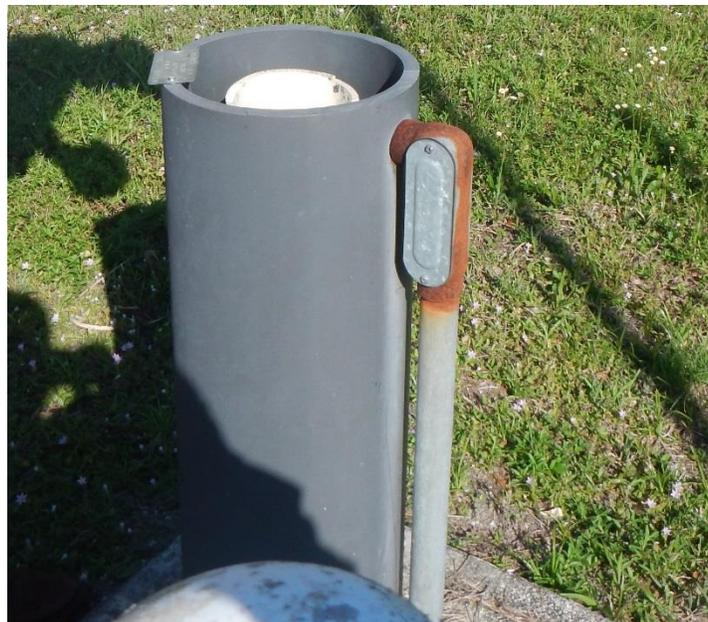
Photo: 46

View facing North Northwestward from onsite, West of the building. Photo depicts inactive 4" surficial aquifer monitoring well.

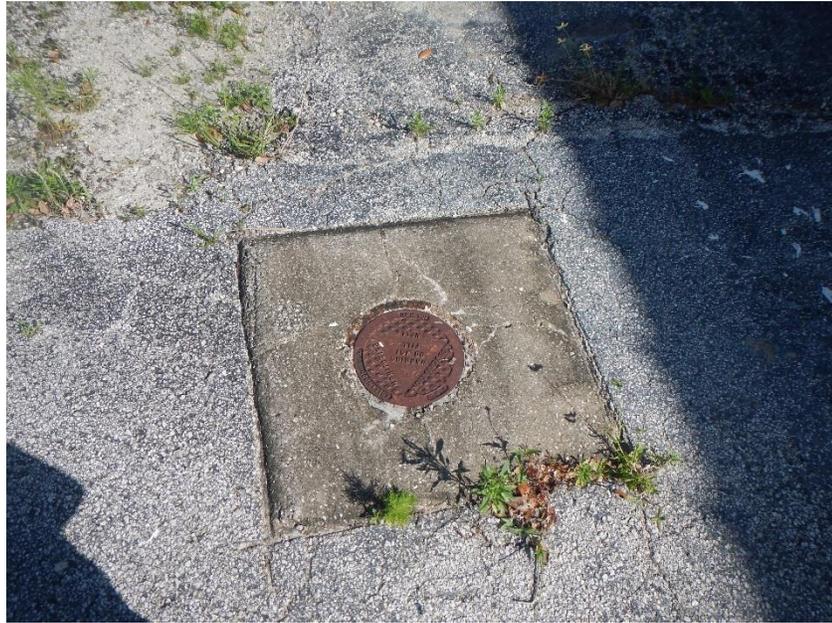
Photo depicts typical inactive abandoned/plugged monitoring wells.
