**Environmental Assessment for the  
Change in Interim Land Use**

**Bird Drive Restoration Area and Pennsuco Wetlands**

Miami-Dade Counties, Florida  
March 21, 2025

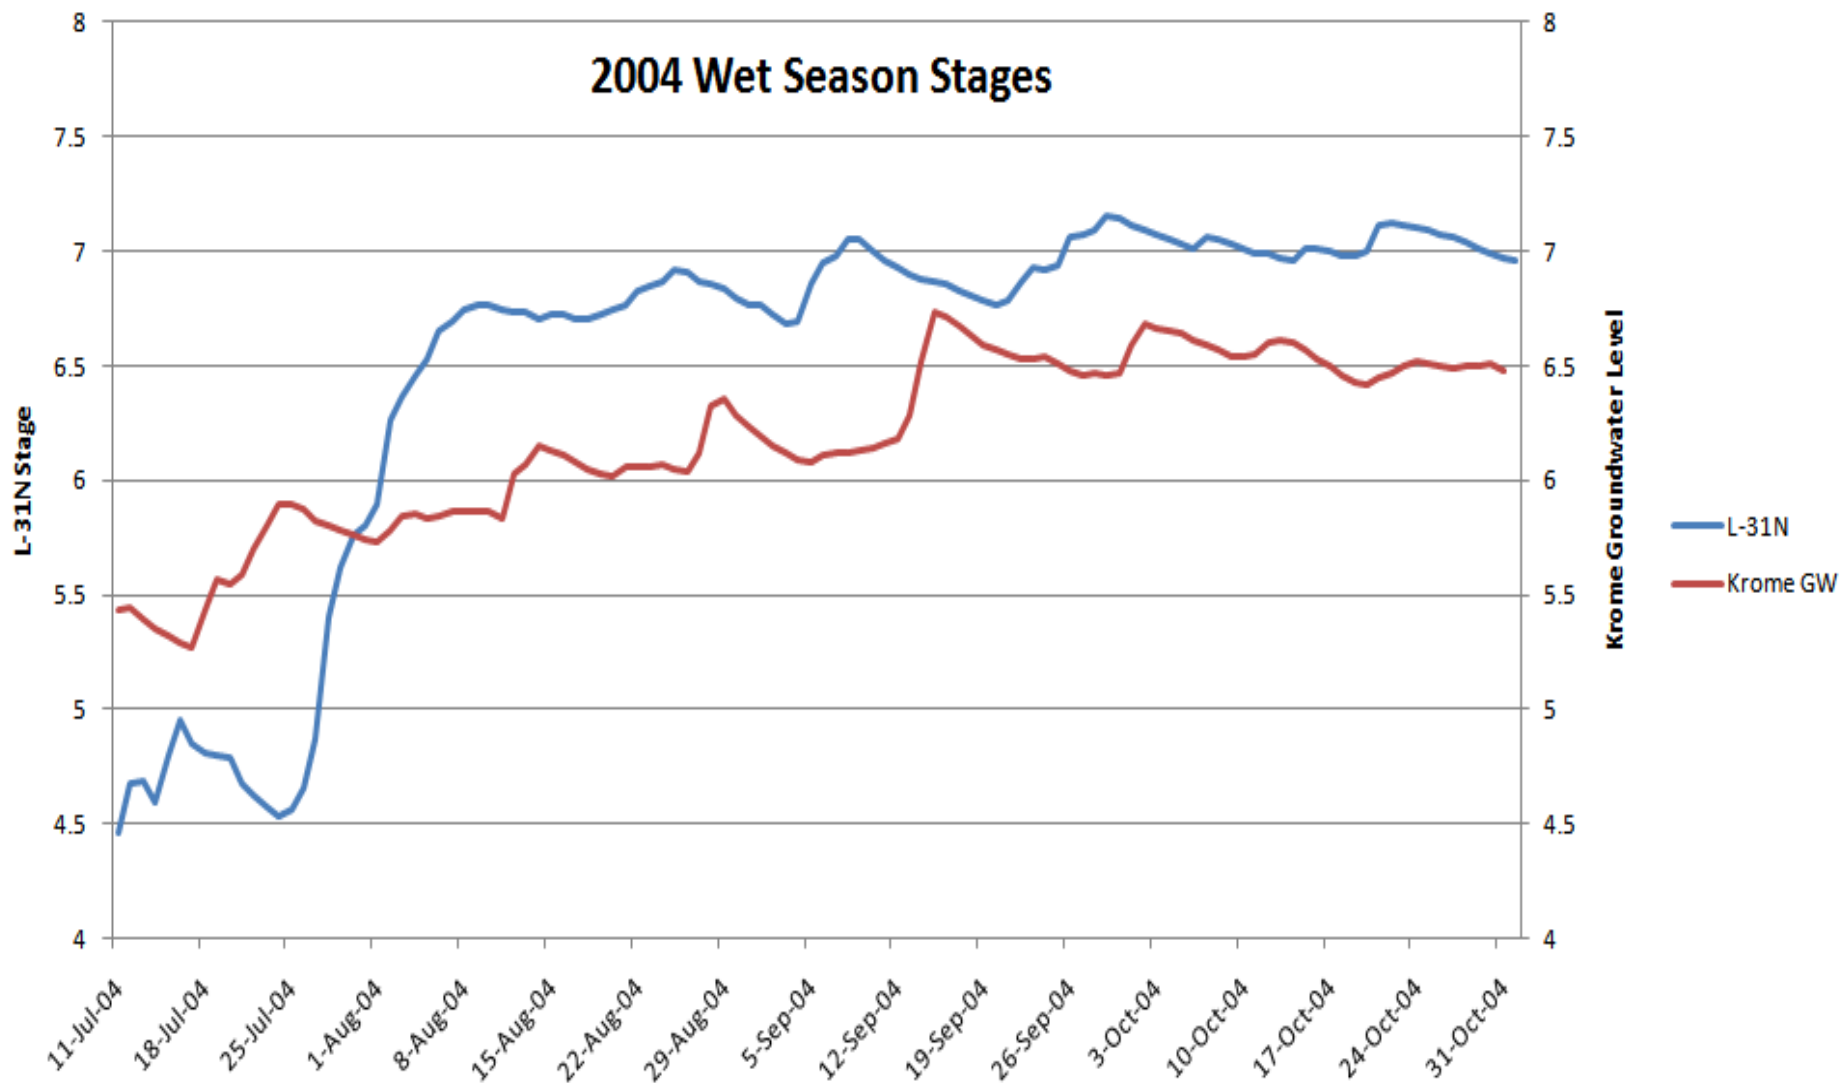
# Seepage Effects Existing Condition
