ERA # 439

**THE 2005 HURRICANE SEASON IN
SOUTH FLORIDA**

**Water Quality Assessment Division
Environmental Resource Assessment Department
South Florida Water Management District
3301 Gun Club Road
West Palm Beach, FL 33406**

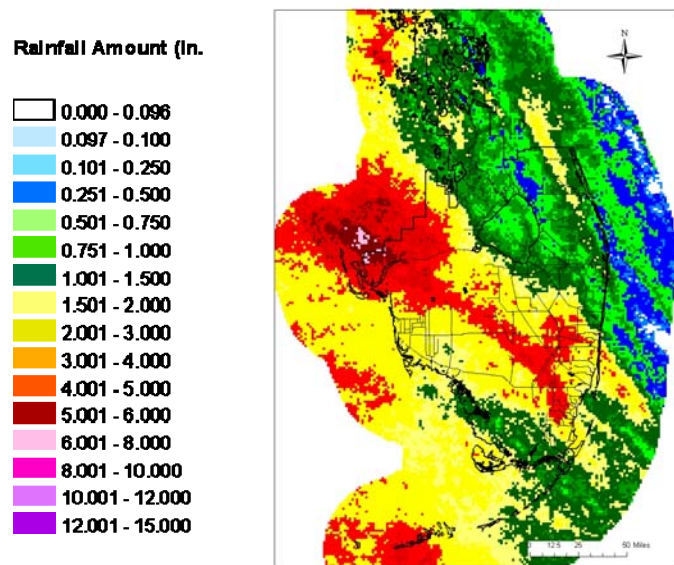
Figure 2a. Radar rainfall from Hurricane Dennis as it passed south of the Florida Keys (July 8-10, 2005).

For the purpose of hydrologic impact of Hurricane Dennis on South Florida, rainfall associated with the hurricane from July 8-10, 2005, is totaled for each rainfall area (**Figure 3**) and presented in **Figure 4**. Key West rainfall in July 2005 was 6.37 inches compared to a historical average of 3.27 inches (<http://www.srh.noaa.gov/eyw/HTML/climate/eywclimate.html>).

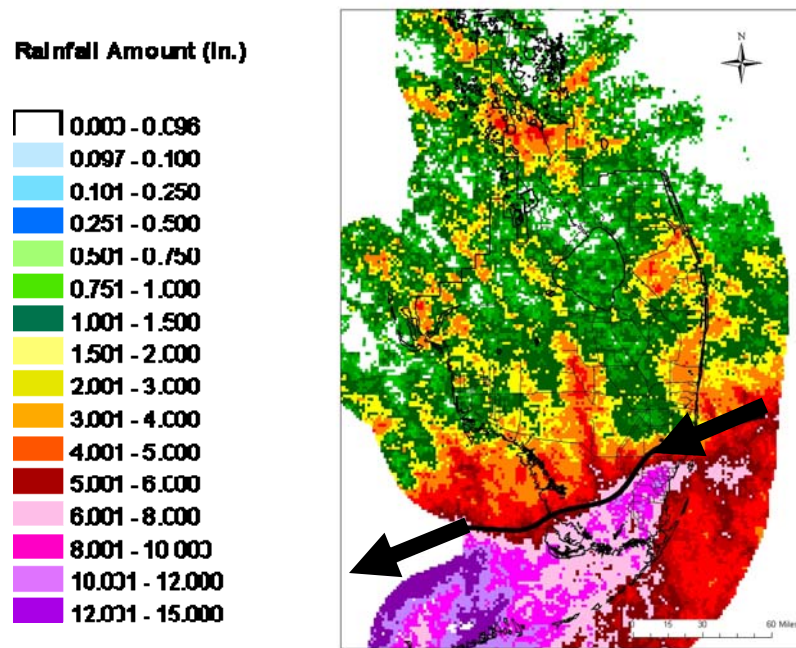
Figure 2b. Hurricane Katrina path and radar rainfall (August 24-27, 2005).

For the purpose of hydrologic impact of Hurricane Katrina on South Florida, rainfall associated with the system from August 24-27, 2005, is totaled for each rainfall area (**Figure 3**) and presented in **Figure 4**. As seen from the radar rainfall estimates (**Figure 2a**), the highest areal rainfall was observed in Miami-Dade (6.27 inches), followed by the Everglades National Park (ENP) (6.1 inches). Areal rainfall is reported on the District's web site (<http://iweb/iwebB501/omd/weather/opswthr.htm>) as the Thiessen average of a network of rain gauges for each rainfall area. ENP area rainfall is computed from a simple average of eight gauge readings (S332, S174, S18C, HOMESTEADARB, JBTS, S331W, S334, S12D). It should be noted that the eastern section of the ENP got higher rainfall than the north and northwest sections (**Figure 2a**). Hurricane Katrina impacted Key West in storm surge and high rainfall. August rainfall for Key West was 13.49 inches compared to the average for the month, 5.40 inches (<http://www.srh.noaa.gov/eyw/HTML/climate/eywclimate.html>).

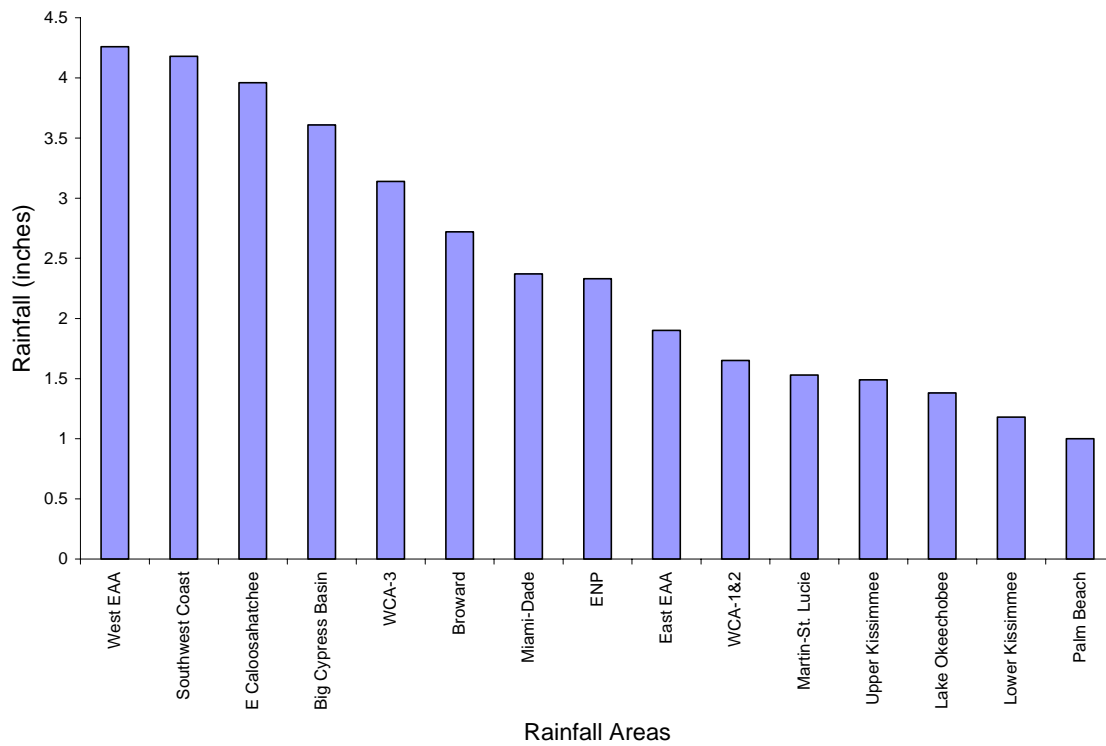
Figure 4. Hurricane Dennis areal average rainfall (July 8-10, 2005).

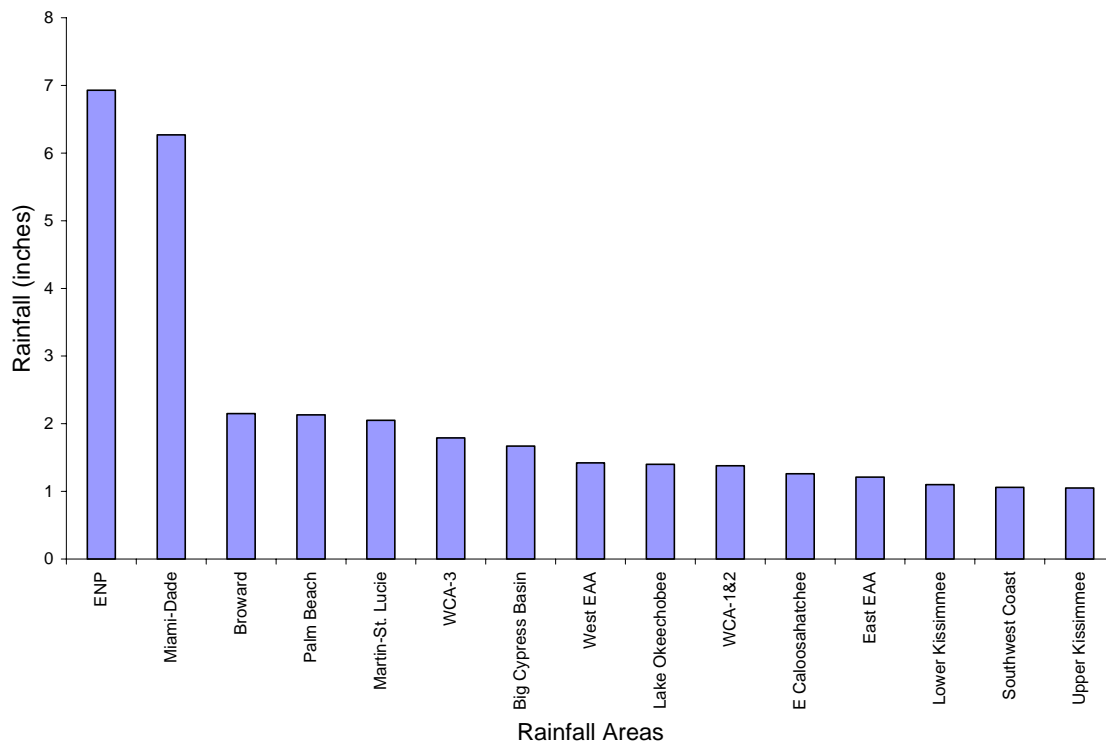
Figure 5. Hurricane Katrina areal average rainfall (August 24-27, 2005).

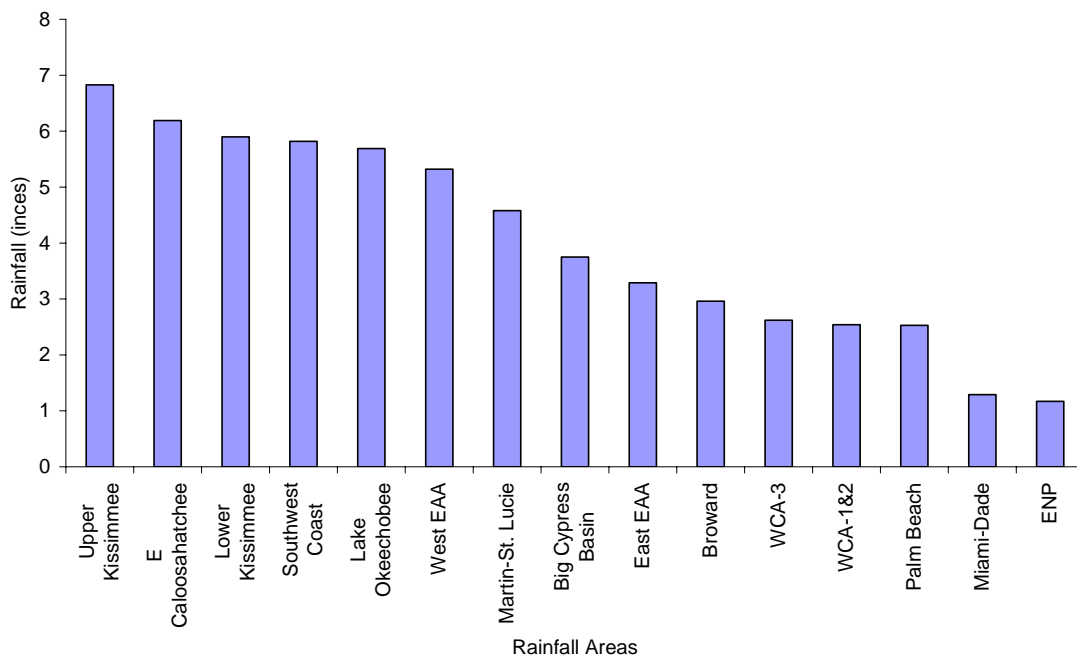
Figure 7. Hurricane Wilma areal average rainfall (October 22-25, 2005).

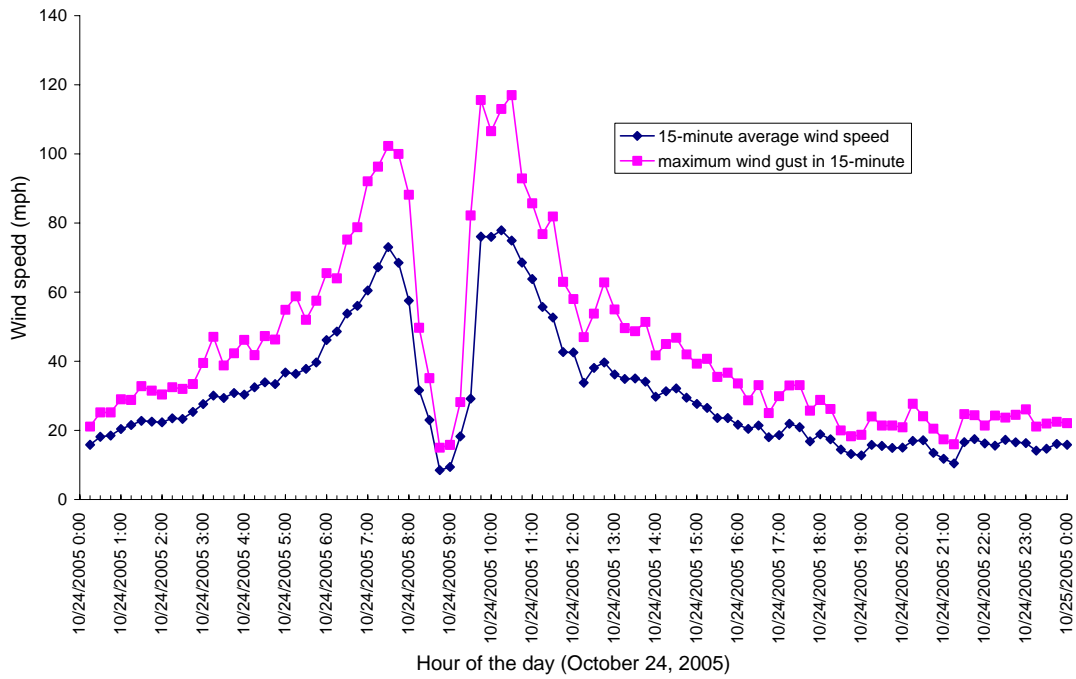
Figure 11. Wind speed at BELL GL weather station during Hurricane Wilma.

Wind speed data from 15 District weather stations was available as 15-minute average wind speed and maximum gust wind speed in every 15-minute time interval. The sampling and averaging of wind speed and characterizing peak wind speed for these weather stations is different from the ASTM standard. The ASTM standard for characterizing surface wind is a 3-second continuous observation and outputs of peak 3-second, 10-minute mean, and peak 1-minute wind speed and other additional output options (ASTM, 1996). For District weather stations, maximum gust wind speed in every 15-minute interval is instantaneous wind speed sampled every minute (15 instantaneous samples) and the maximum of the fifteen samples registered as maximum gust wind speed. Fifteen-minute average wind speed is derived as average of 90 instantaneous observations at 10-second intervals within the 15-minute time period. While the 15-minute average wind speed dampens out peak wind speed, the maximum gust wind speed record relatively demonstrates how high instantaneous wind speed reached in 15-minute interval at the 1-minute interval sampling. However, the instantaneous 1-minute observations may be too far apart to capture the maximum instantaneous gust wind speed. Also, instantaneous wind speed has no sustained gust wind speed representation following most requirements. Nevertheless, the data can be used to estimate how high the hurricane wind reached instantaneously. Wind speed is measured at a height of 33 feet at the land-based weather stations. Wind speed on Lake Okeechobee (L006) is measured at about 23 feet above the average lake water level at the time. The height for wind speed sensors at the remaining three weather stations (L001, L005, and LZ40) is similar to L006. **Figure 8** depicts the L006 weather station on Lake Okeechobee. **Figure 9** depicts peak gust wind speeds at each weather station and time of peak. The weather stations report in Eastern Standard Time. The location of weather stations is shown in **Figure 10**. **Figures 11** through **25** depict 15-minute average wind speed and maximum gust wind speed at each 15-minute time interval on October 24, 2005 for each weather station where data was available. Weather stations in the eye of the hurricane distinctly reflect calmer conditions when the eye was passing over the area. The maximum gust wind speed observed from the 15 weather stations is 117 miles per hour (mph) at the BELL GL weather station in Belle Glade.

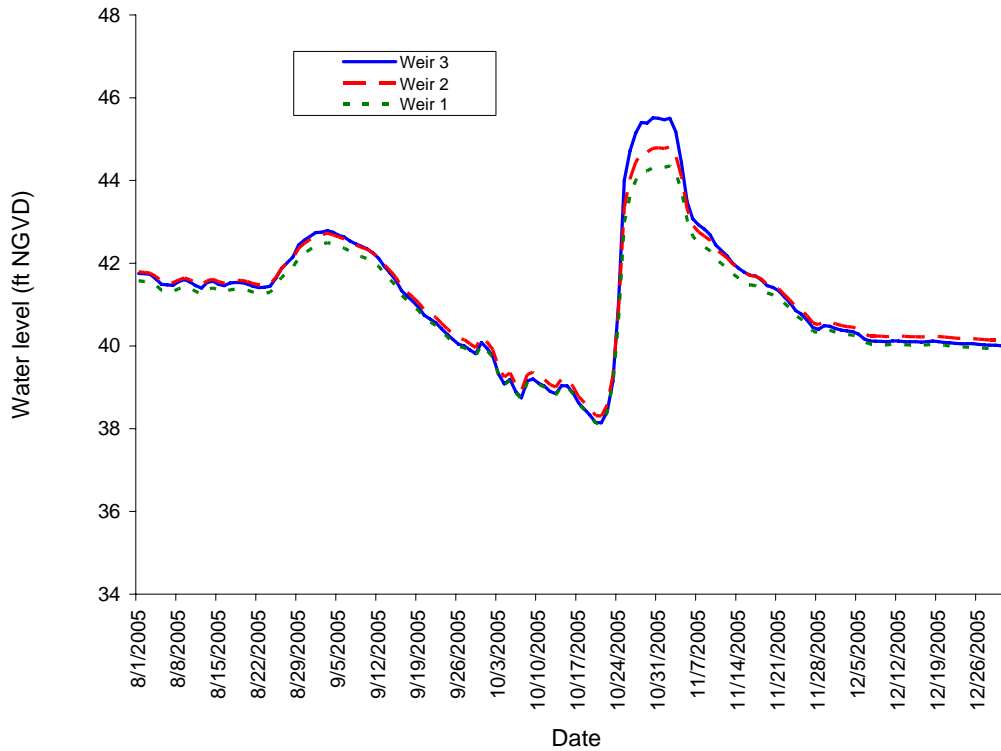
Figure 39. Kissimmee River floodplain water levels at the restoration area, weirs 1, 2, and 3, during the 2005 hurricane season.
