INTERIM FINAL DRAFT REPORT  
ON  
EMBANKMENT FAILURE  
FLORIDA POWER & LIGHT COMPANY  
MARTIN PLANT COOLING RESERVOIR

April 1980

South Florida Water Management District  
West Palm Beach, Florida

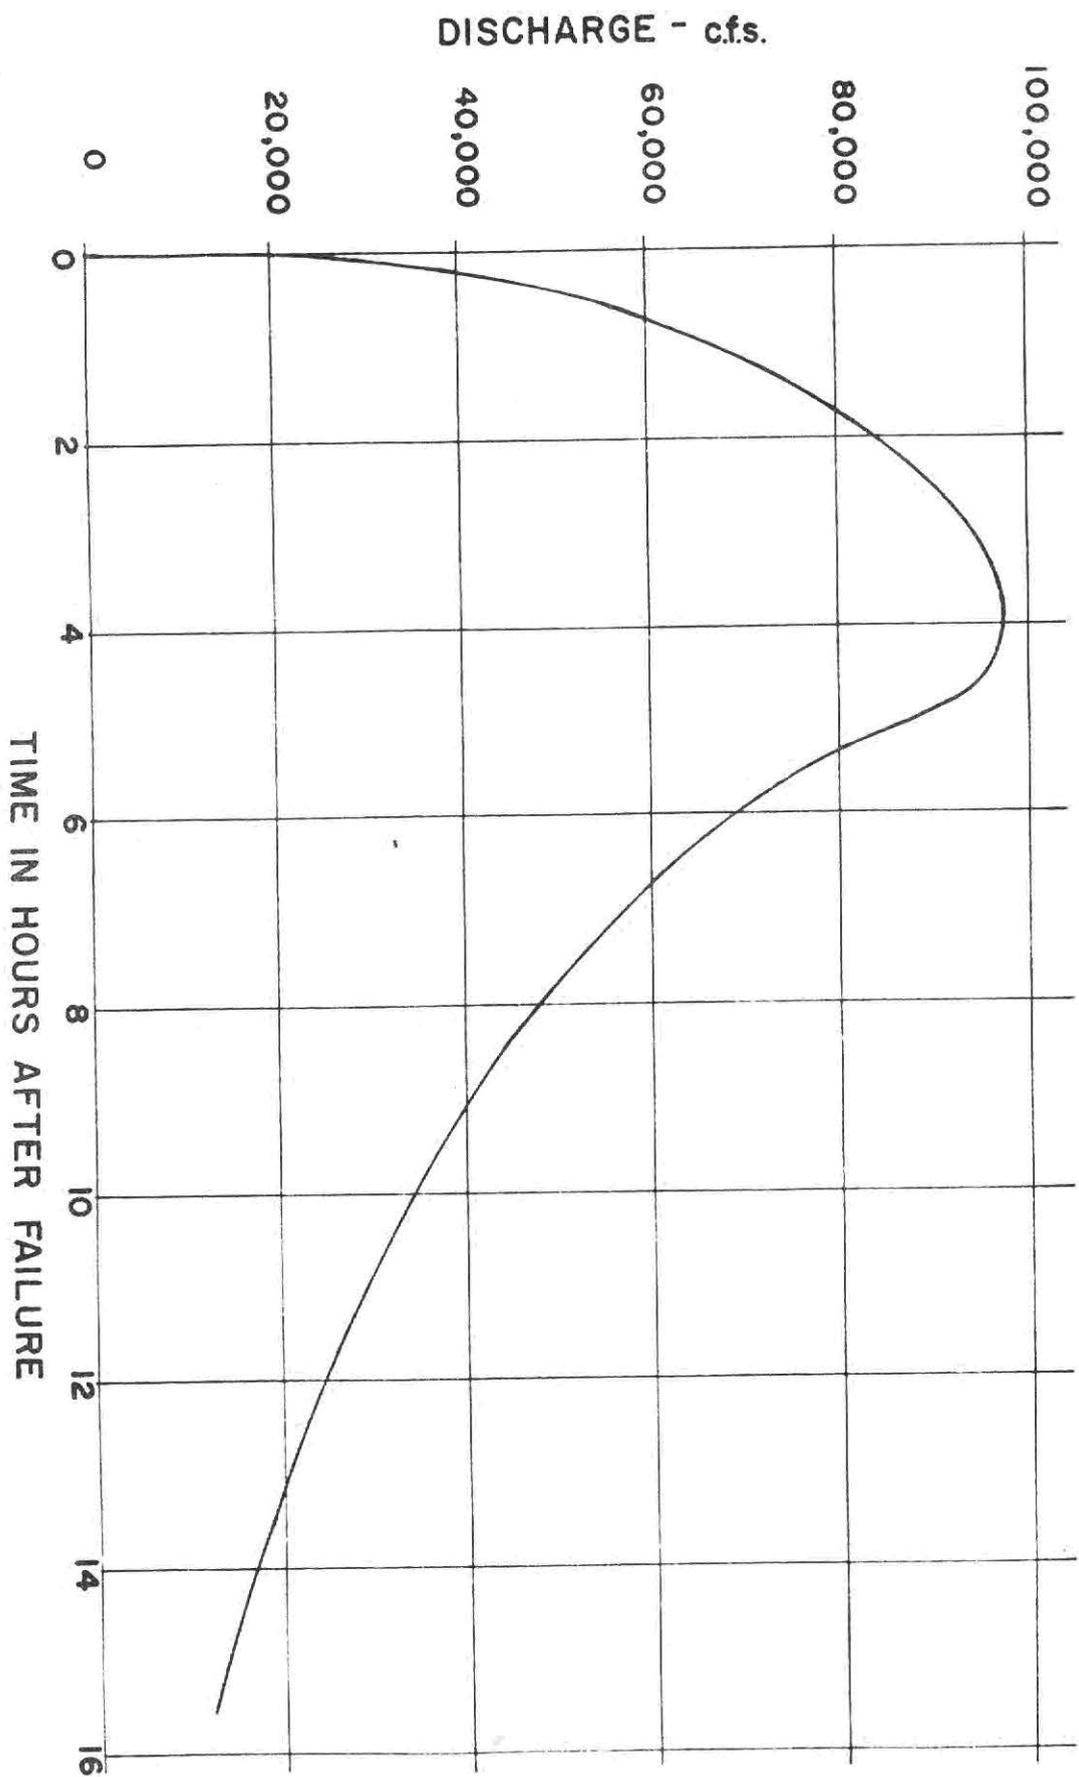
Figure 1-5

450 feet wide (parallel to the dike) by about 700 feet long (perpendicular to the dike). See Fig. 1-5. The deepest part of the scour hole was located in the center and west of the breach. This deepest hole was also rectangular in plan, 190 feet wide by 400 feet long. The invert of this hole was at elevation -7 feet at the east end; it sloped upward to an elevation of about +4 feet at the west end. Surrounding this deep scour hole a dark brown silty sand stratum was uncovered at about elevation 0 to +4. All material above this stratum was eroded away in the scour area. A vertical section along the embankment center line through the breach was U-Shaped, about 600 feet across the top, with vertical faces from natural ground to the embankment crest.

The soil cement slope protection collapsed in place, ending in a heap along the embankment alignment except in the very center of the breach. See Fig. 1-5. In this location a gap was left in the remnants of soil cement, about 10-15 feet wide. The soil cement as it fell into its final resting place broke into large random sized slabs on an average of 6 feet x 6 feet. Each slab was about 6 inches thick, the original thickness. On each side of the center gap in the soil cement, the remaining pieces were moved about 40 feet to the west. A few large slabs about 5 feet square were deposited roughly 300 feet below the embankment and numerous smaller pieces (1+ feet square) were carried as far downstream as the railroad.

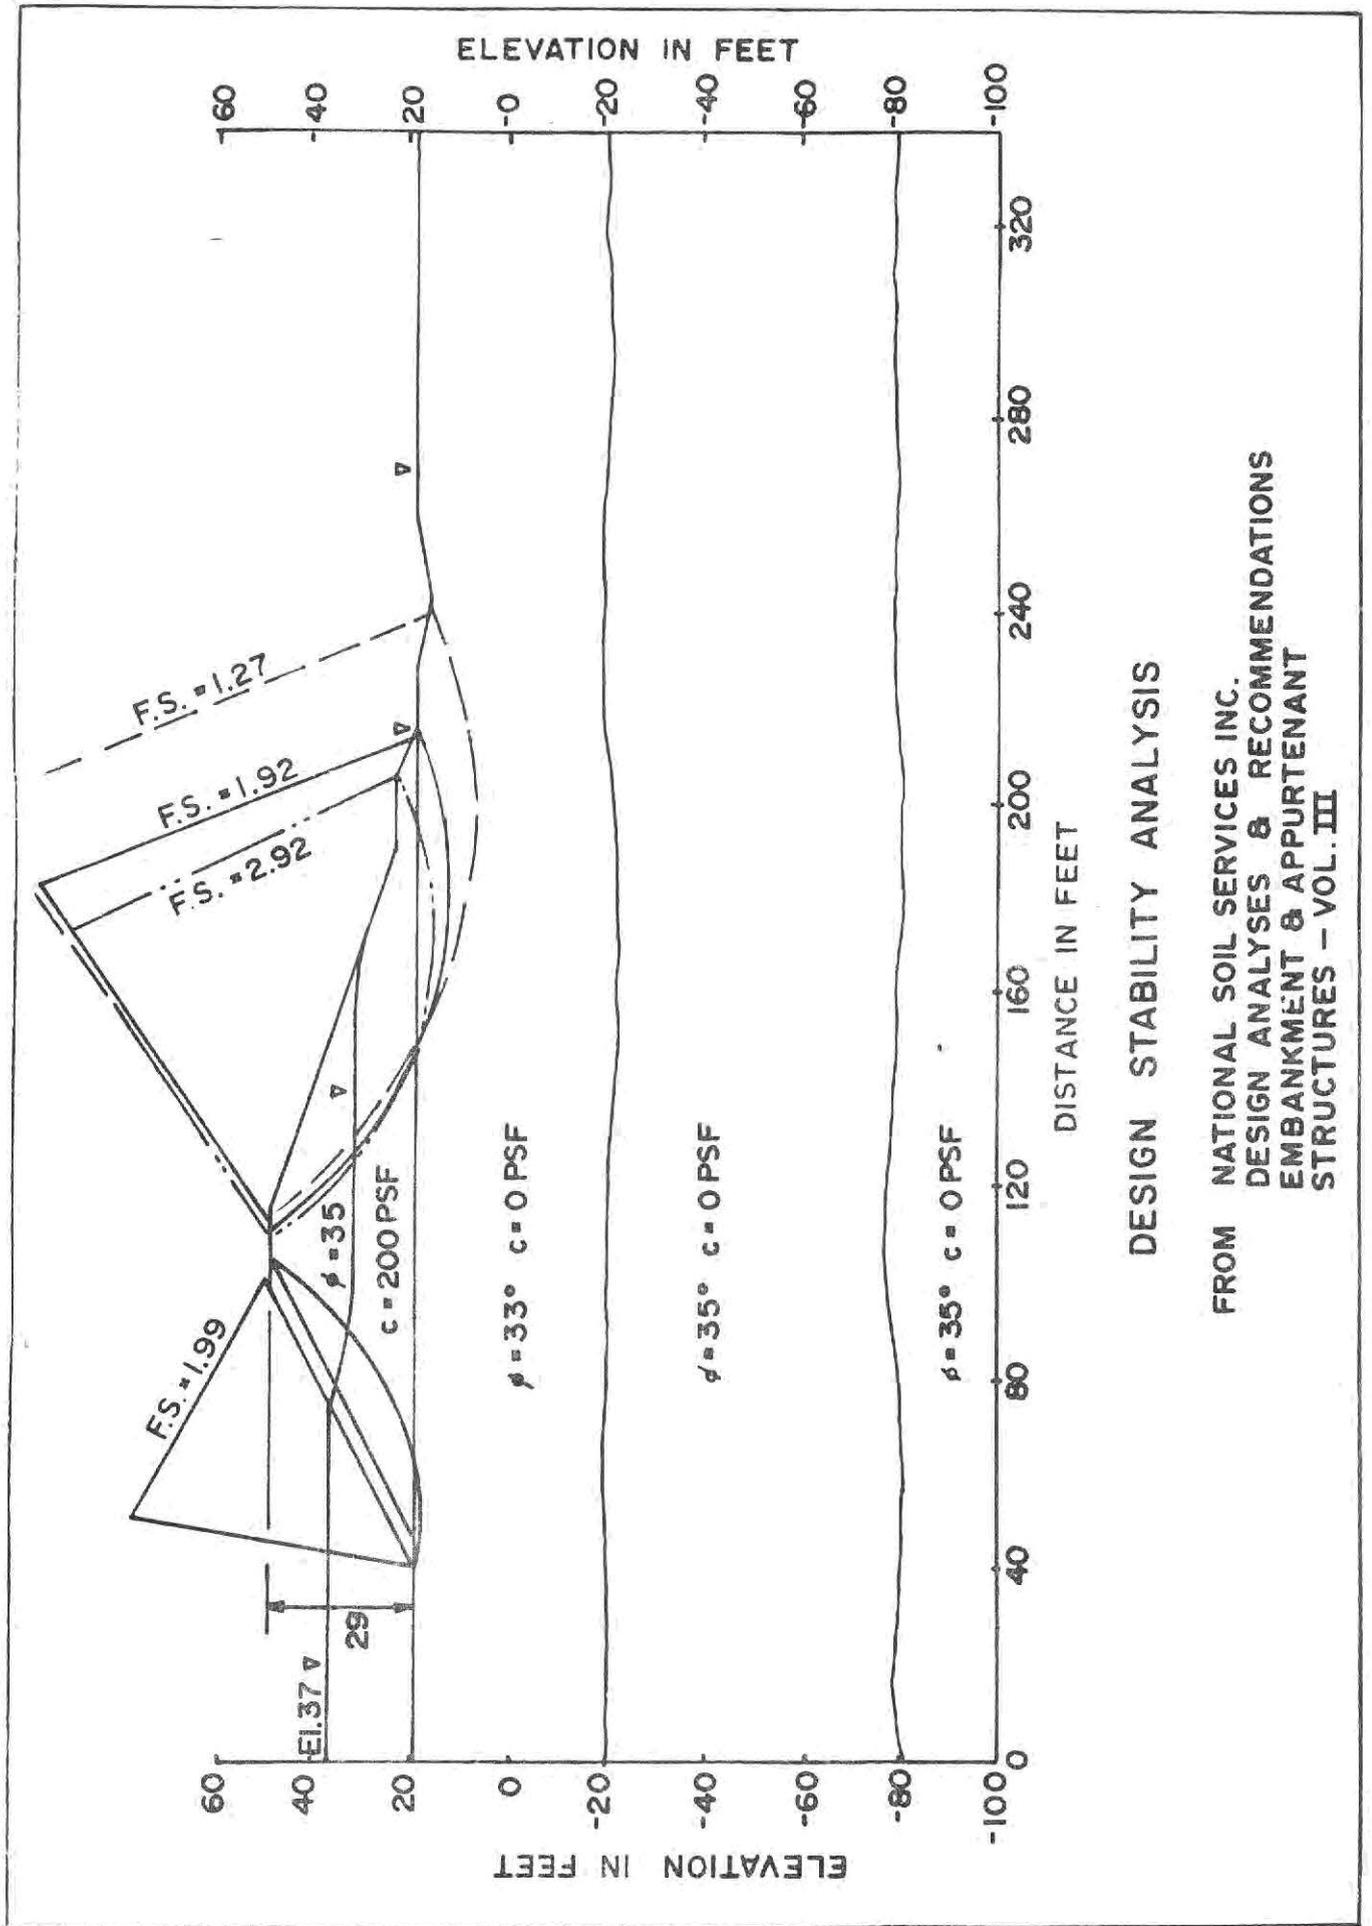
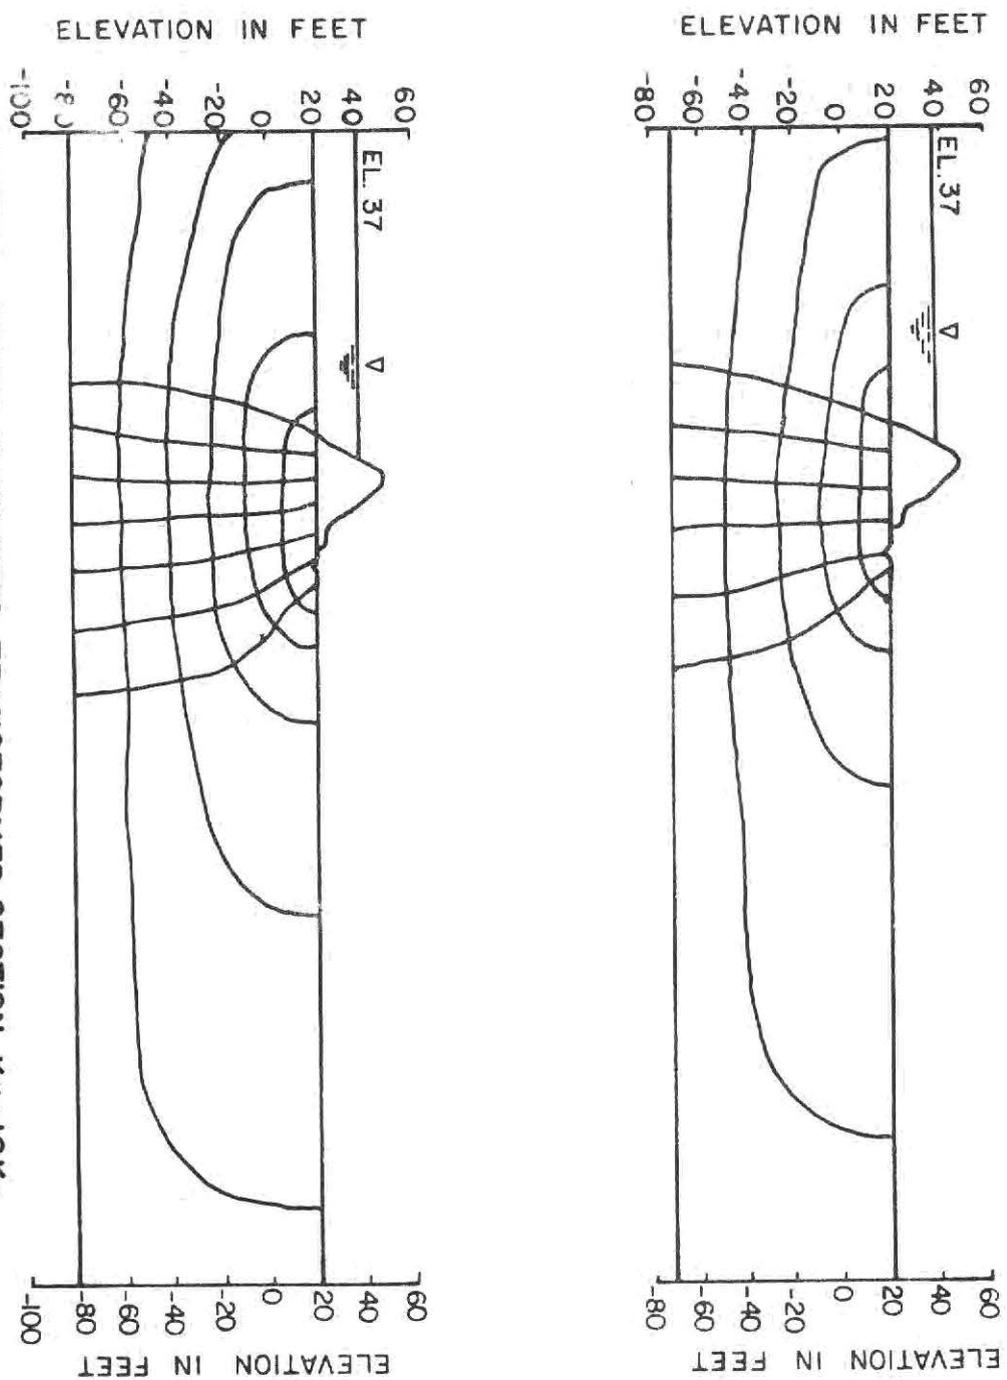
Figure 2-5

Thus, for a water surface elevation of 37, the total seepage would be 121 cfs.

A typical flow net is shown in Figure 2-5.

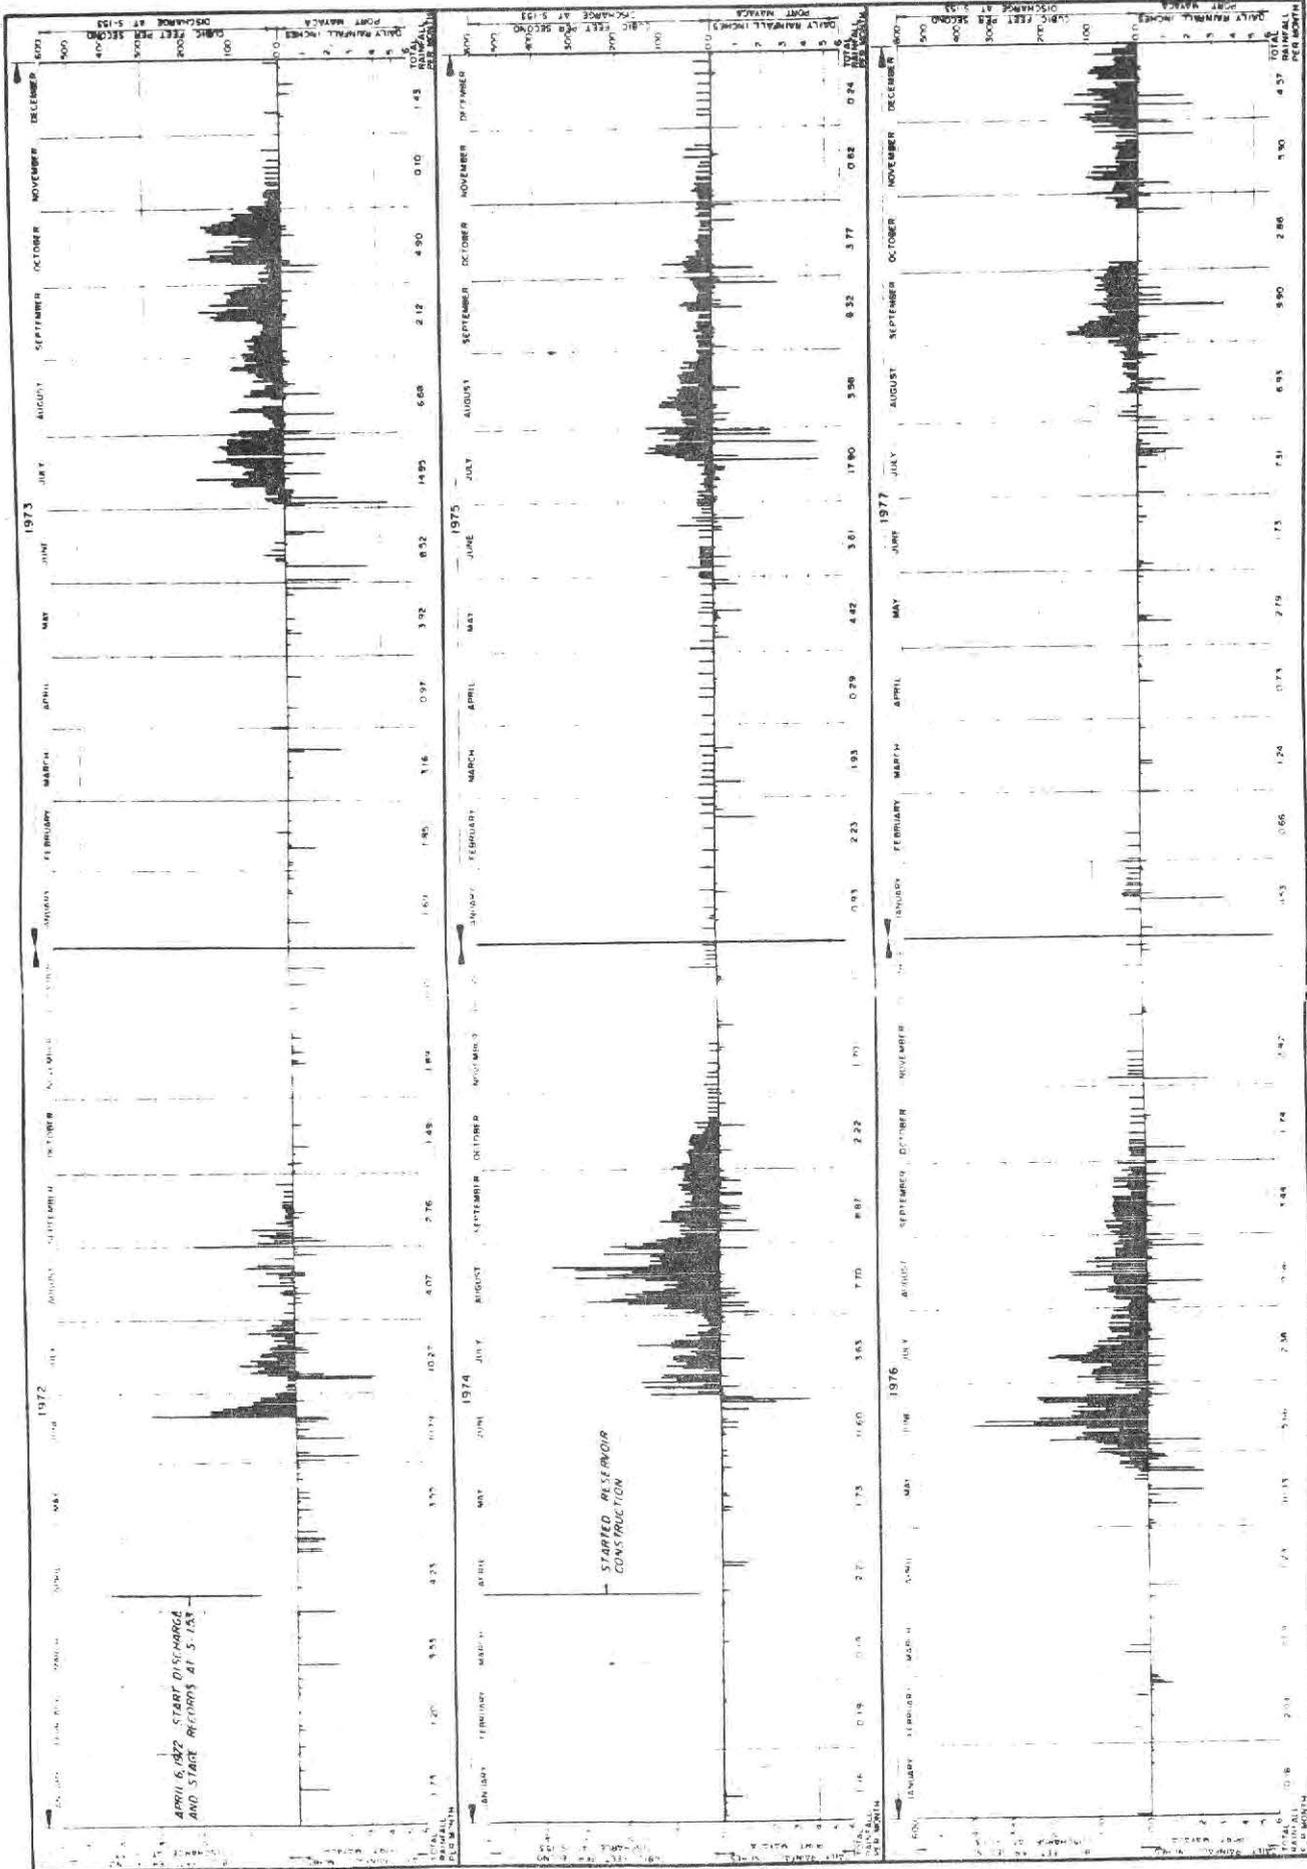
Figure 4-44

Seepage losses, calculated from formula (2) are shown in Figures 4-4A+B. Unfortunately, these values are meaningless because the "reasonable" evaporation values obtained from formula (3) are specious. These values range from 0.2 to 0.6 inches per month. Class A pan evaporation, measured by the National Weather Service at Moore Haven Locks, ranges from 4 to over 10 inches per month during the same time period. It must be recognized,

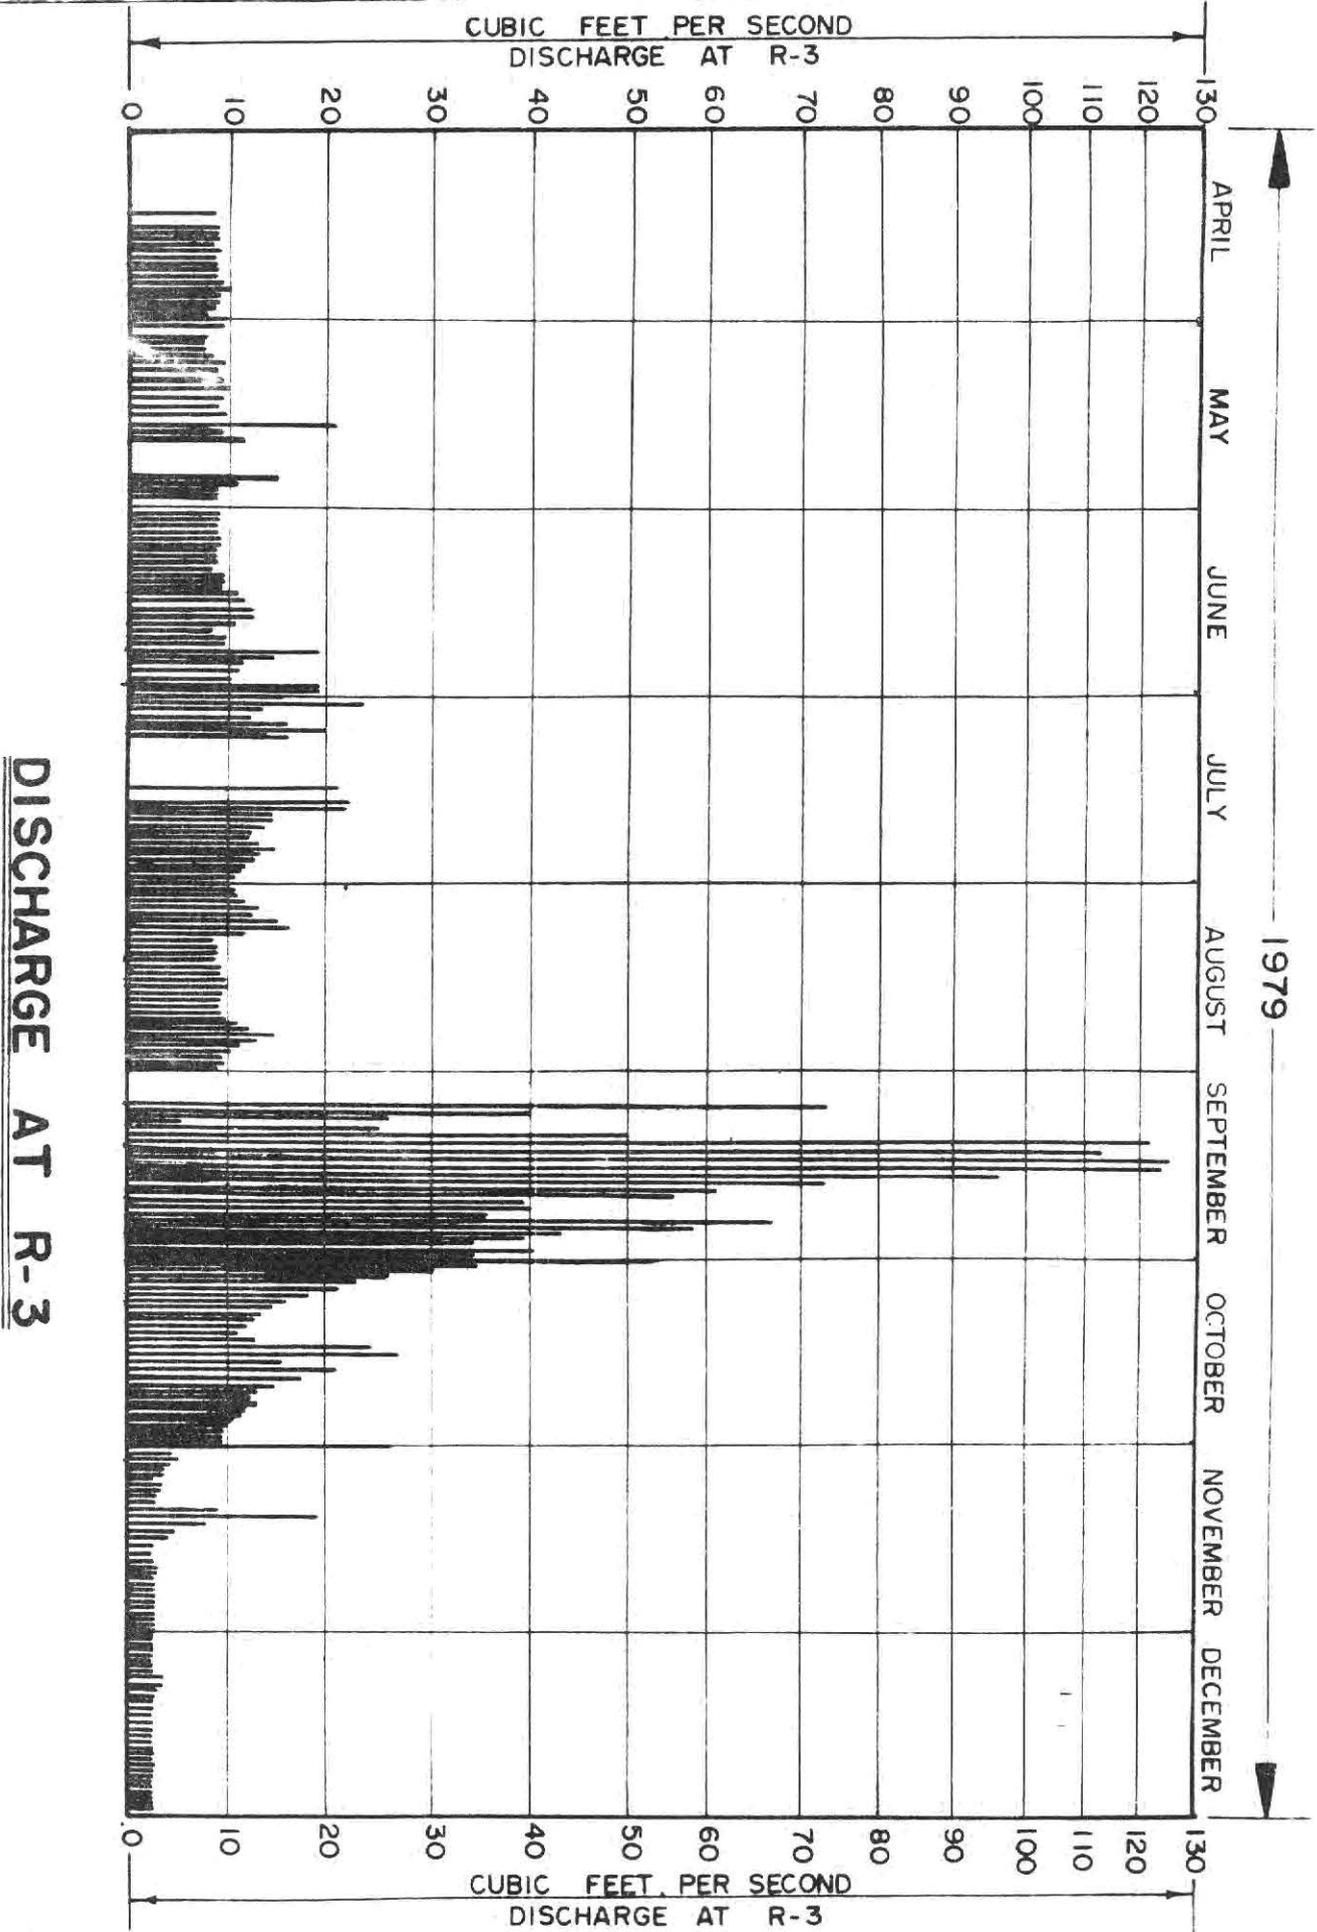
Figure 4-5

the reservoir as well as seepage from the entire north embankment. Because of the diverse source of this runoff, these records are of little value and have not been considered further. The calculated flow at R3 on the other hand is very significant. Unfortunately the drainage area of this gage includes about a two-square mile area between the power plant and SR 710. Consequently, after substantial rainfall, this latter area contributes heavily to the runoff. After sustained drought periods, R3 records the seepage from the reservoir and a small base flow. Figure # 4-5 shows a rather consistent discharge of about 8 cfs between April 13 and May 15, 1979. There was little rainfall recorded between March 8 and May 15. Again, after the embankment failure on October 30, the discharge at R3 rapidly declined to a rather consistent level or a base flow of about 2 cfs from November 15 to December 31, 1979. Rainfall in the antecedent period from October 15 to December 31 was also very light, except for a one day event on November 12. Thus it may be concluded from an analysis of this hydrograph, that the pre-failure flow from the six-mile reach on the east side of the reservoir of 8 cfs was equal to the seepage of 6 cfs plus a base flow of 2 cfs. The <sup>runoff from</sup> seepage therefore was roughly one cfs per mile. Much of the seepage, however, probably didn't reach the toe ditch, but evaporated along the very wet toe of the embankment. Thus the total <sup>reasonably</sup> seepage might be 2 cfs per mile.

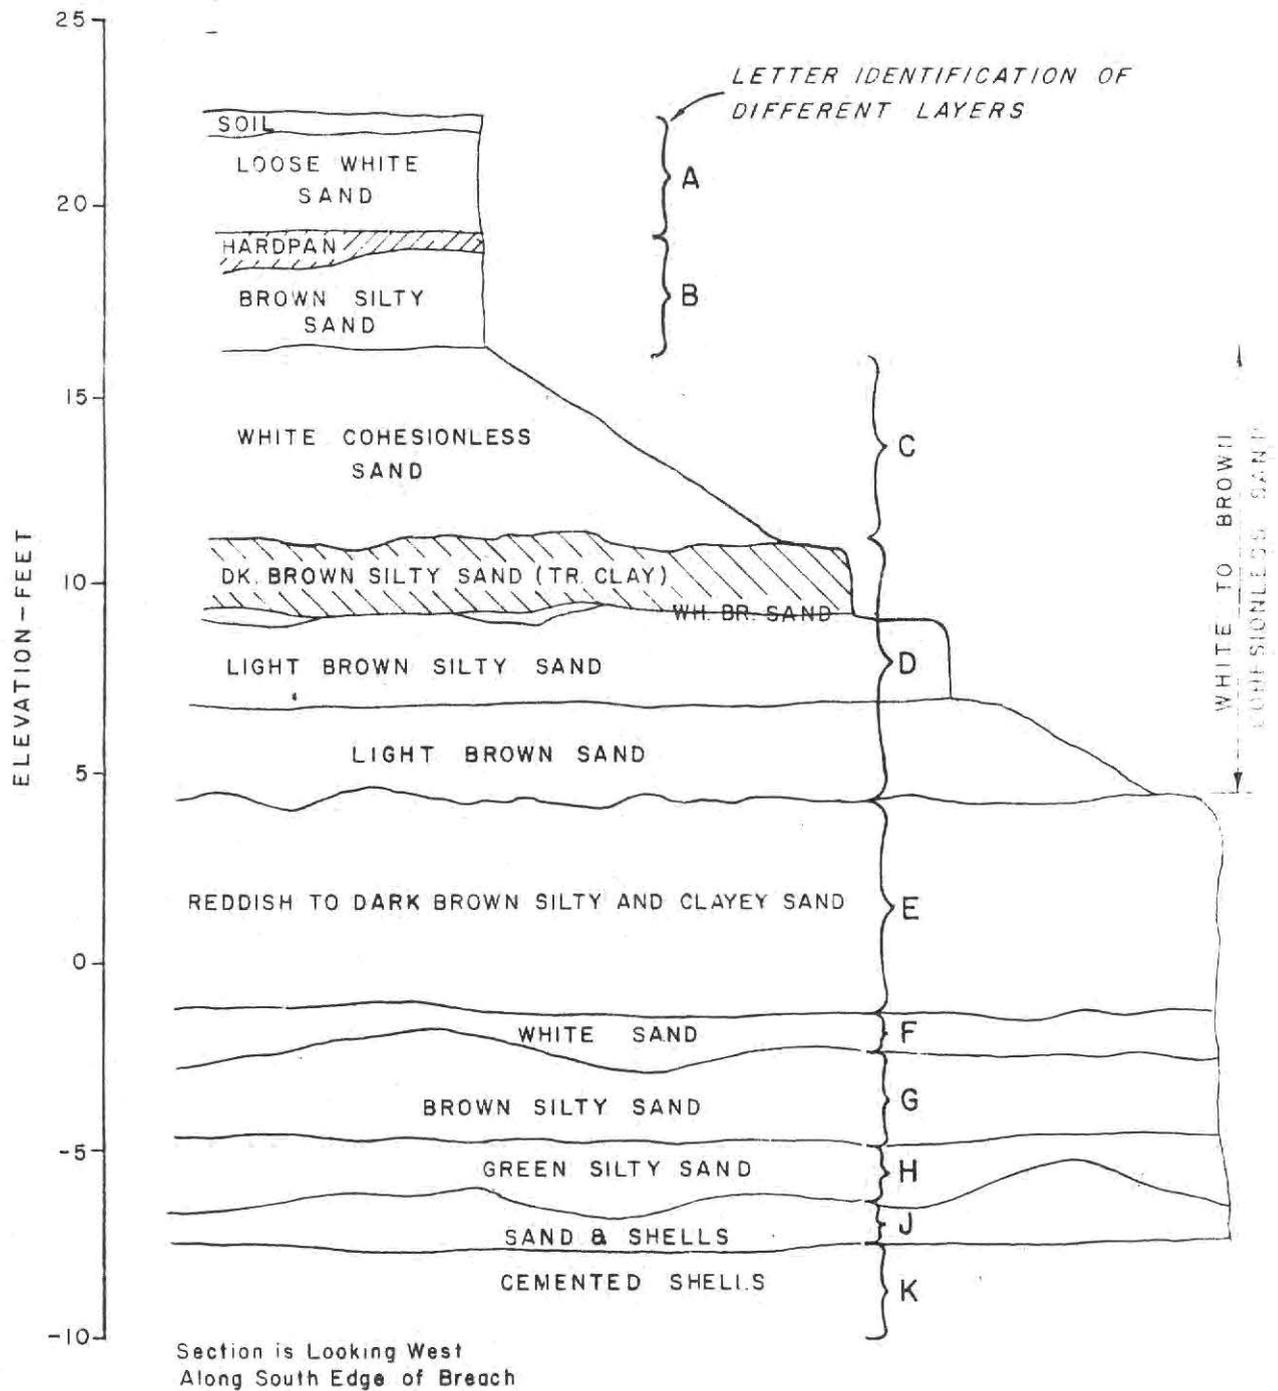
GENERALIZED COLUMNAR SECTION

3. The cemented shell (layers J and K), the top of which is at approximately elevation -5, has a somewhat irregular surface and, in its upper part at least, consists of three units. The top most unit is a weakly cemented to uncemented shell hash

choked with sand. Cementing is random and variable. This formation consists of shells which are, for the most part, whole and range in size from the smallest size to conch 10 inches in length. It also includes coral heads of a similar size. There are numerous whole bi-valves all of which is indicative of very active, open water, onshore wave action. The middle layer is a very hard, massive, gray black, mud entrained carbonate rock which is in turn underlain by a weakly cemented open fabric shell hash. Examination of these units reveals numerous vertical to high angle fractures and possibly "holes". The significance of these features, viewed in conjunction with the downward gradients shown to exist in the piezometers (D and E) at the downstream toe, lead to the theory that this gradient caused migration of sands and silts from the overlying sediments and into the shell hash leading eventually to settlement, cracking, arching and subsequent failure of the embankment.

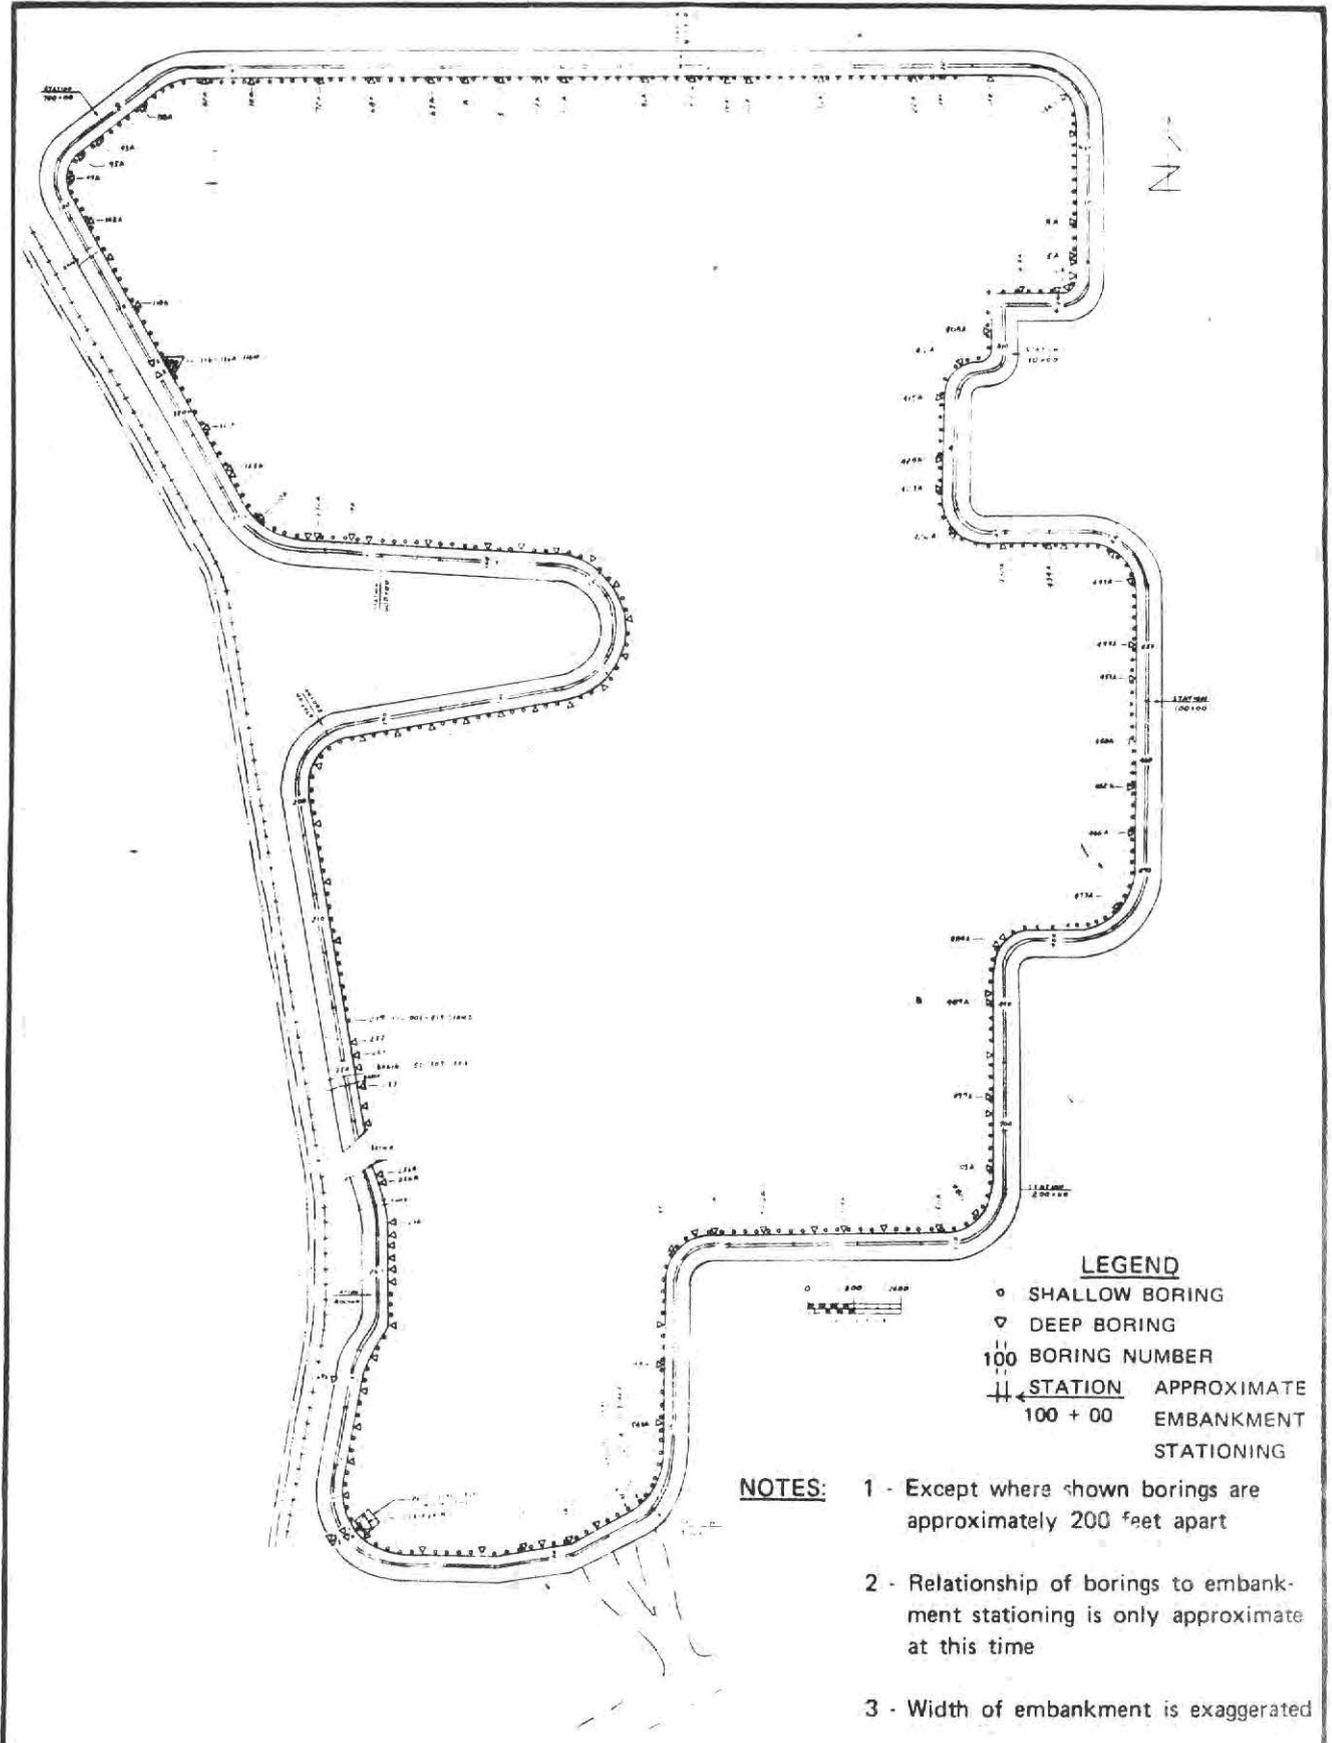
About 500 borings were made at the upstream embankment toe around the entire reservoir. This number equates to a spacing of about 200 feet. See Figure 5-3A for the location of these borings. The original purpose of these borings was to identify the depth to the so-called hardpan layer (Layer B). Consequently about 80% of these borings were 8 to 12 feet deep. The remainder were about 30 feet deep. Each hole was sampled continuously and a continuous record of blow counts was also retained. Any unusual conditions, such as loss of drilling fluid were also noted. The samples were described in the field, and retained for more careful subsequent analysis. A detailed plot of all the findings of the explorations was made and correlations between the drill holes

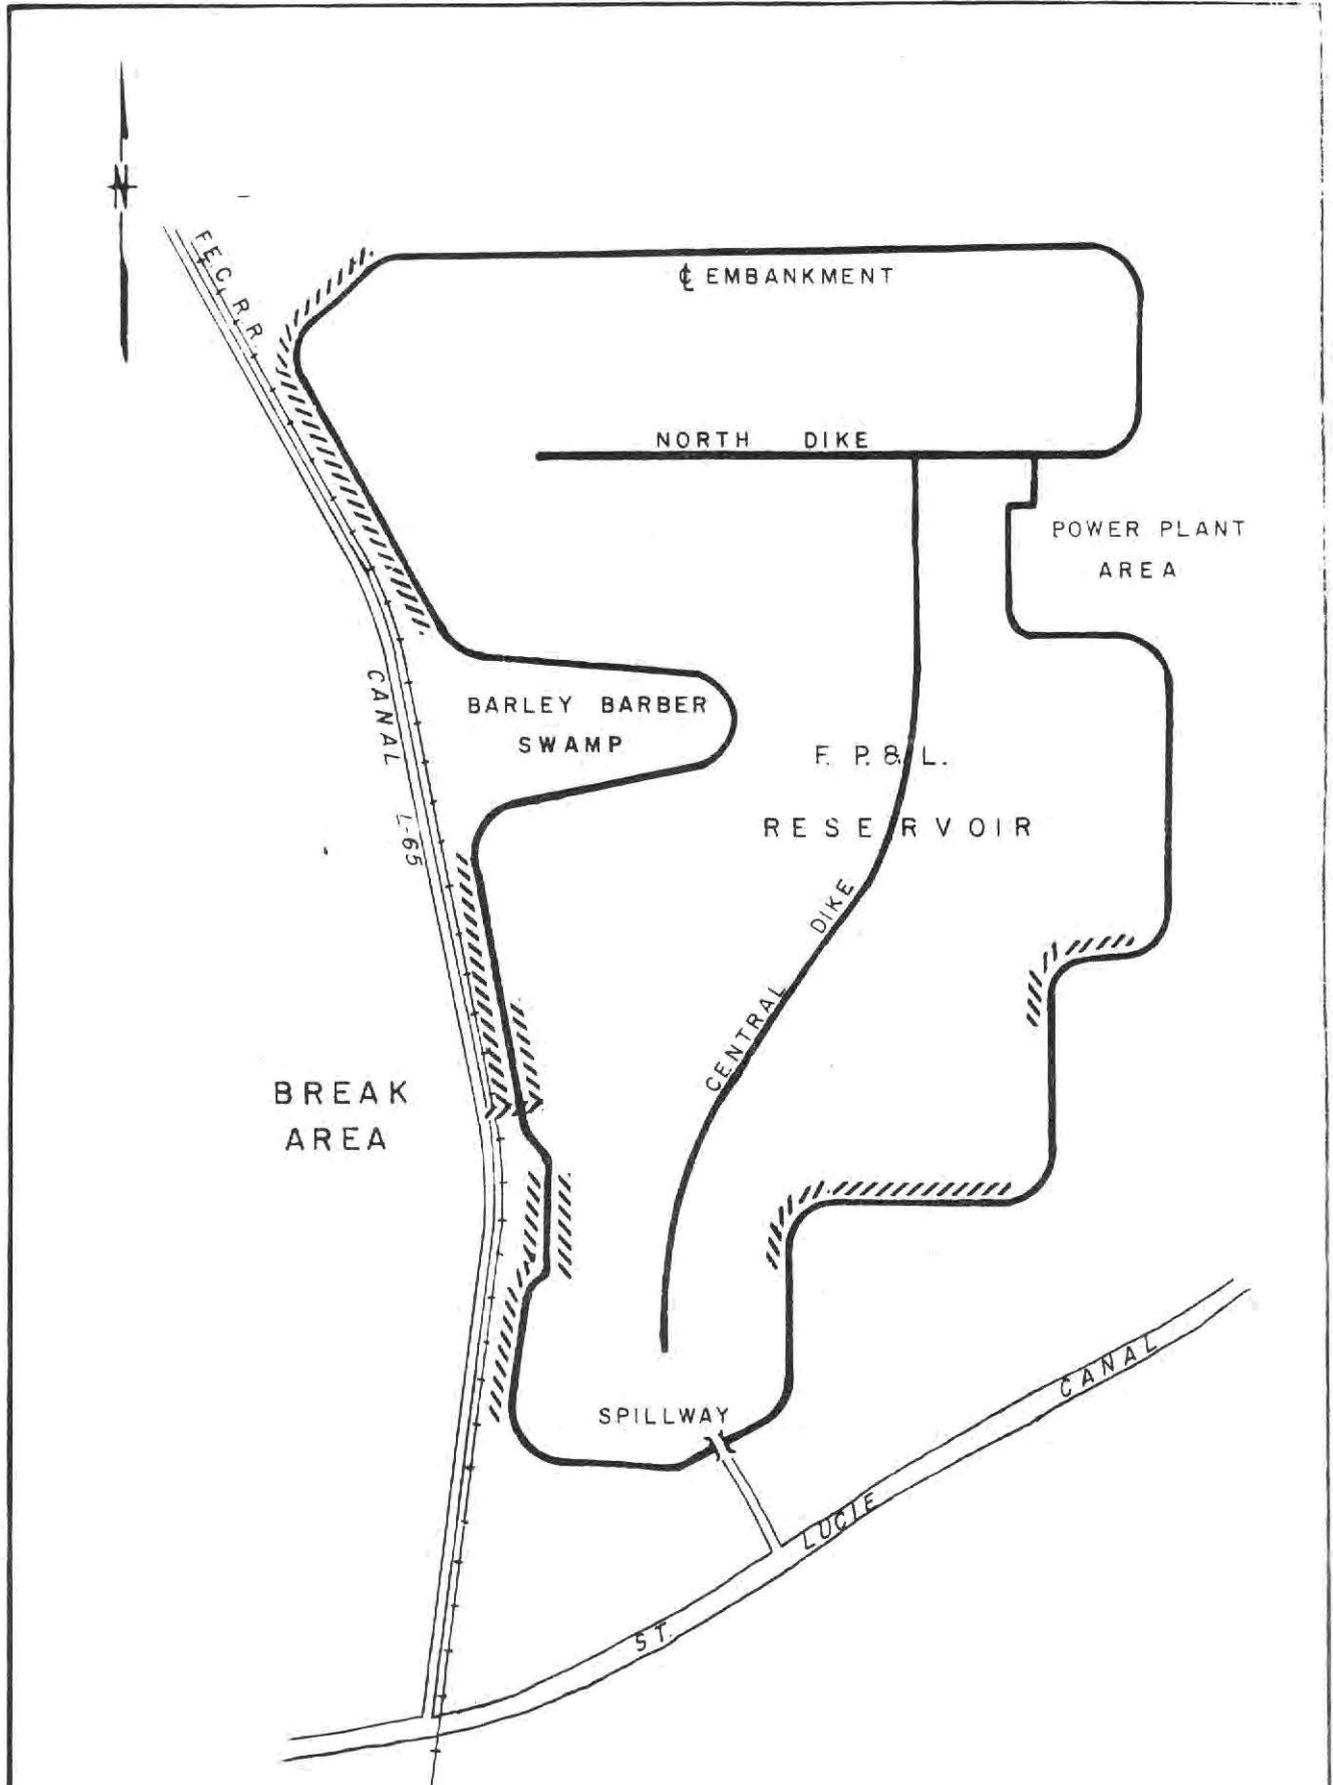
1. through the embankment north of the breach.
2. between the embankment and the L-65 canal.
3. along the downstream toe road both north and south of the breach.
4. along the upstream toe of slope south of the breach.
5. two areas north of the pump station.

The general location of these investigations is shown on Figure 5-4.

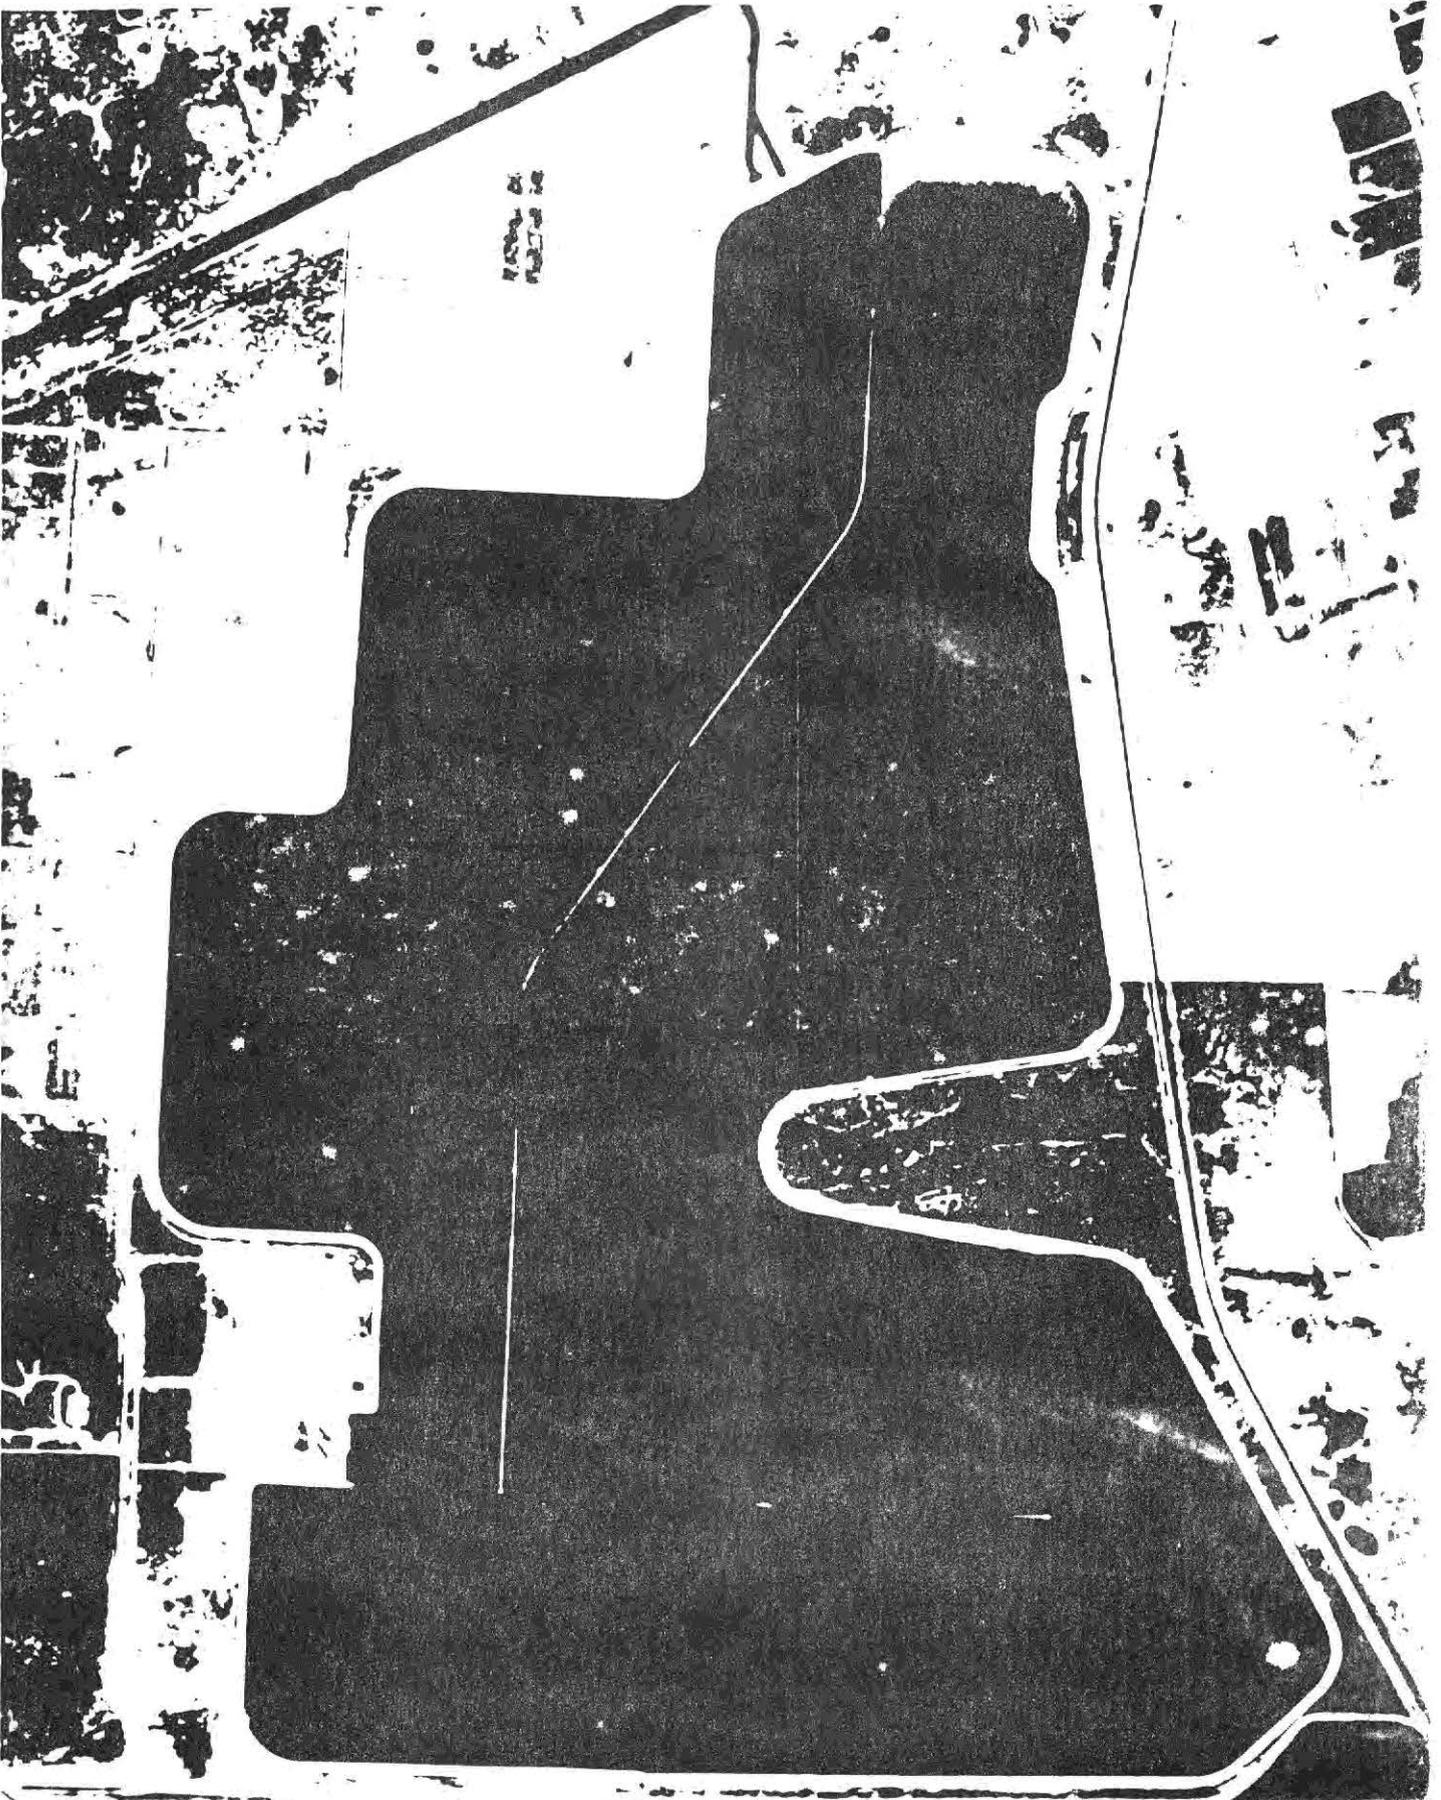
Figure 5-10

5. Photos taken from the District helicopter within twenty-four hours after failure which were used in gaining additional insight into location and direction of flow through and downstream of the breach area. See Figure 5-10.
