INTERIM FINAL DRAFT REPORT  
ON  
EMBANKMENT FAILURE  
FLORIDA POWER & LIGHT COMPANY  
MARTIN PLANT COOLING RESERVOIR

April 1980

South Florida Water Management District  
West Palm Beach, Florida

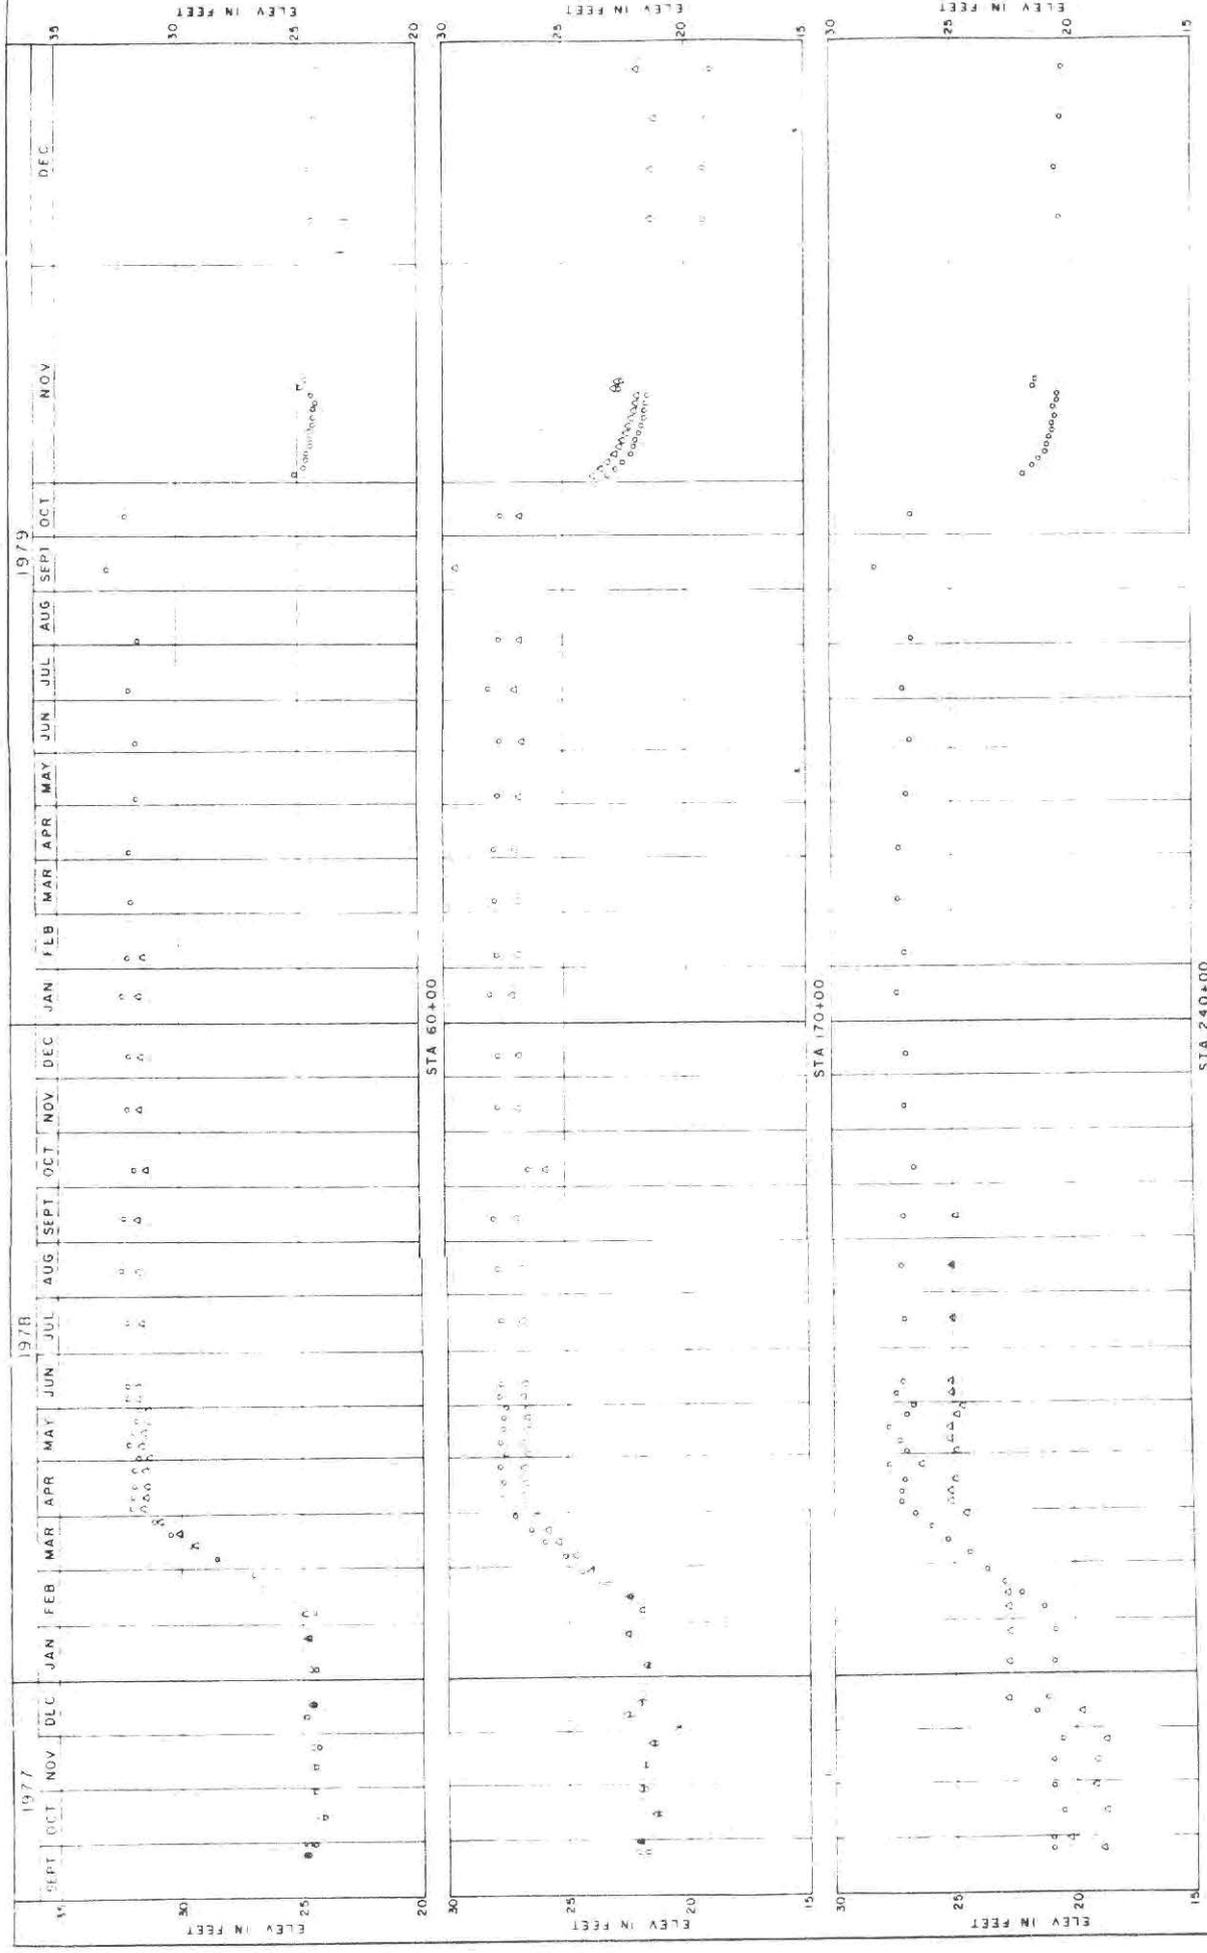
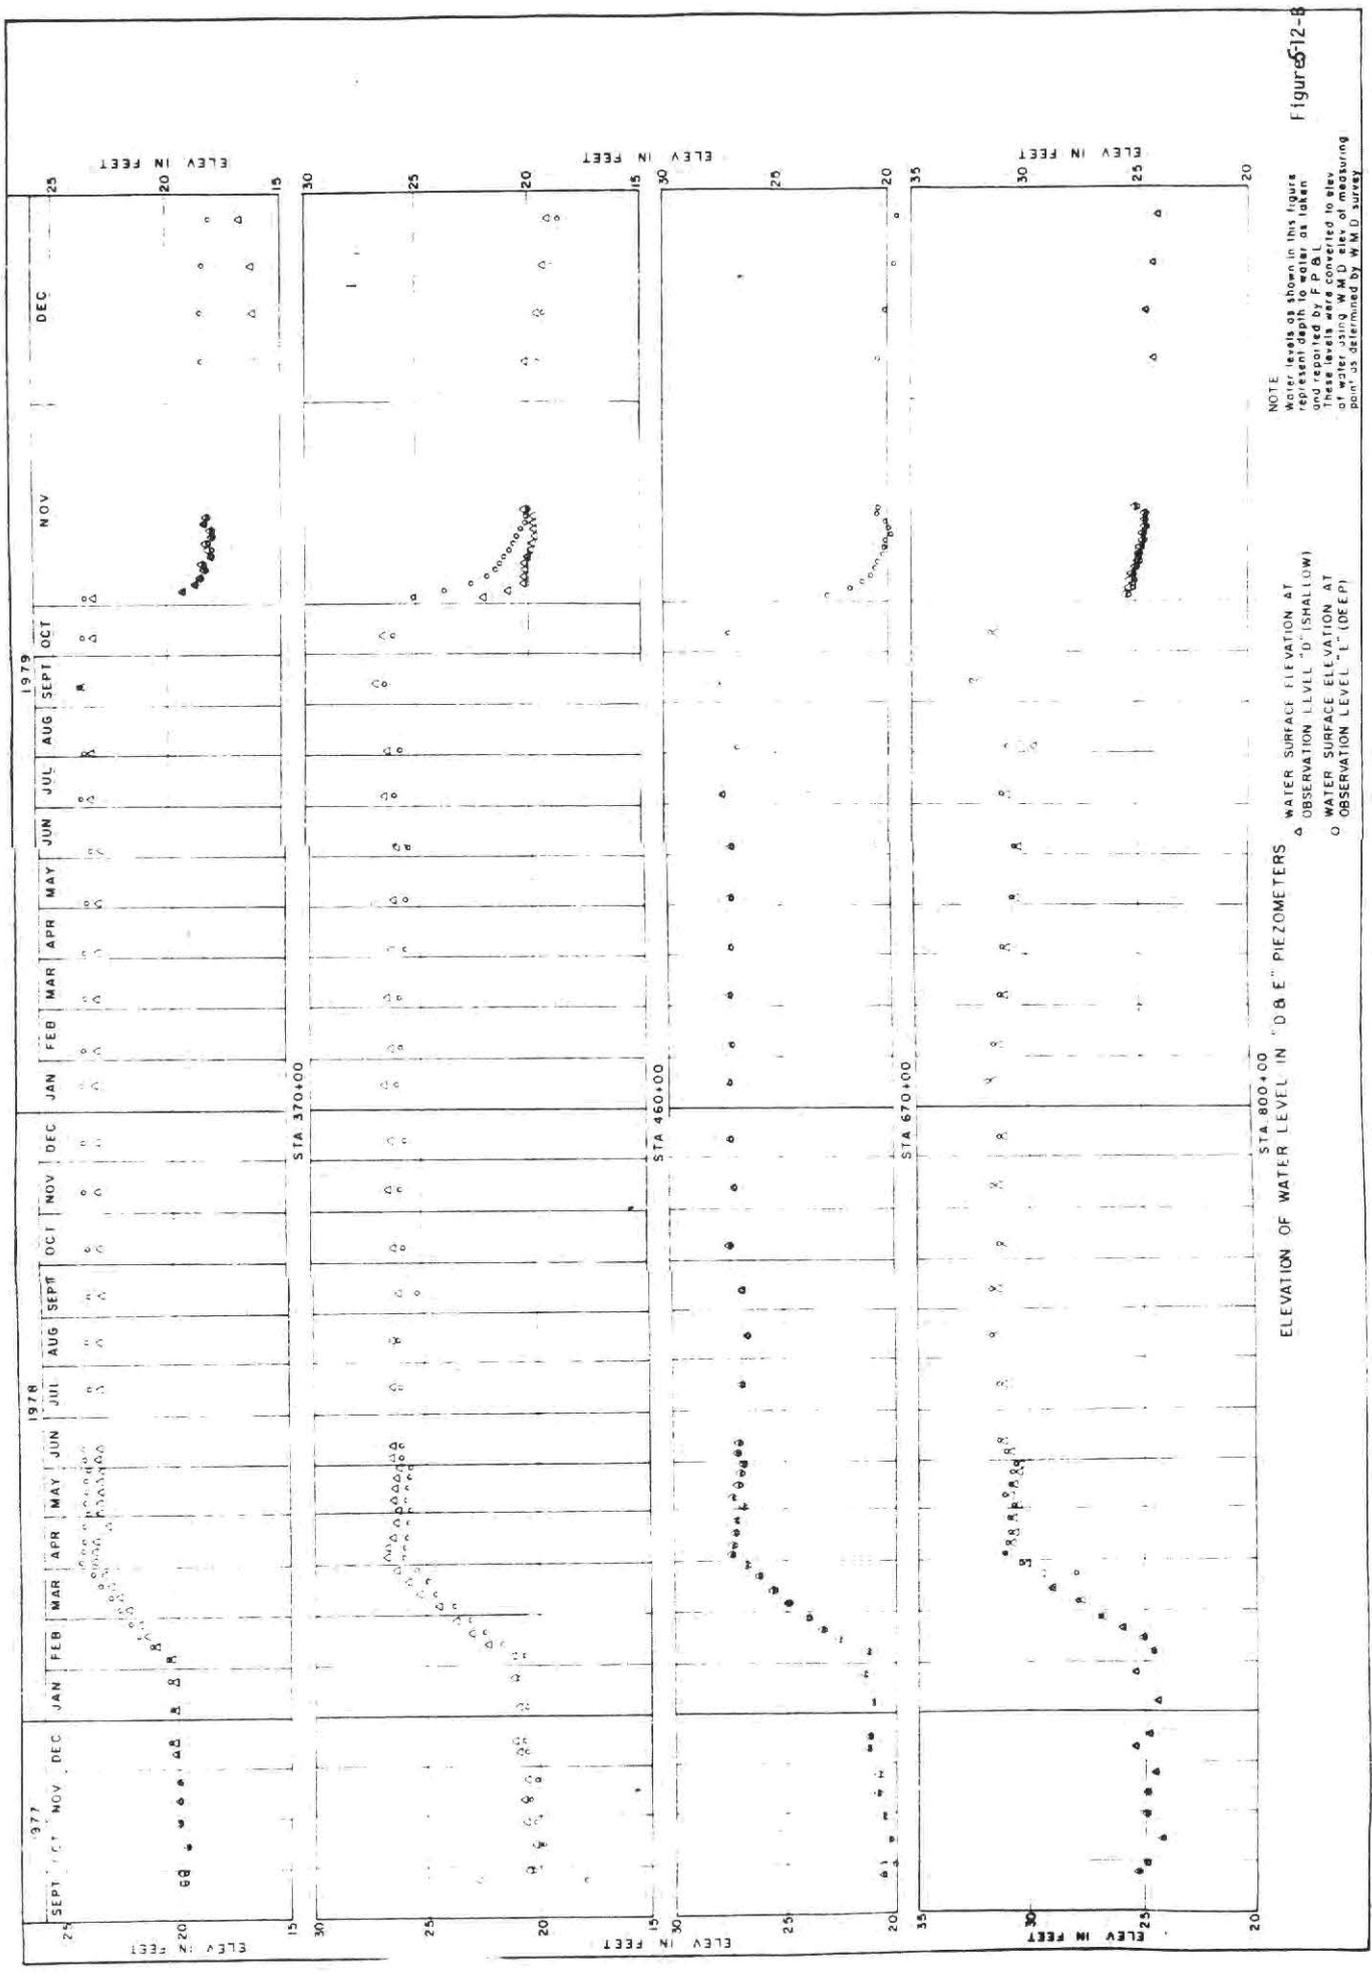
3. The D and E piezometers were plotted for their entire period of record and are shown in Figure <sup>5-12A & 5-12B</sup>. An inspection of pairs of piezometric heads reveals what can be considered to be anomalous conditions. For example, the potentiometric gradient from transect to transect changes. That is, in some transects the water level above the shell is higher than water levels measured below the cemented shell. Thus the gradient would be in a downward direction. This can be seen in the D & E piezometers at station 460+00. Conversely, at all other stations (60, 170, 240, 370, 670, 800) the water levels measured in the deep piezometer (E) stand higher than water levels measured in the shallow wells (D). In this latter situation the potentiometric gradient can be considered to be in an upward direction. The reason for this change in potentiometric gradient most probably relates to subtle changes in permeability of the various soil layers in the vicinity of the piezometers and the position of the regional hydraulic gradient.

4. The direction of the gradient does, however, take on meaning when evaluated in terms of probable causes of failure. One of the theories that had been proposed suggests that a downward gradient could drive the very fine sand overlying the shell into the underlying open fabric of the shell rock; and, by degrees, sediment would be removed by upward "stoping" and deposited in the shell until finally the reservoir embankment could be breached and failure could occur. The mechanics of such a

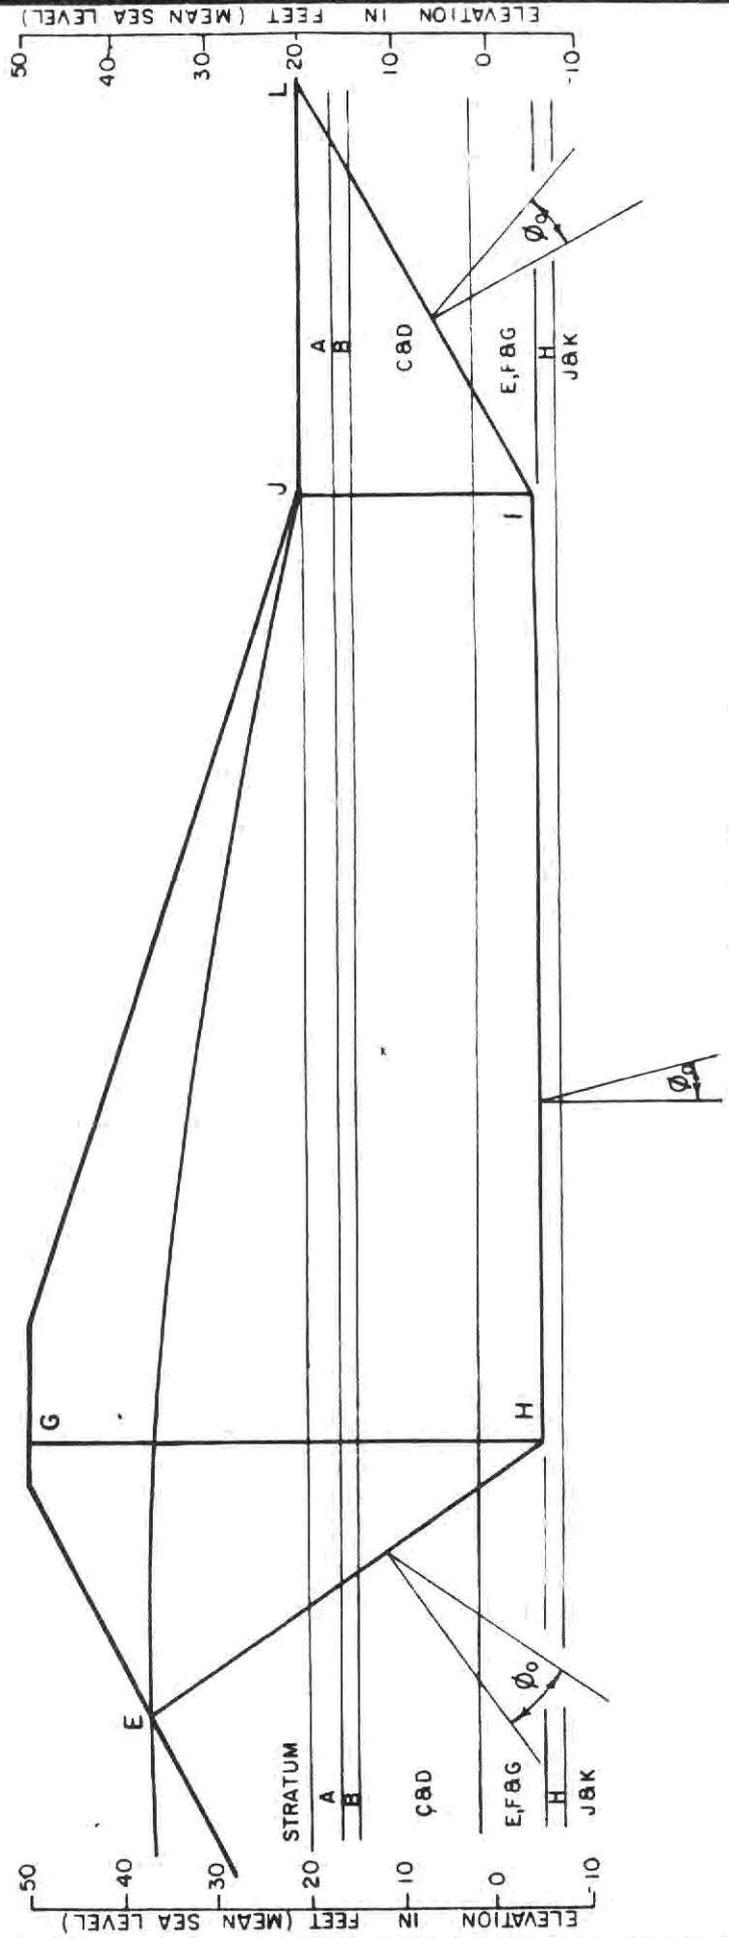
TYPICAL STABILITY ANALYSIS  
SLIDING BLOCK METHOD

CASE 7

BLOCK OR WEDGE	WT. (Kips)	$\phi_w$	$U_{HL}$	$U_{HR}$	$U_V$	TRIAL SAFETY FACTOR	$T_{on} \phi_0$	$\phi_0$	F	$P_A$	$P_{PW}$	$P_{PB}$
ACTIVE WEDGE EHG	101.3	33.3°	45.6	42.2	31.9	1.7	0.3858	21.1°	82	48'		
PASSIVE BLOCK GHIJ	427.0	25°	42.2	32.6	207.5	1.7	0.2743	15.3°	60.3			50.7
PASSIVE WEDGE JIL	56.5	32°	32.6	32.6	57.3	1.7	0.3676	20.2°			0

TABLE 5-9  
Stability Analysis Summary

Case	Layer H Angle of Internal Friction in degrees	Hydrostatic Pressure	Safety Factor
		Swedish Circle Method	
1	25	A	1.58
2	25	B	1.30
3	0	A	1.05
4	0	B	0.81
5	11	B	1.00
		Sliding Block Method	
6	25	A	>2.0
7	25	B	>1.7
8	10	B	1.00

A - Hydrostatic pressure between hardpan and cemented shell as measured in the piezometer transect at Station 370, one mile south of the break, about elevation 25. This case corresponds roughly to the flow net No. 1 in the Appendix.

B - A high hydrostatic pressure between hardpan and cemented shell of elevation 30. This case corresponds roughly to flow net No. 3 or 13 in the Appendix.
