PRELIMINARY REPORT ON
RAINSTORM OF APRIL 23-26, 1982

Steve Lin

Water Resources Division
Resource Planning Department

May 6, 1982

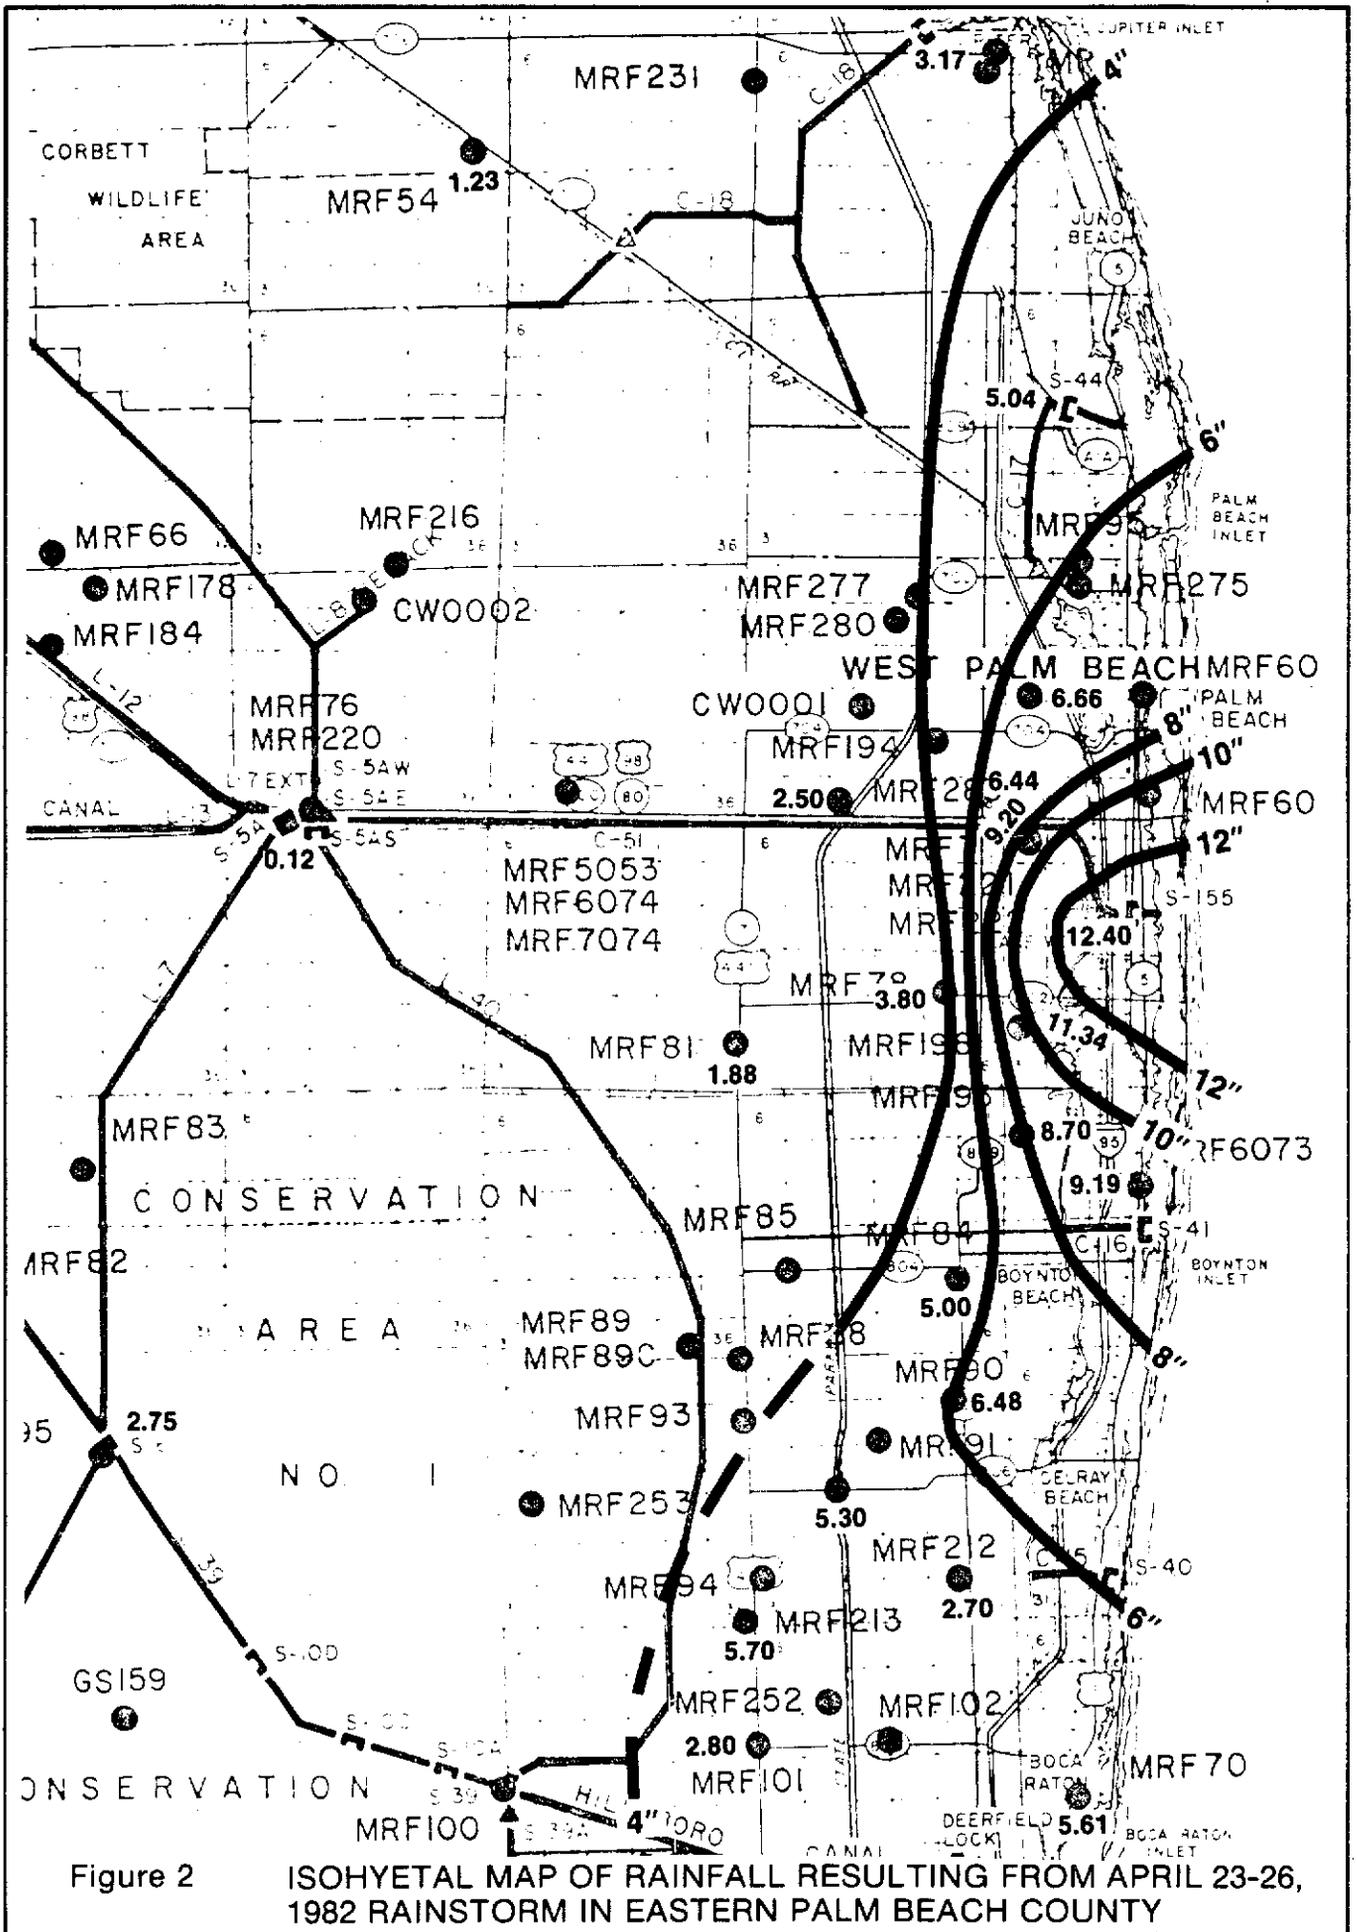
Figure 2 shows the isohyetal map of rainfall resulting from this rainstorm in eastern Palm Beach County. The areas of next highest rainfall intensities were the areas west and southwest of Miami, including the Cities of Miami, Miami Springs, Hialeah, South Miami, etc. Total rainfall of 8 to 15 inches was reported in this area. Figure 2A shows the isohyetal map of rainfall distribution resulting from this rainstorm in this area. The return frequency of the measured rainfall (maximum two days) was compared with frequency analysis presented in the District Technical Publication 81-3 entitled "Frequency Analysis of Rainfall Maximum for Central and Southern Florida". The highest rainfall area, which included Lake Clarke Shores, Palm Springs, Lake Worth along Congress Avenue, and eastward to the Atlantic Ocean was on the order of between a one in 10 and a one in 25 year event. The greater Miami area which includes Miami, Miami Springs, Hialeah, and the area between the Miami International Airport, Coral Gables and Sweetwater had rainfall on the order of a one in 5 to one in 10 year event. An approximately five square mile area, including the western portion of South Miami, was on the order of one in 25 to 50 year event.

ISOHYETAL MAP OF RAINFALL RESULTING FROM APRIL 23-26, 1982 RAINSTORM IN EASTERN PALM BEACH COUNTY

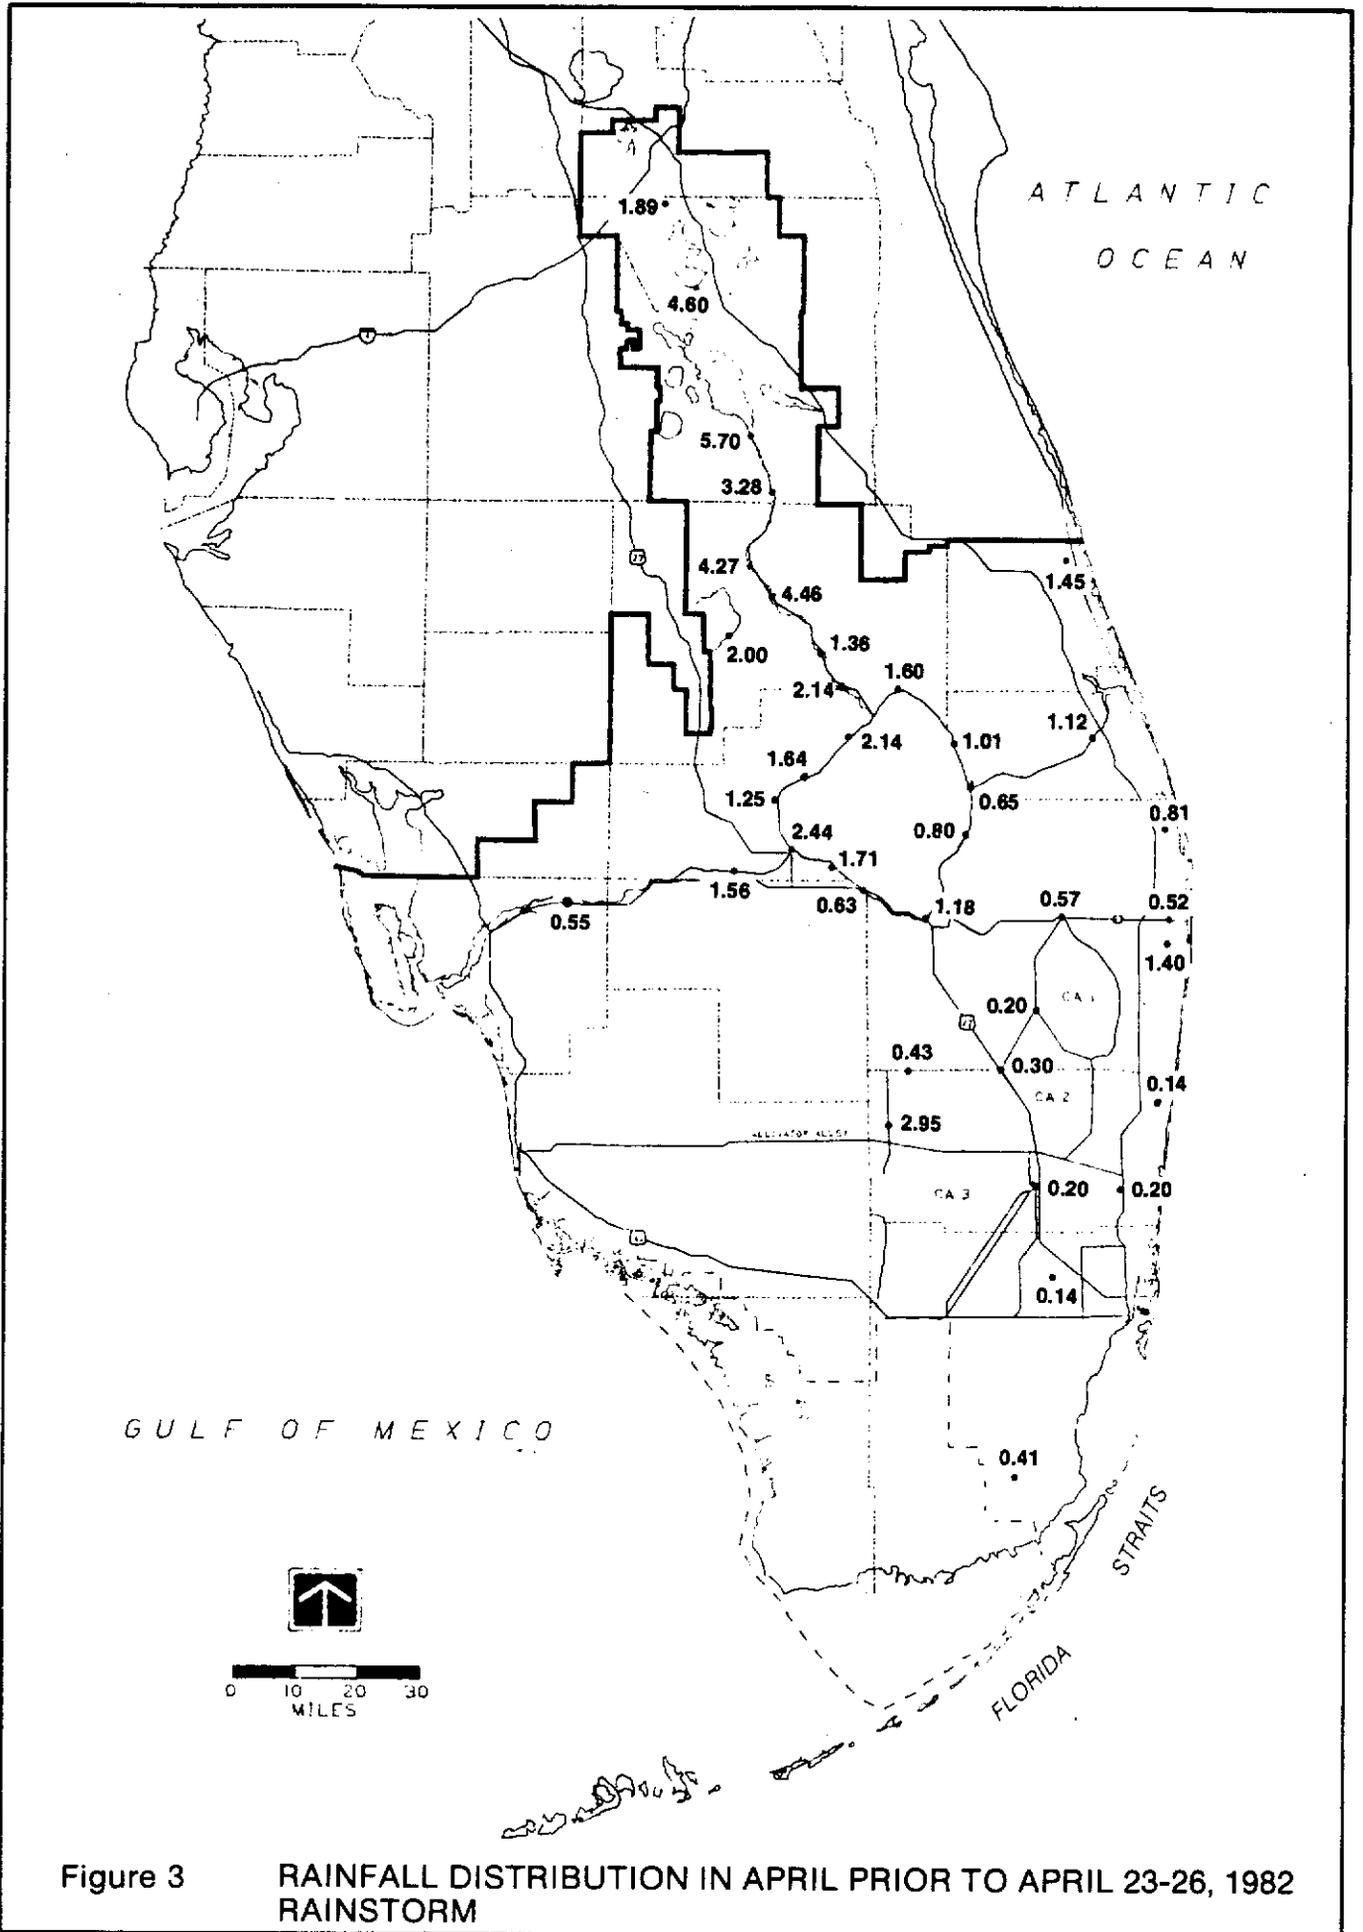
Rainfall deficiencies existed in most parts of the District except the lower east coast area of Palm Beach and Martin Counties. Figure 3 shows the rainfall distribution in April prior to this rainstorm. Most of the District area had received less than 1.0 inch of rain, except the area between Lake Tohopekaliga and S-65B which had about 3 to 5.7 inches. Even though the rainfall received in eastern Palm Beach County was less than 1.0 inch, the antecedent soil moisture condition in the area was still very wet and standing water existed in many places due to the severe rainstorm of March 28-29, 1982. This contributed to the flooding situation resulting from this storm. The antecedent soil moisture condition in south Dade was far dryer than the area

Figure 3 RAINFALL DISTRIBUTION IN APRIL PRIOR TO APRIL 23-26, 1982 RAINSTORM
