TECHNICAL PUBLICATION 79-1

FLOODPLAIN MANAGEMENT STUDIES
OF THE SHINGLE CREEK BASIN

Resource Planning Department
South Florida Water Management District
April 1979

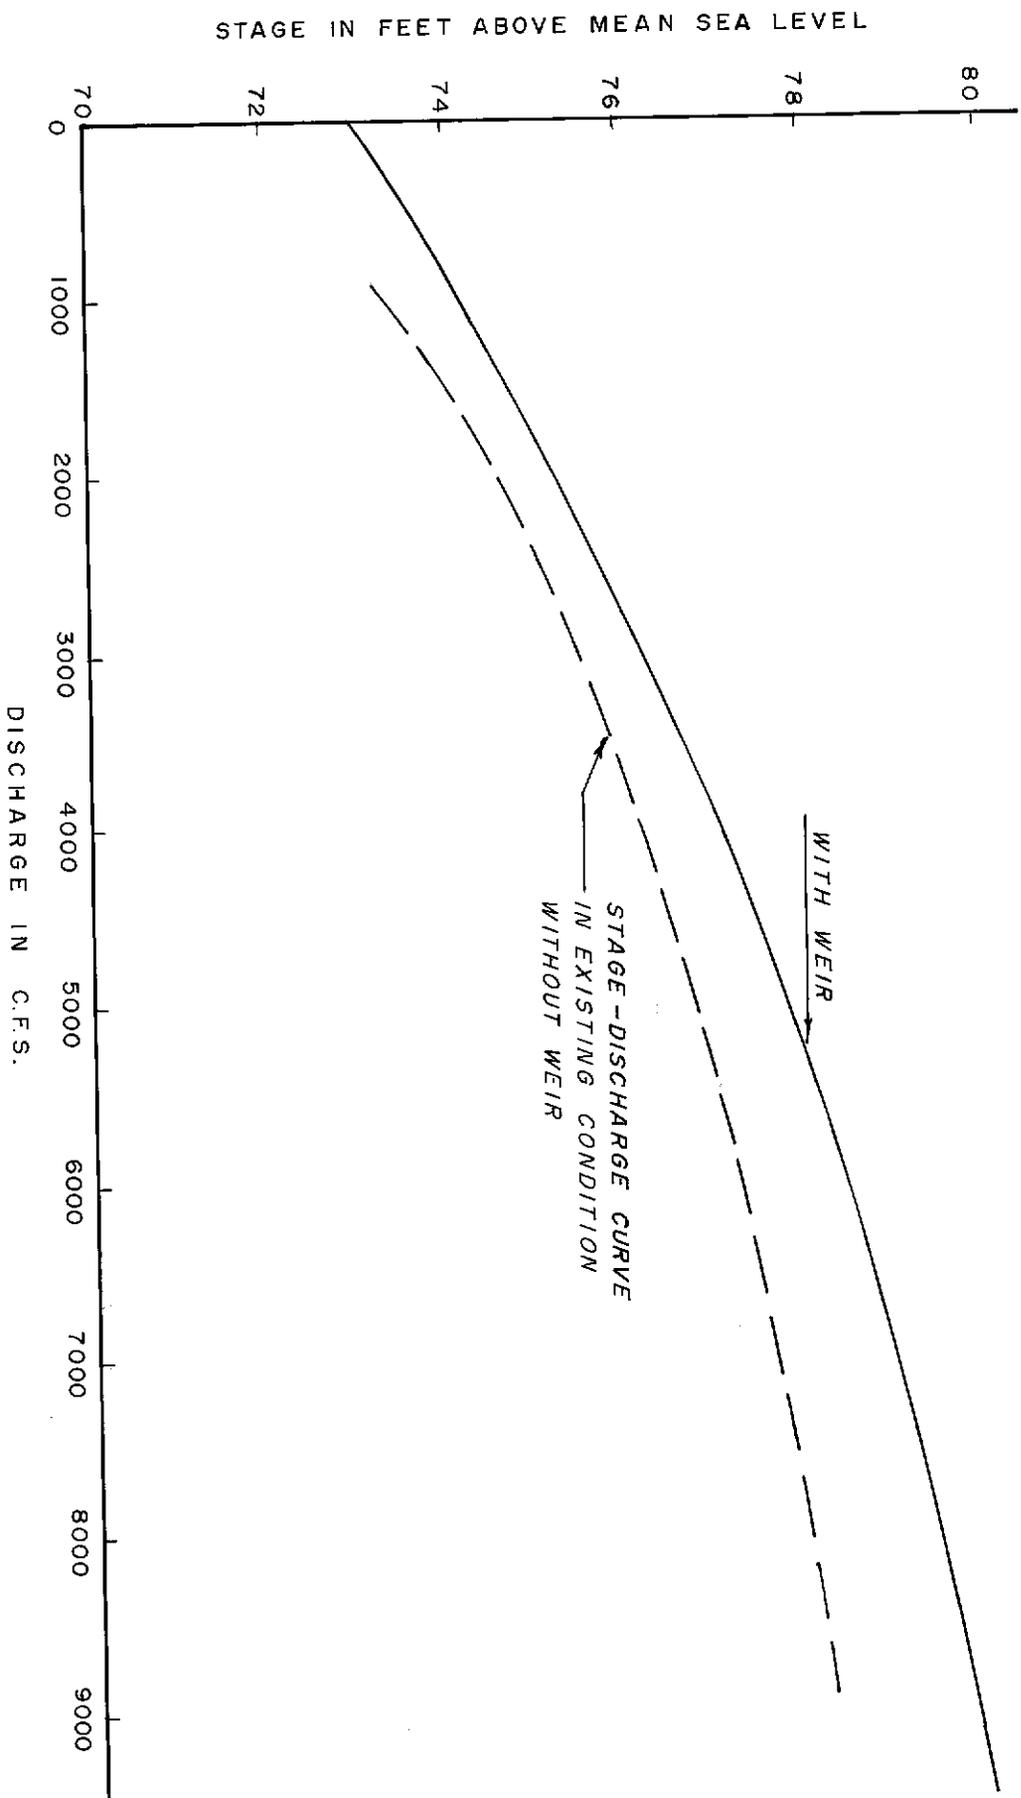
Figure 1 RATING CURVE AT STA. 747+00 WITH AND WITHOUT WEIR

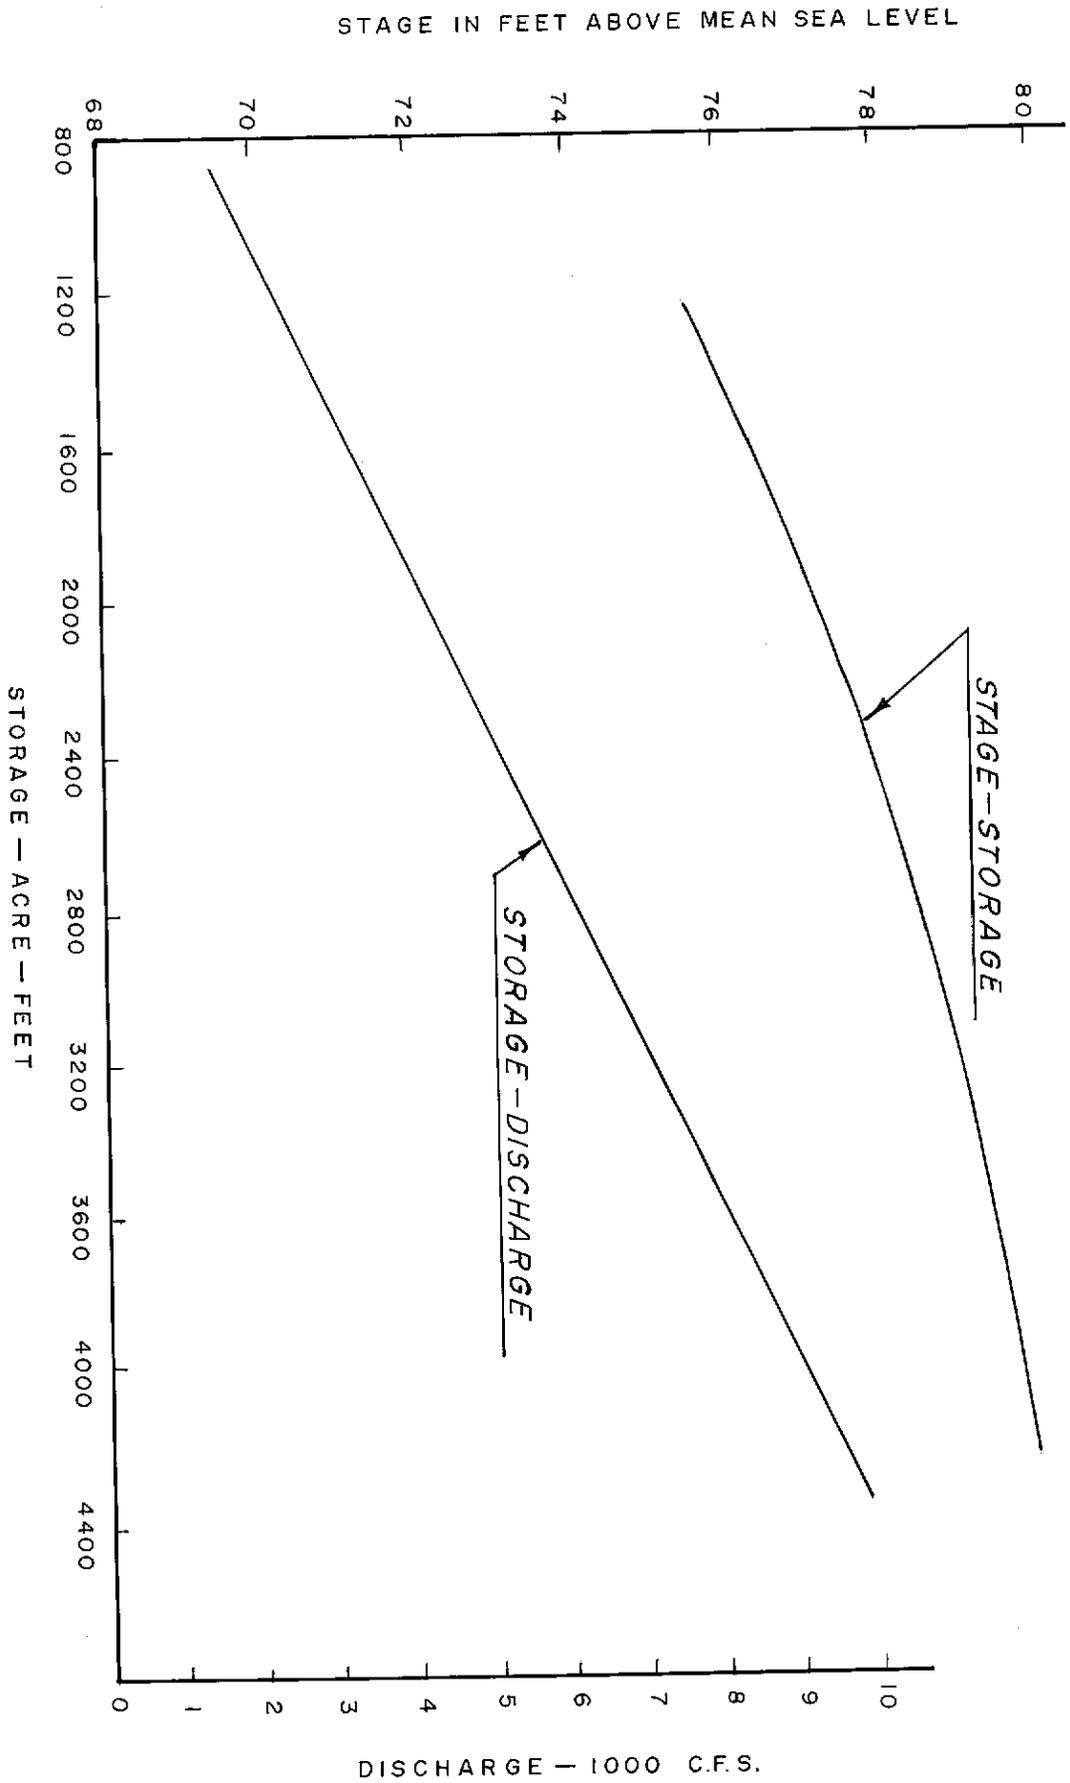
Figure 2 STAGE, STORAGE, AND DISCHARGE RELATION FOR REACH No. 11A WITH ON STREAM STRUCTURE

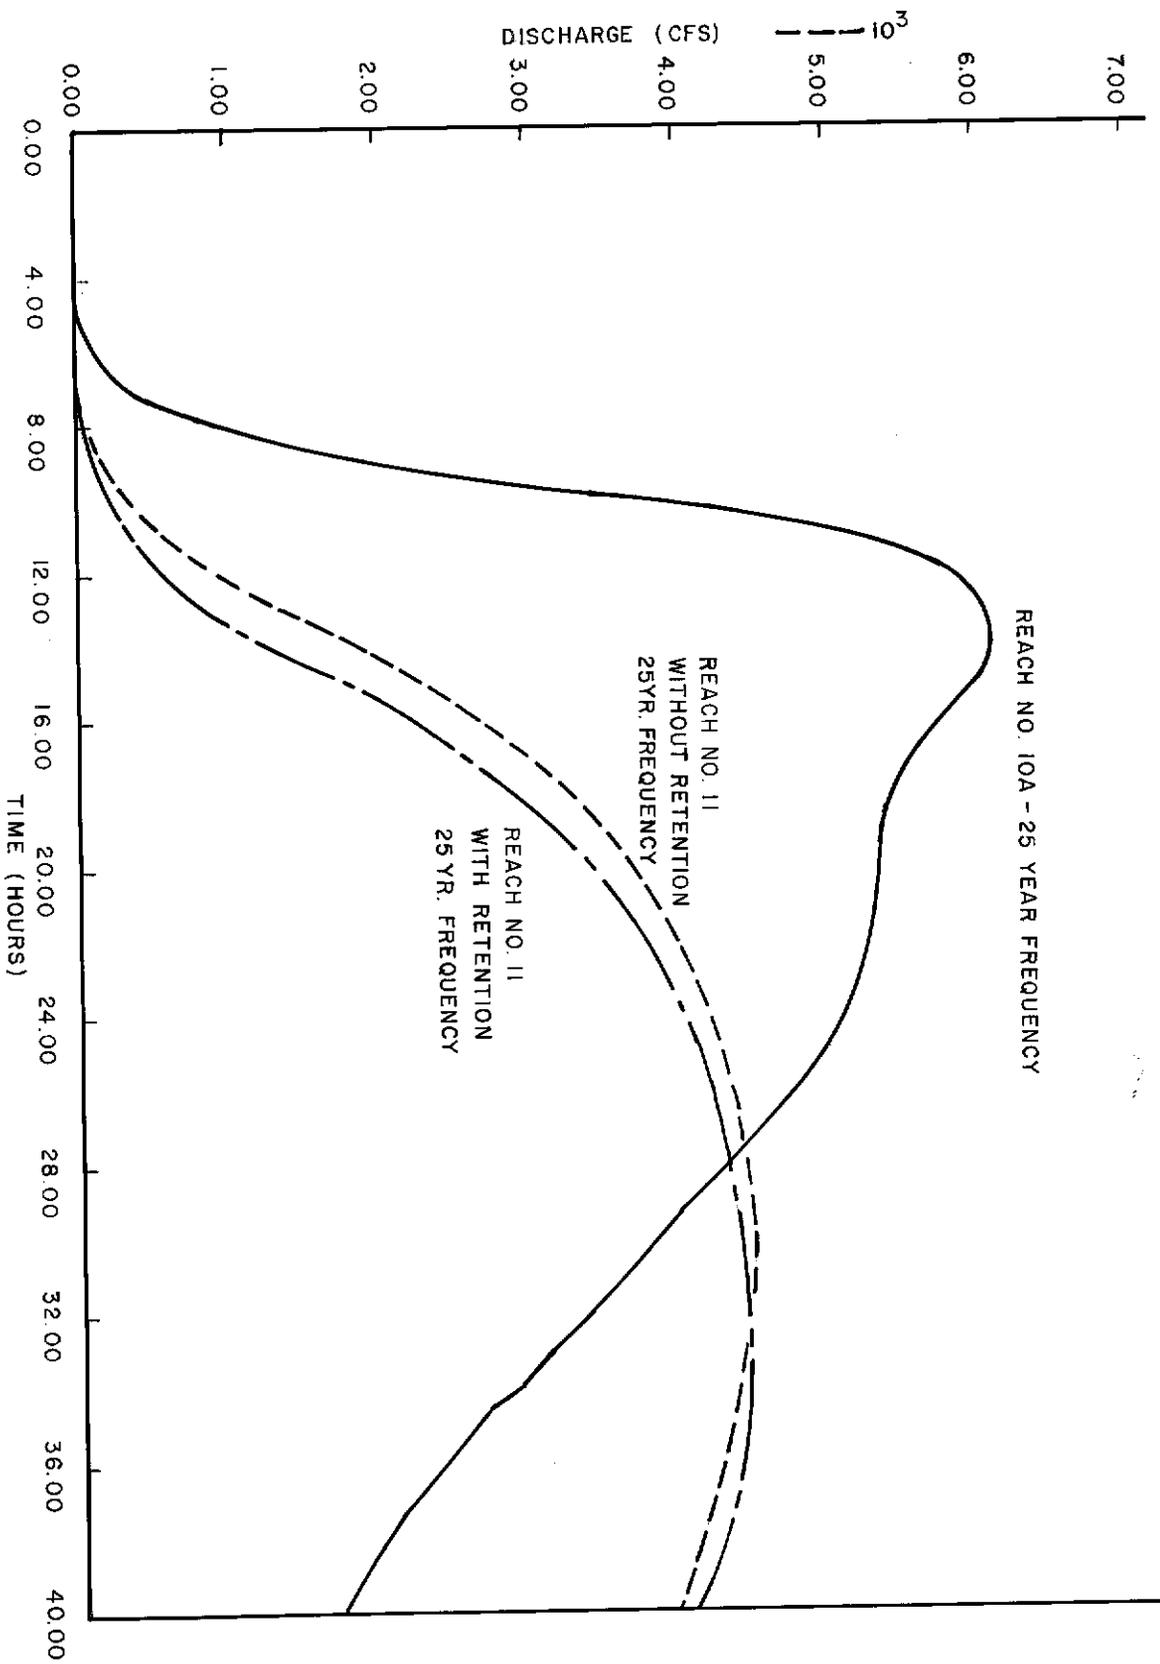
Figure 3 COMPARISONS OF INFLOW AND OUTFLOW HYDROGRAPHS FROM LARGE CYPRESS MARSH UNDER 25 YEAR FLOOD WITH & WITHOUT ON-STREAM RETENTION.

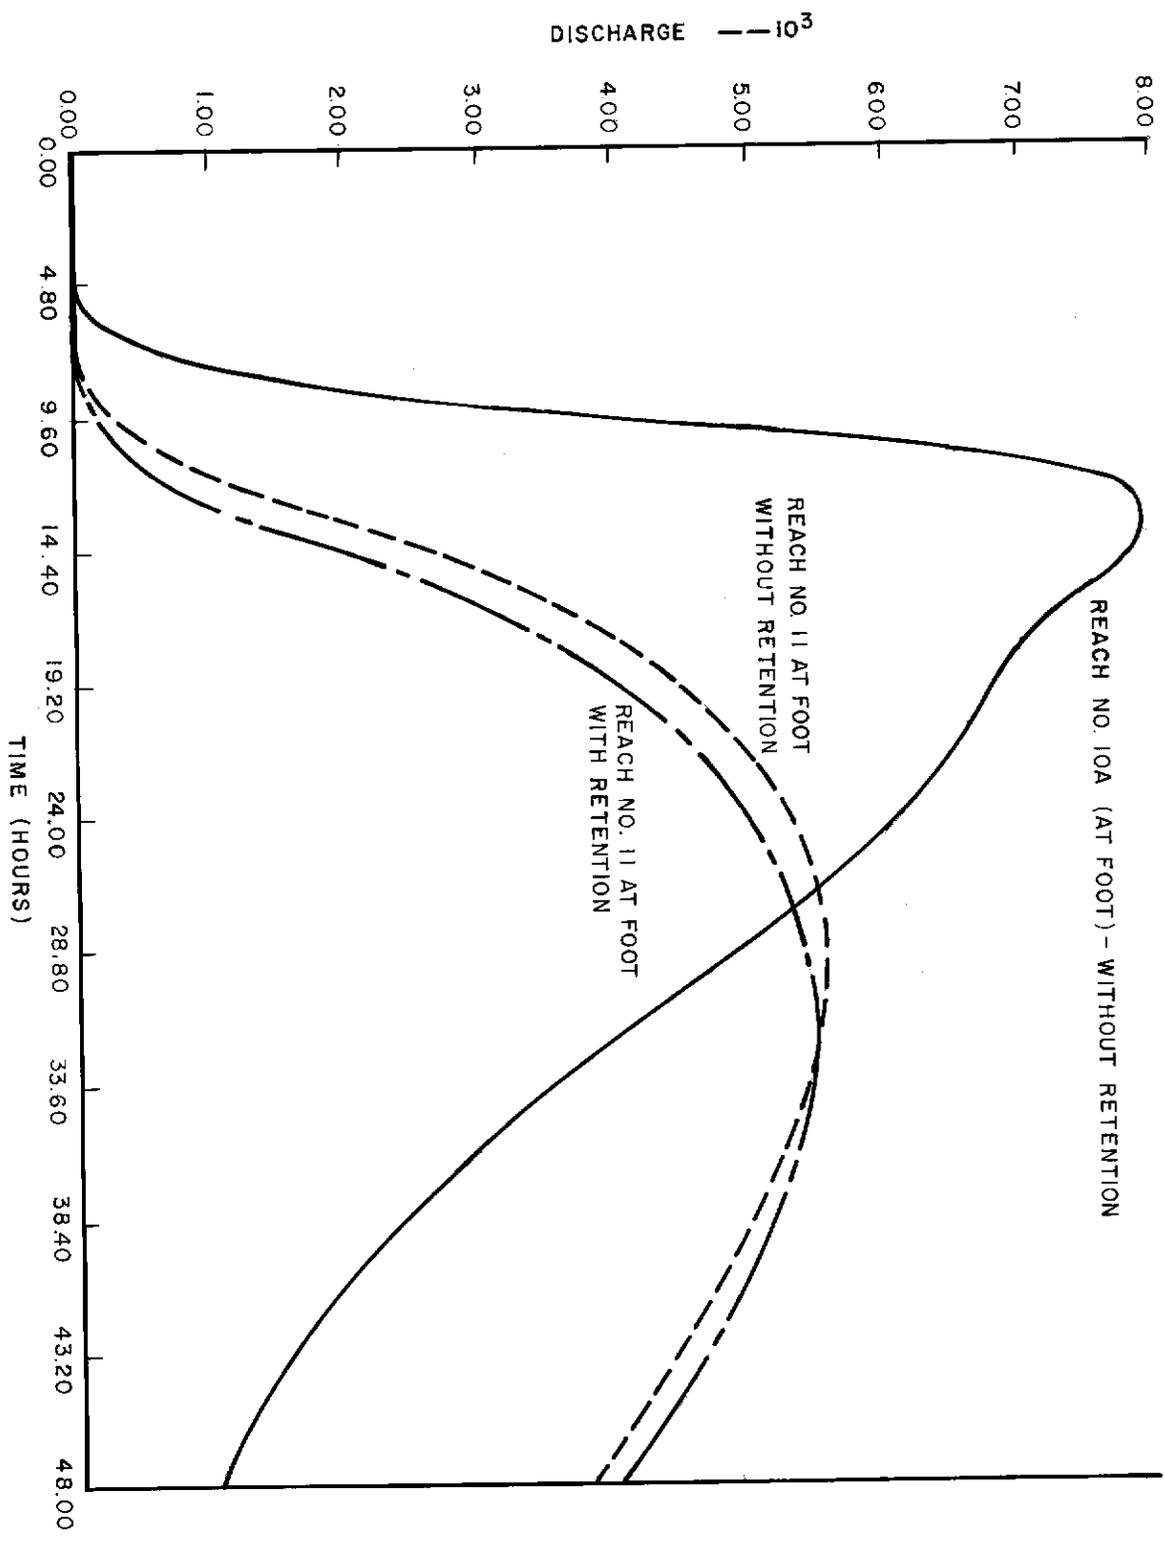
Figure 4 COMPARISON OF INFLOW AND OUTFLOW HYDROGRAPHS FROM LARGE CYPRESS MARSH UNDER 100 YEAR FLOOD WITH & WITHOUT ON-STREAM RETENTION.

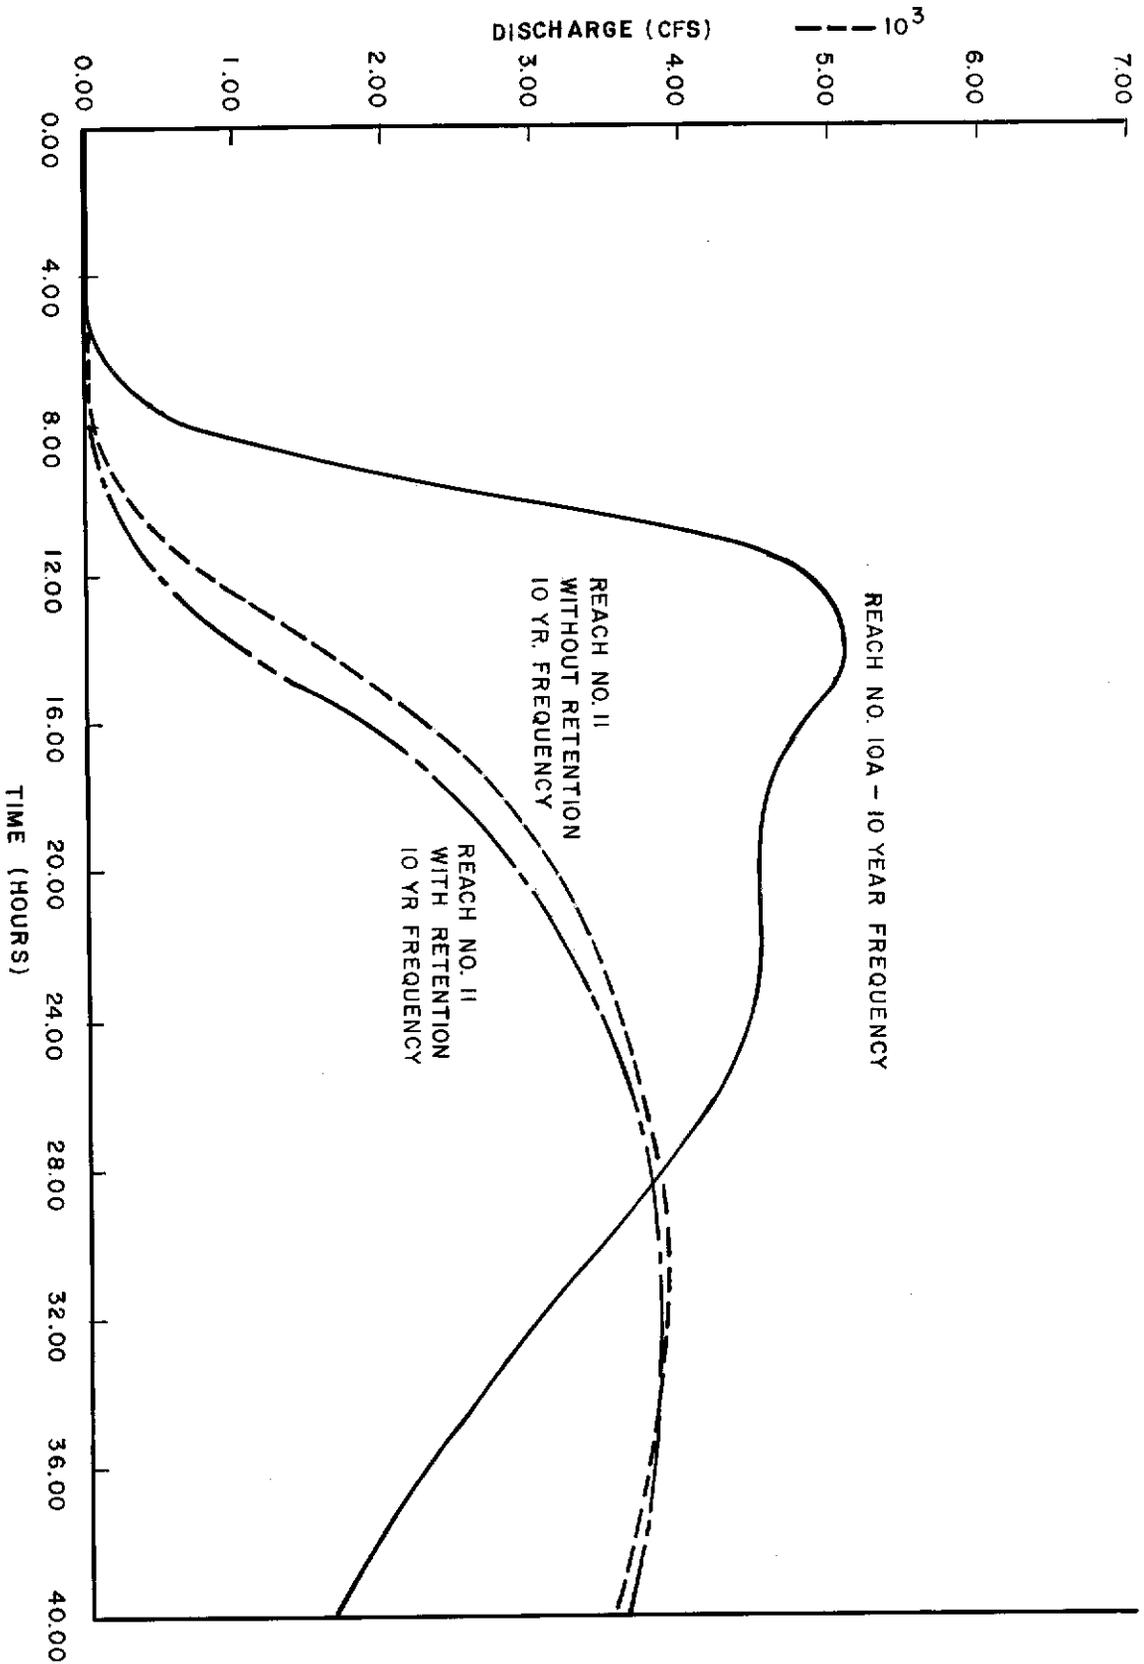
Figure 5 COMPARISON OF INFLOW AND OUTFLOW HYDROGRAPHS FROM LARGE CYPRESS MARSH UNDER 10 YEAR FLOOD WITH & WITHOUT ON-STREAM RETENTION.

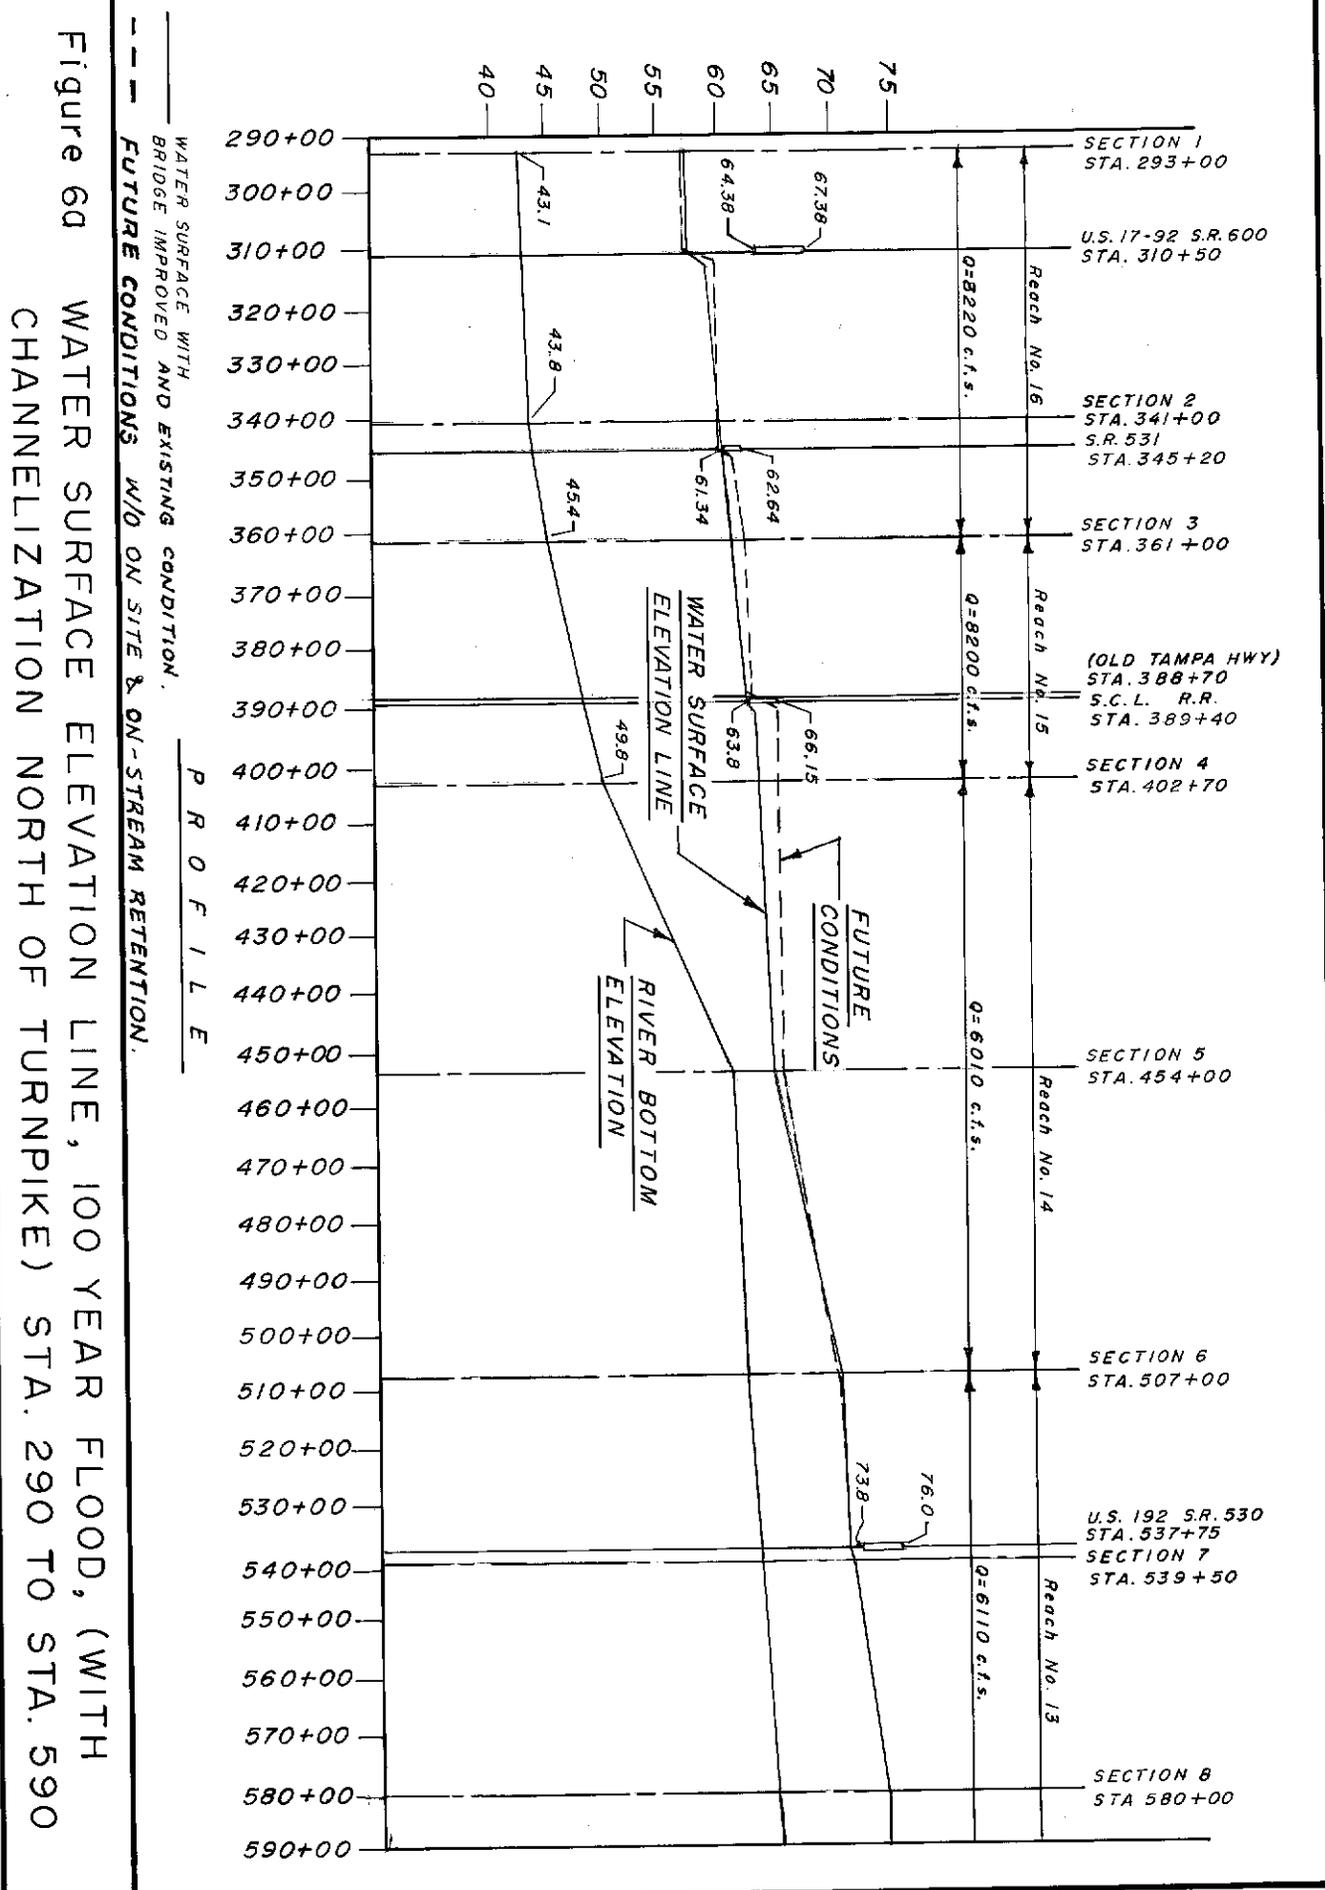
Figure 6A WATER SURFACE ELEVATION LINE, 100 YEAR FLOOD, (WITH CHANNELIZATION NORTH OF TURNPIKE) STA. 290 TO STA. 590

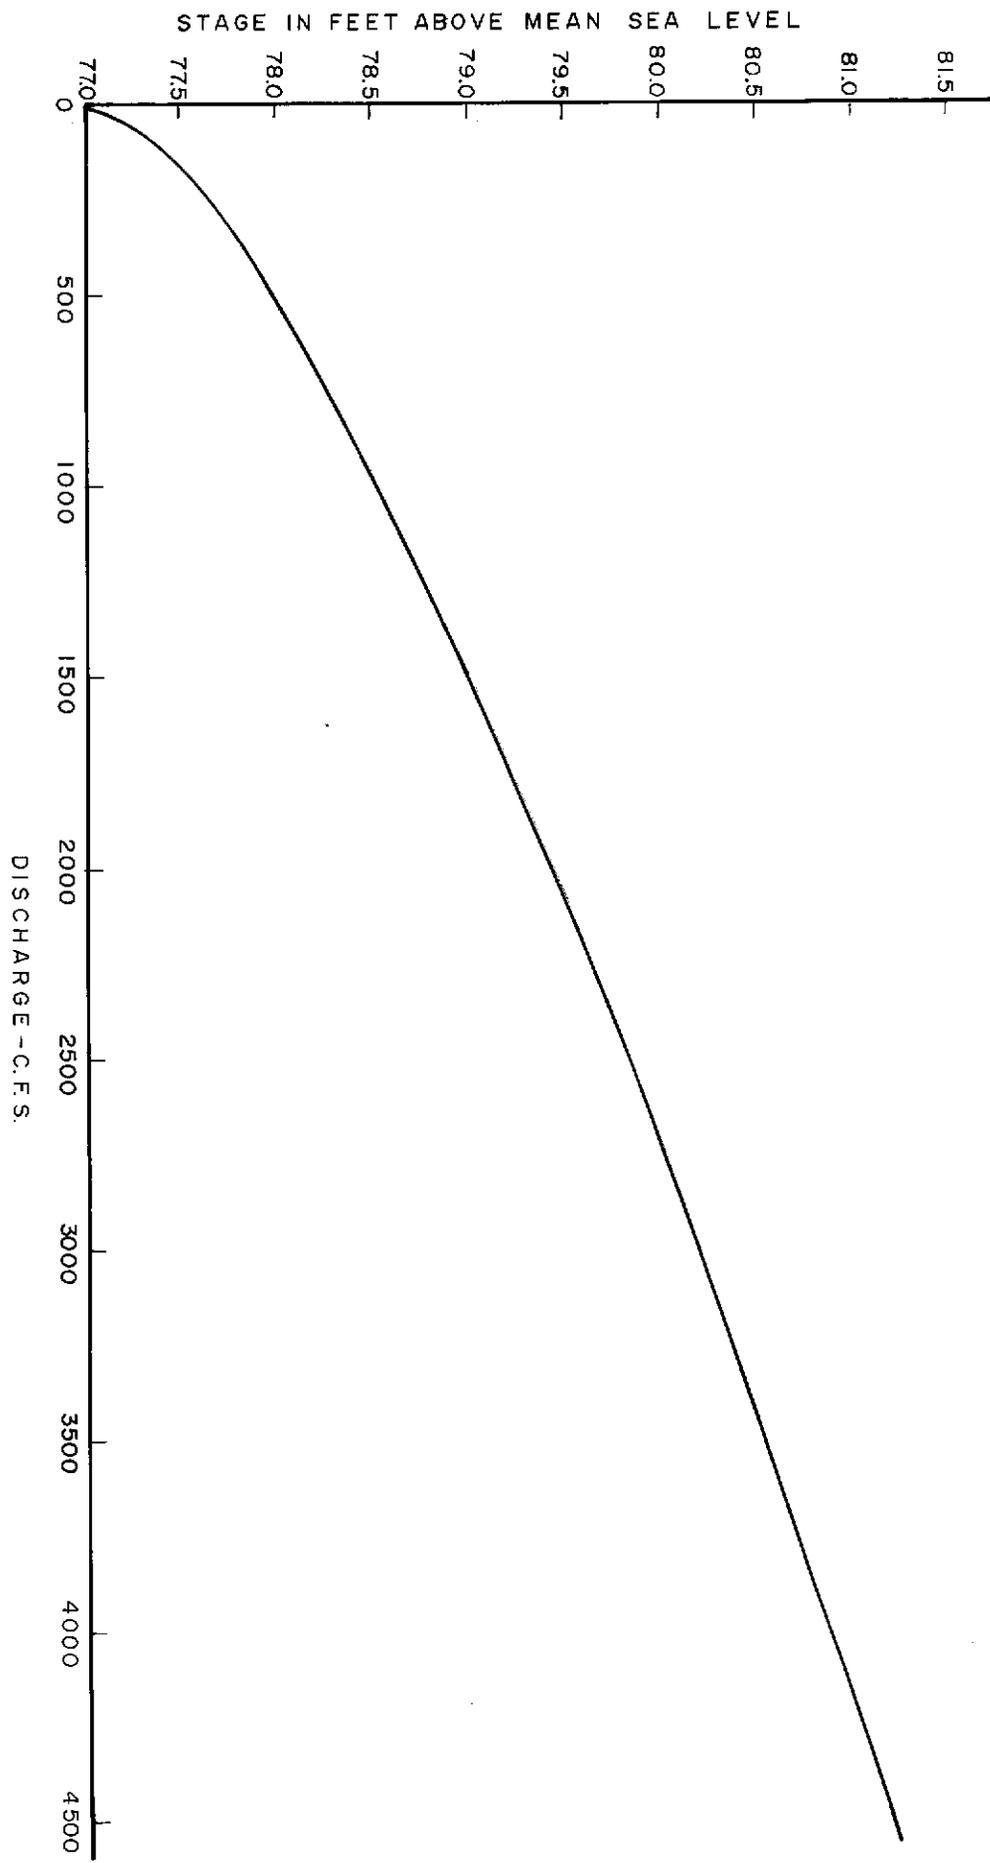
Figure 11 STAGE-DISCHARGE FOR 200 FOOT WEIR AT STATION 747+00

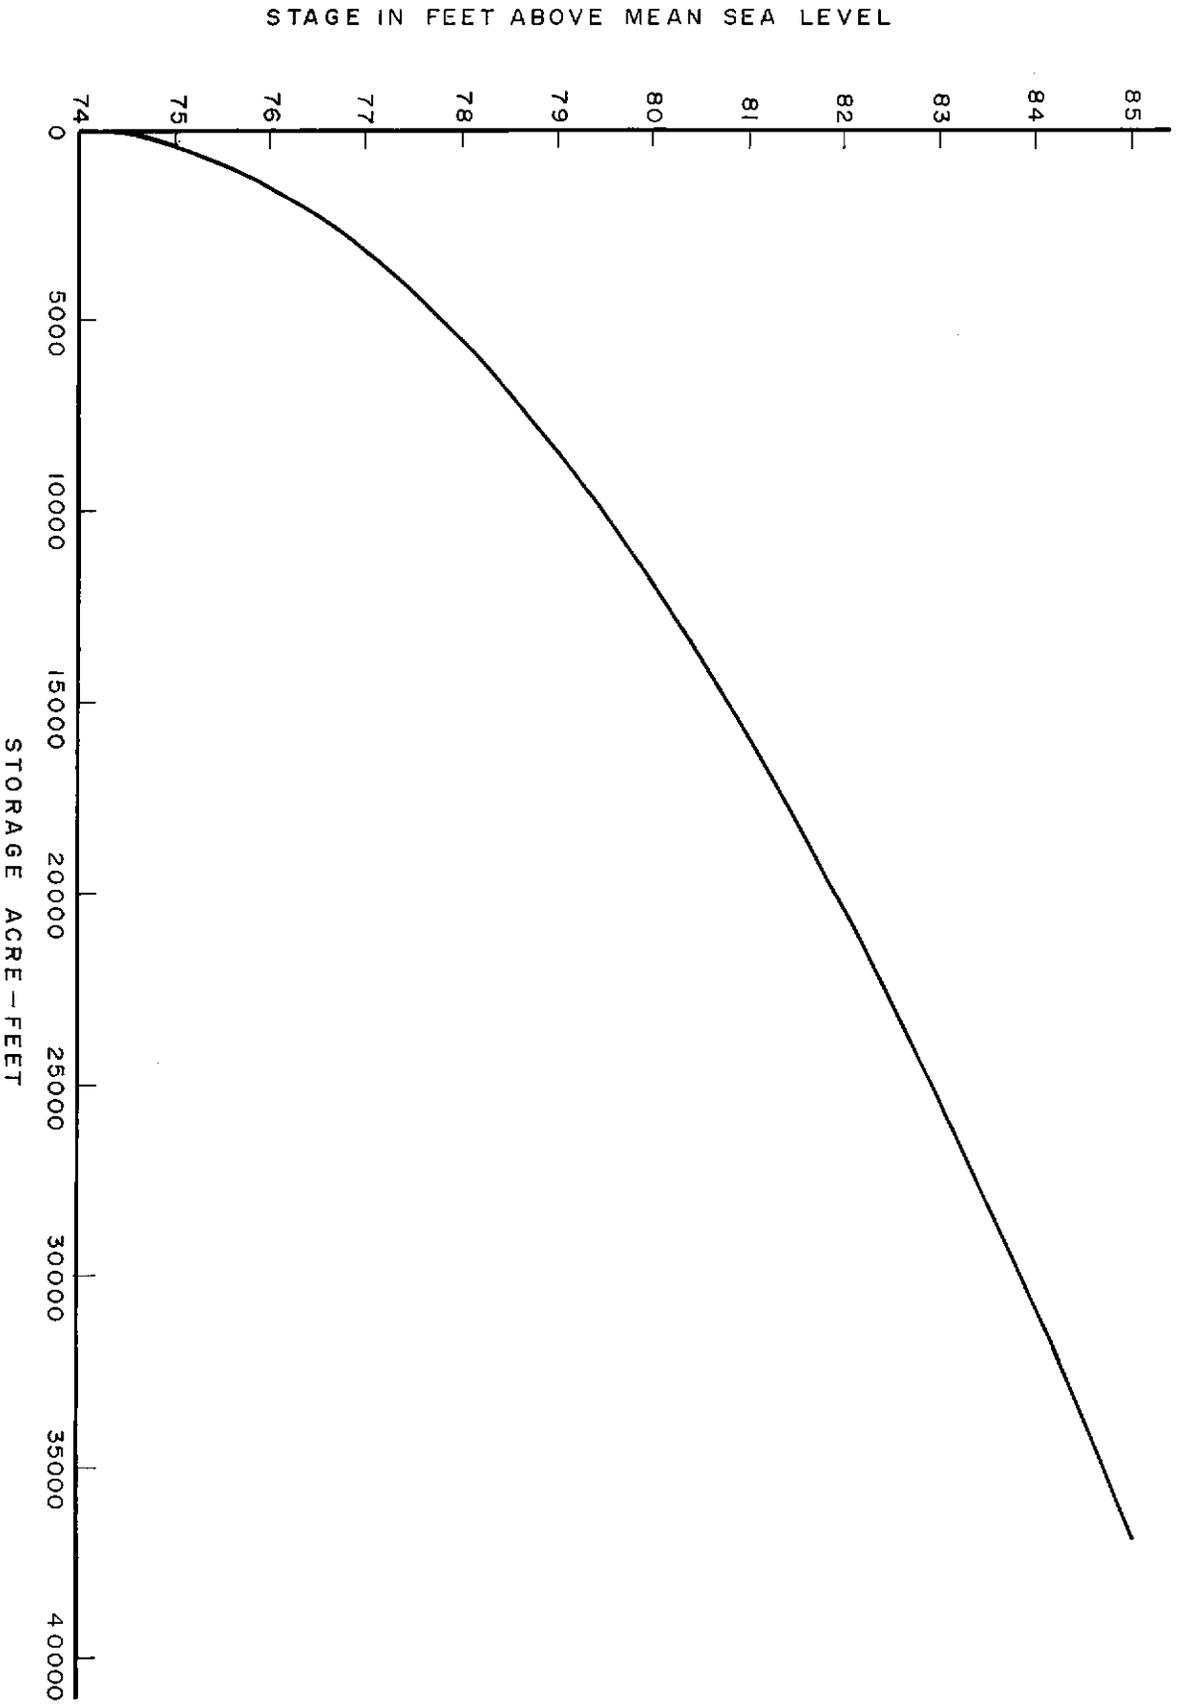
Figure 12 STAGE STORAGE SHINGLE CREEK SWAMP NORTH OF OSCEOLA
 CO. LINE BASED ON RECENT (1978) TOPOGRAPHY

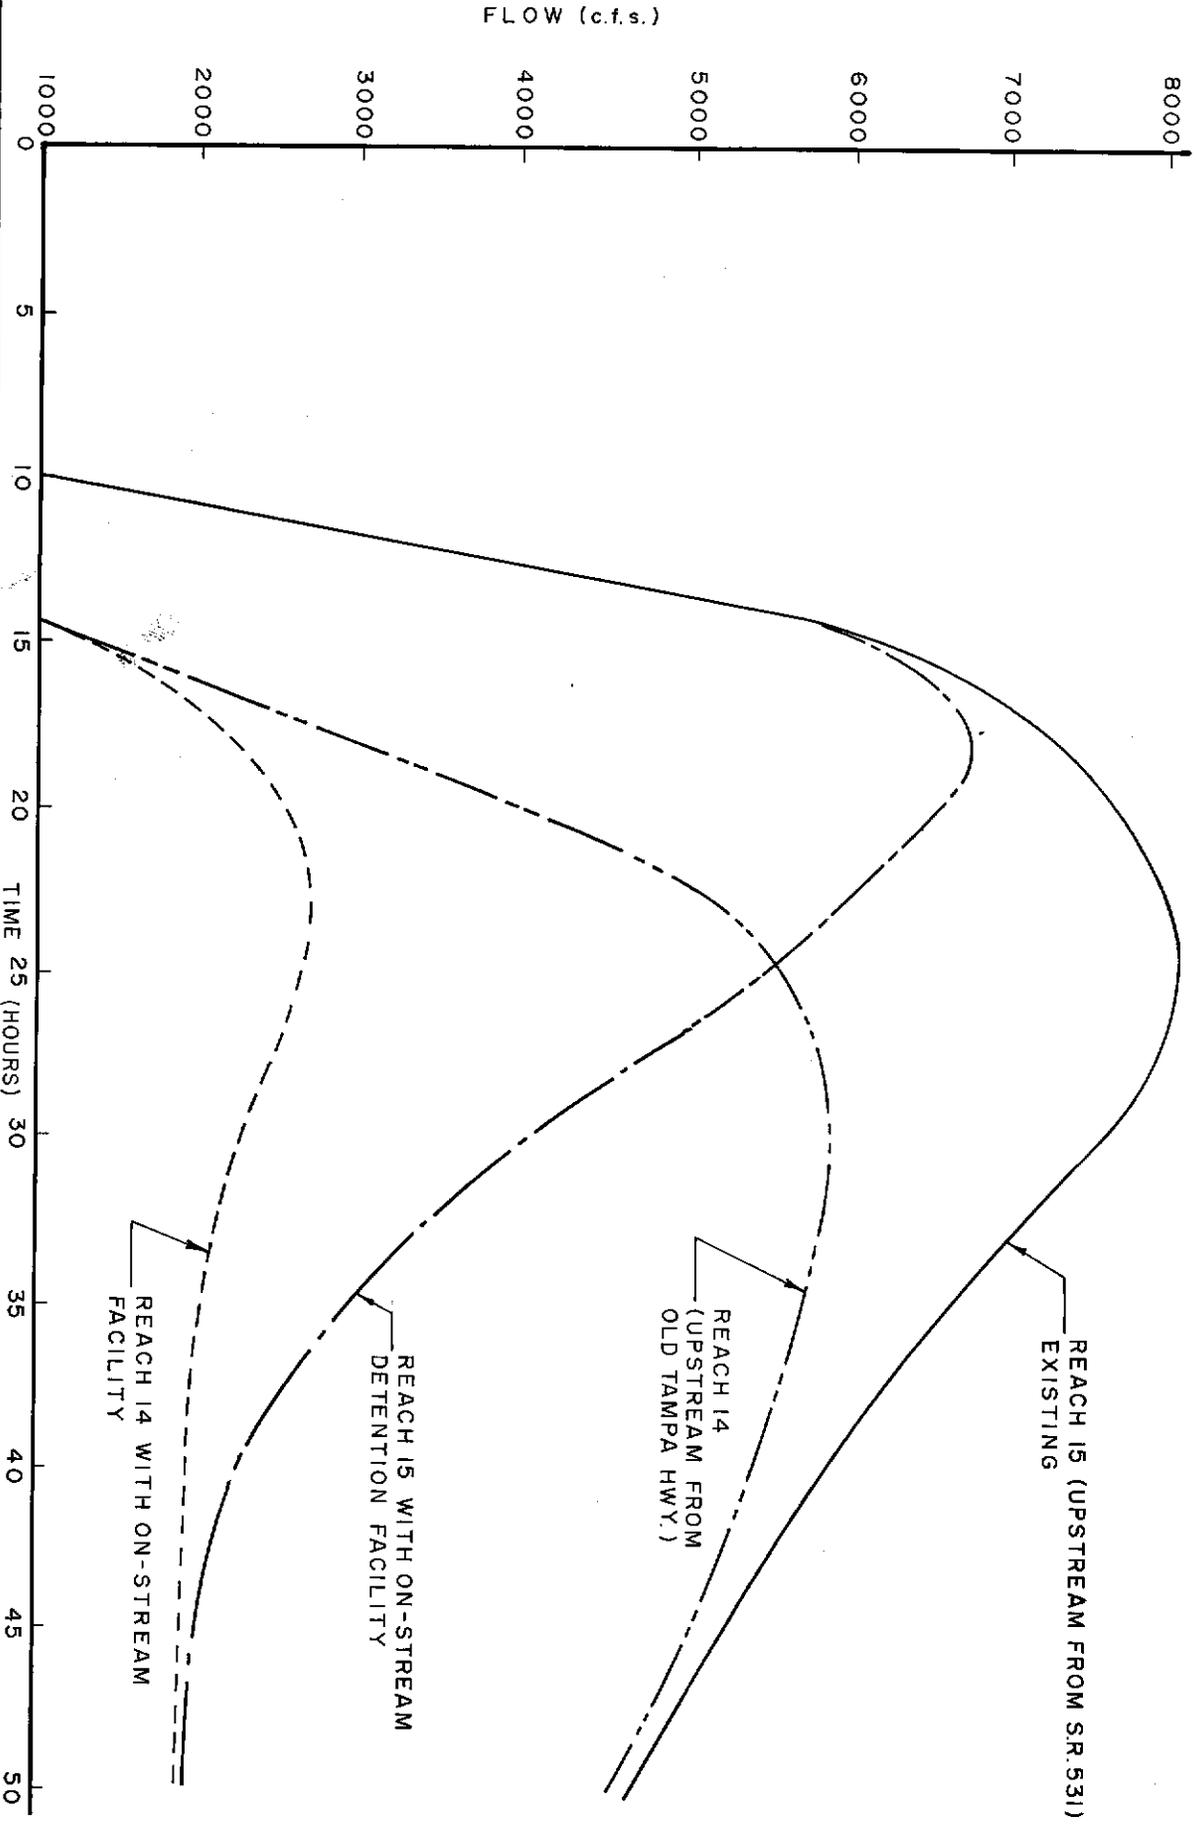
Figure 14 RUNOFF HYDROGRAPHS AT END REACH OF 14 & 15 WITH & WITHOUT ON-STREAM RETENTION LOCATED AT LARGE CYPRESS MARSH JUST NORTH OF COUNTY LINE

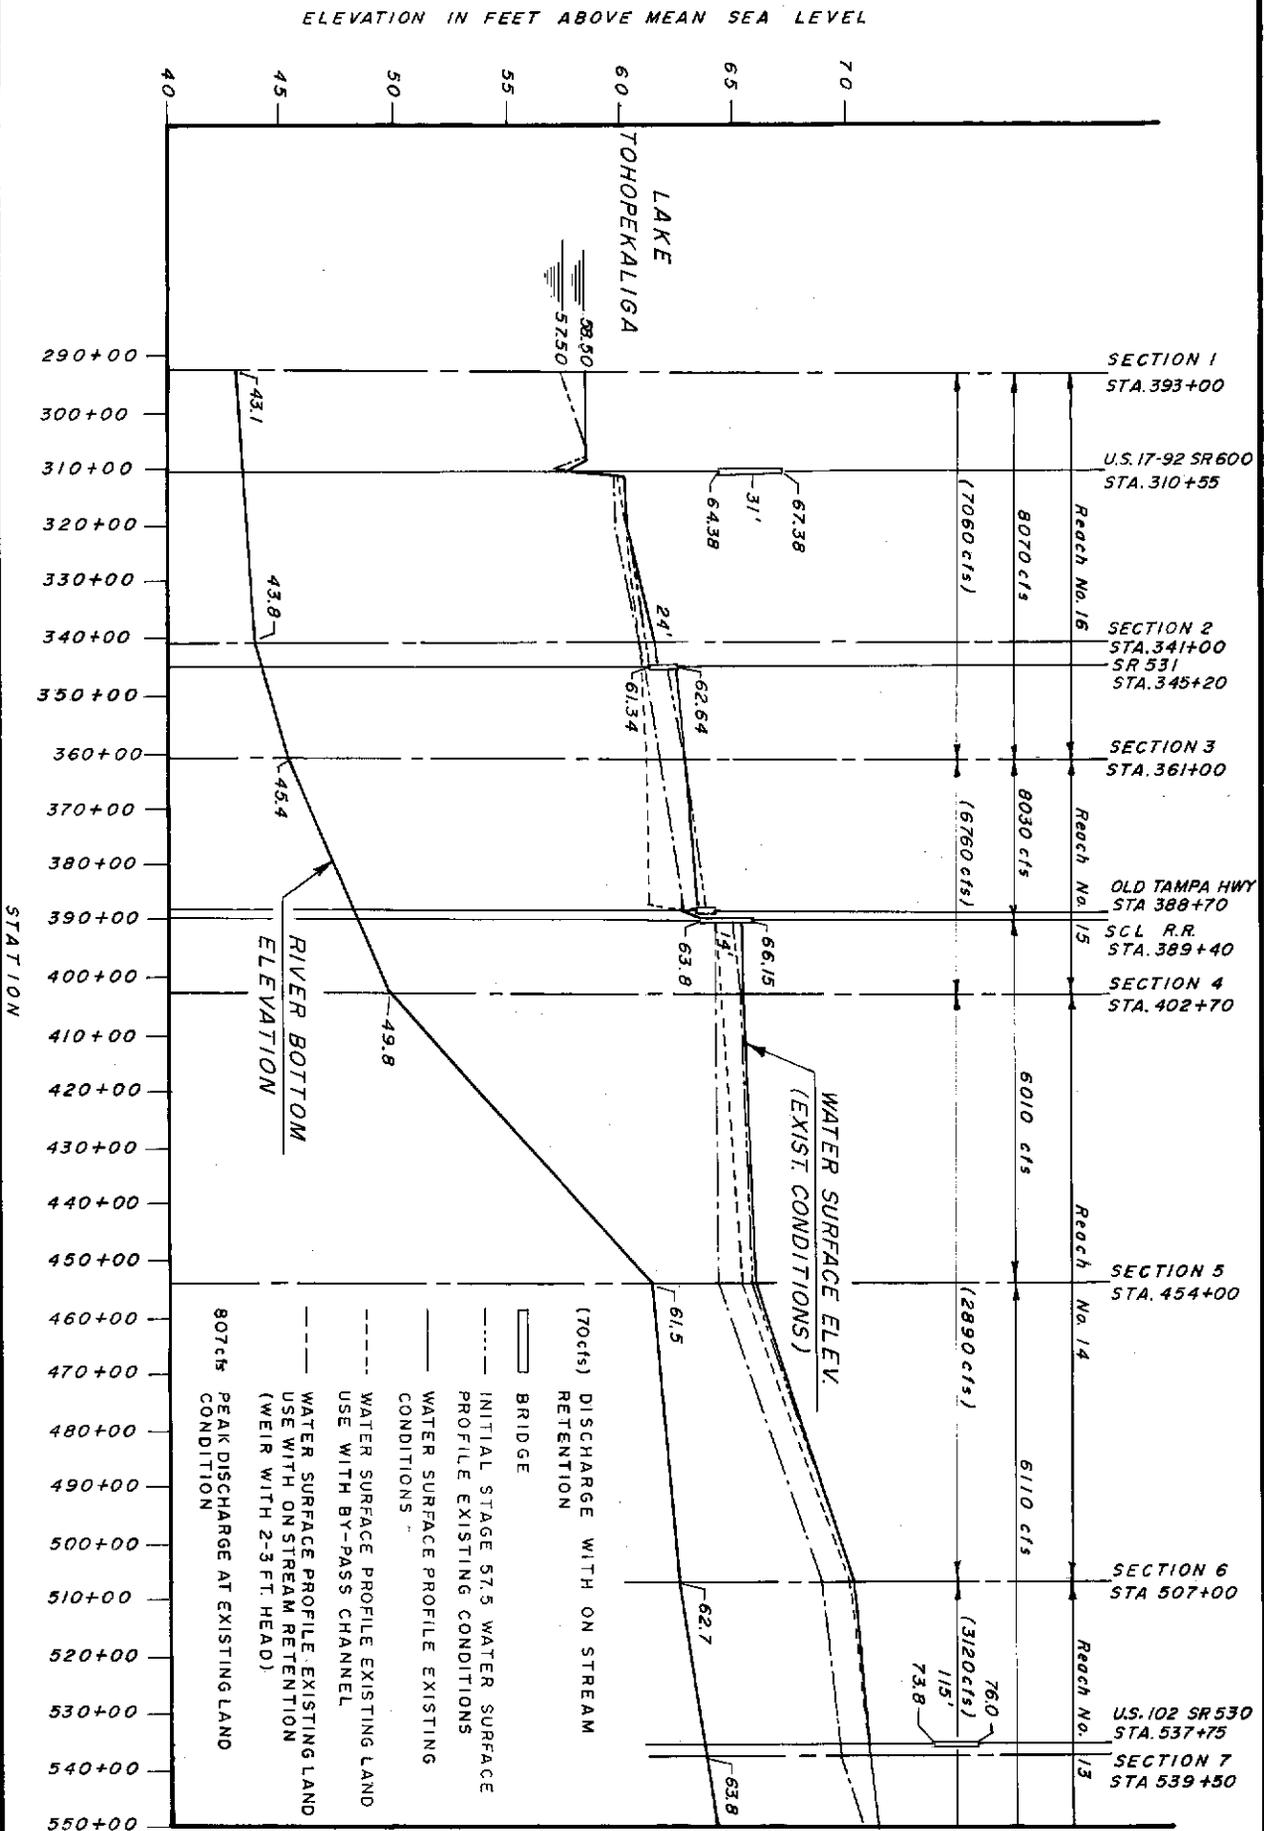
Figure 15b SHINGLE CREEK 100 YEAR FLOOD PROFILES

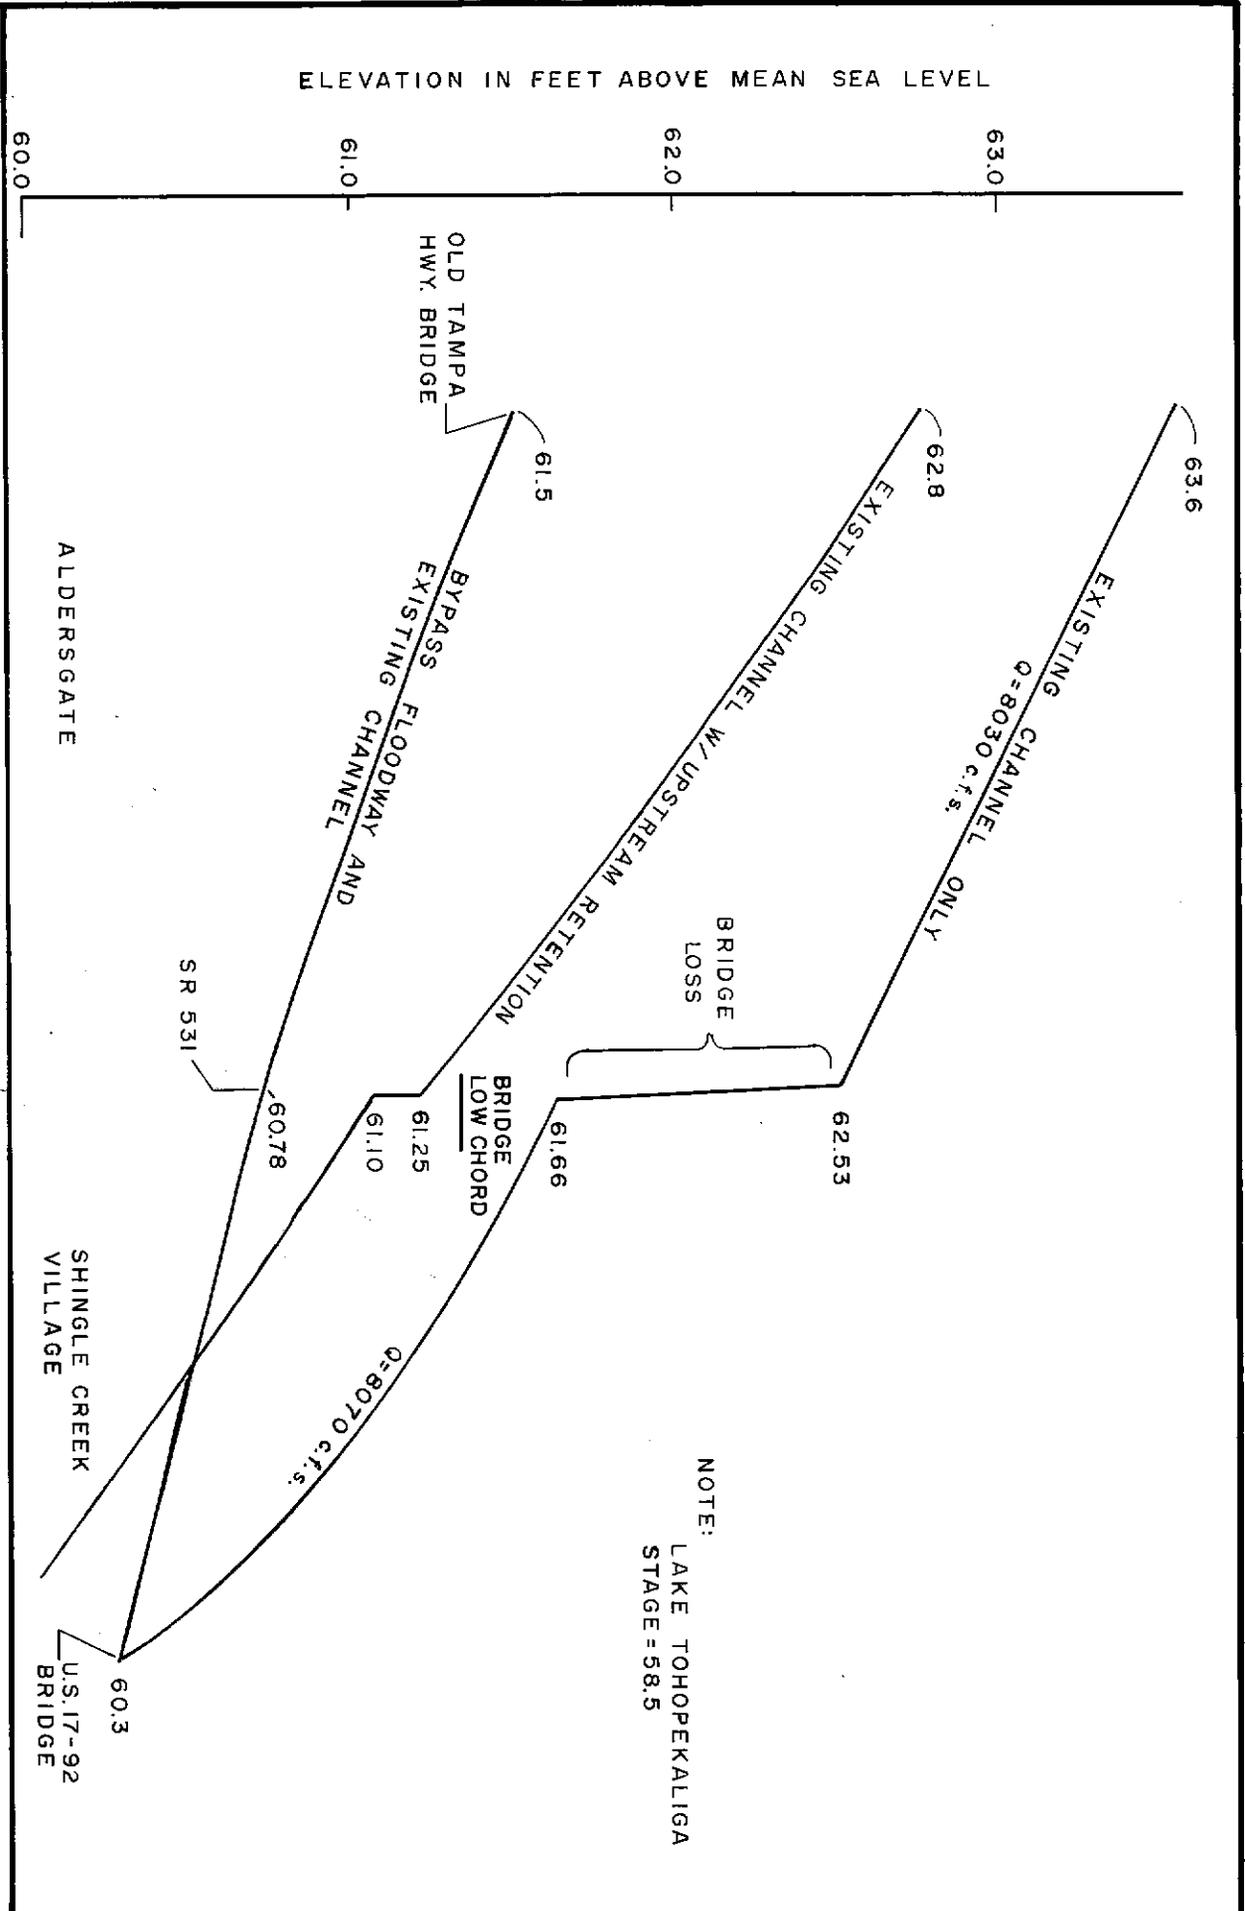
Figure 17 BACKWATER STAGES AT THE REACH BETWEEN ALDERSGATE AND SHINGLE CREEK VILLAGE RESULTING FROM A 100 YEAR FLOOD
