M E M O R A N D U M

DATE: October 4, 2023

SUBJECT: Weekly Environmental Conditions for Systems Operations

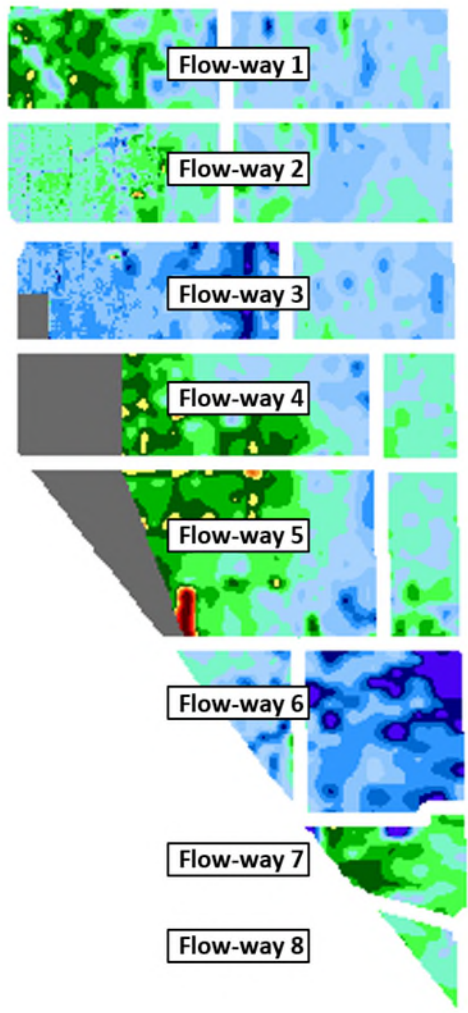
Figure S-3. Western Flow Path Weekly Status Report

STA-5/6	Flow-way Status
Flow-way 1	<ul style="list-style-type: none"> Highly stressed vegetation conditions
Flow-way 2	<ul style="list-style-type: none"> Highly stressed vegetation conditions High 365-day PLR
Flow-way 3	<ul style="list-style-type: none"> Highly stressed vegetation conditions Very high 365-day PLR
Flow-way 4	<ul style="list-style-type: none"> Highly stressed vegetation conditions Vegetation management (prescribed burn)
Flow-way 5	<ul style="list-style-type: none"> Highly stressed vegetation conditions High 365-day PLR
Flow-way 6	<ul style="list-style-type: none"> Highly stressed vegetation conditions
Flow-way 7	
Flow-way 8	<ul style="list-style-type: none"> Stressed vegetation conditions

STA-5/6: An operational restriction is in place in Flow-way 4 for vegetation management (prescribed burn). Most treatment cells are at or above target stage. All treatment cells have highly stressed or stressed vegetation conditions except Flow-ways 7 which is healthy. The 365-day PLRs for Flow-ways 1, 4, 6, 7, and 8 are below 1.0 g/m²/year, the 365-day PLRs for Flow-ways 2 and 5 are high, and the 365-day PLR for Flow-way 3 is very high. (**Figure S-3**).

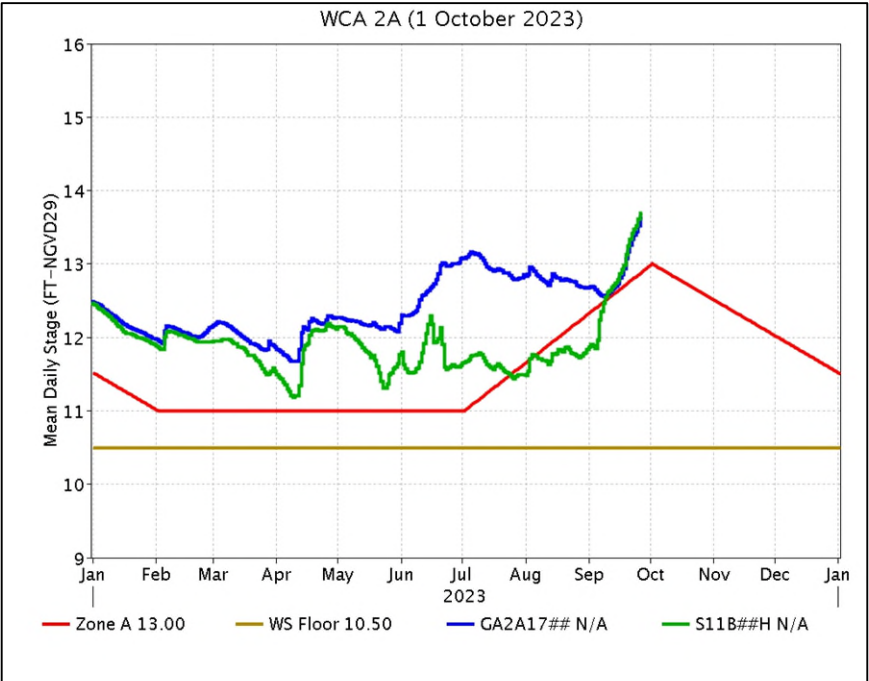
Figure EV-2. WCA-2A stage hydrographs and regulation schedule.
