M E M O R A N D U M

DATE: November 8, 2023

SUBJECT: Weekly Environmental Conditions for Systems Operations

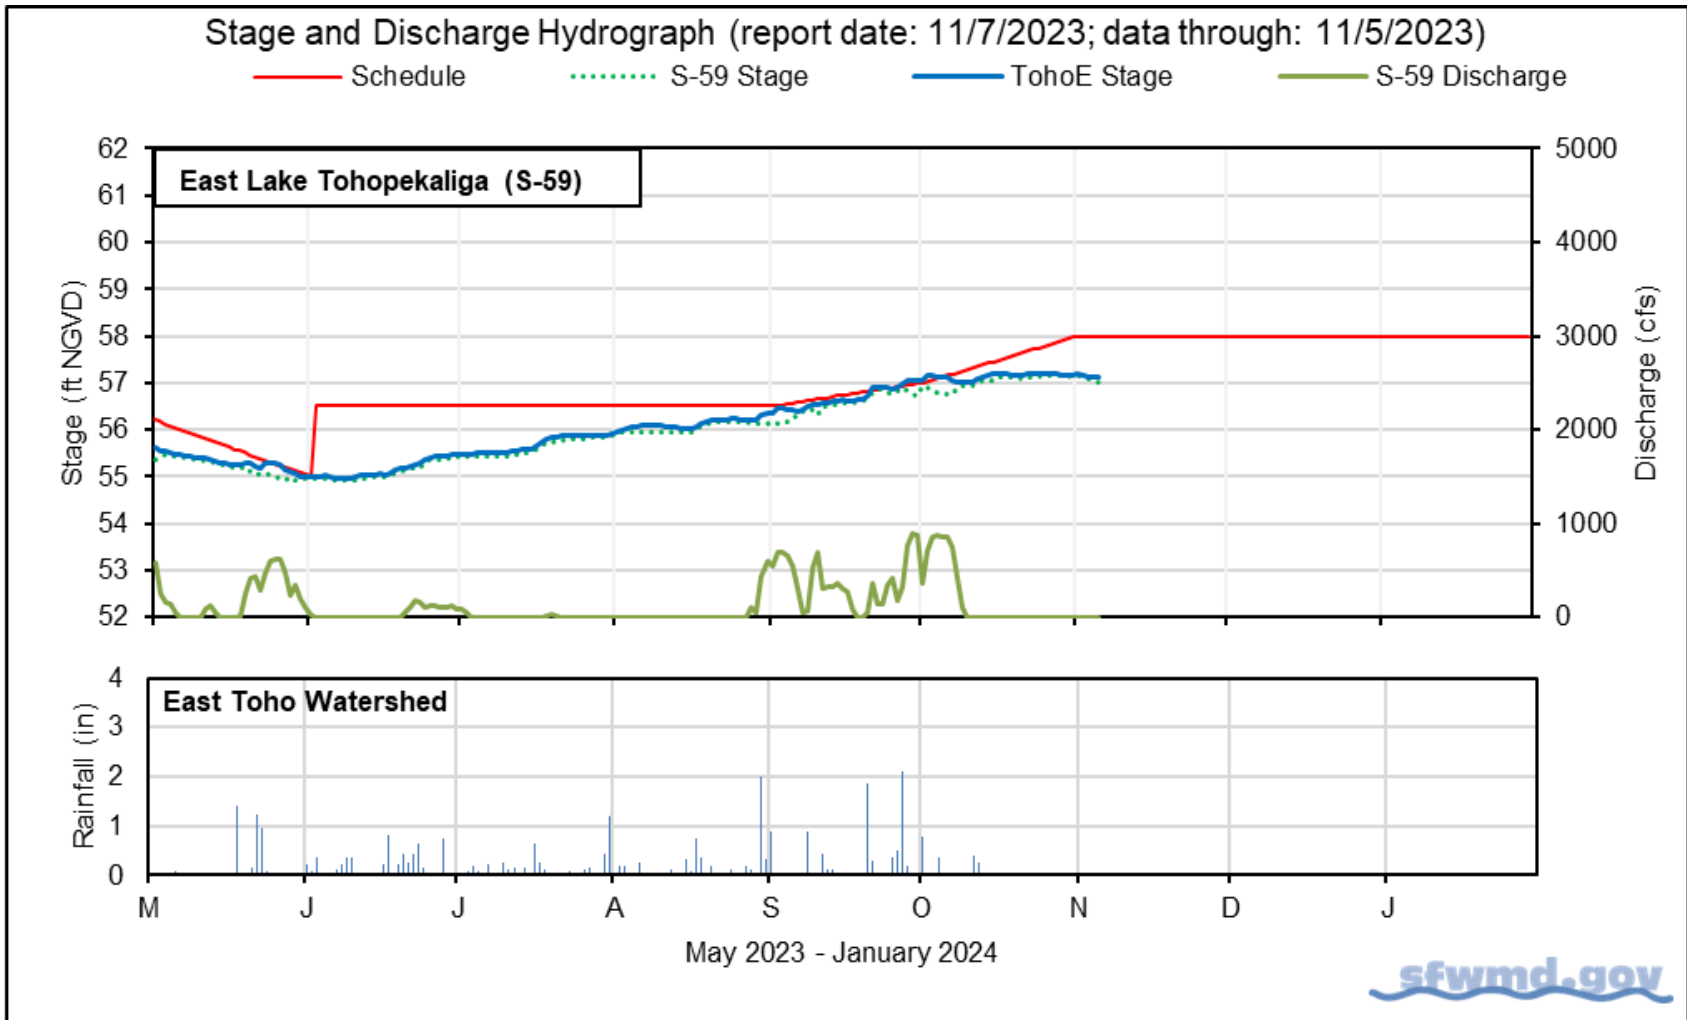
Figure KB-1. East Lake Toho regulation schedule, stage, discharge and rainfall.

On November 5, 2023, mean daily lake stages were 57.1 feet NGVD (0.9 feet below schedule) in East Lake Toho, 54.3 feet NGVD (0.7 feet below schedule) in Lake Toho, and 51.0 feet NGVD (1.5 feet below schedule) in Lakes Kissimmee-Cypress-Hatchineha (KCH) (**Table KB-1, Figures KB-1-3**).

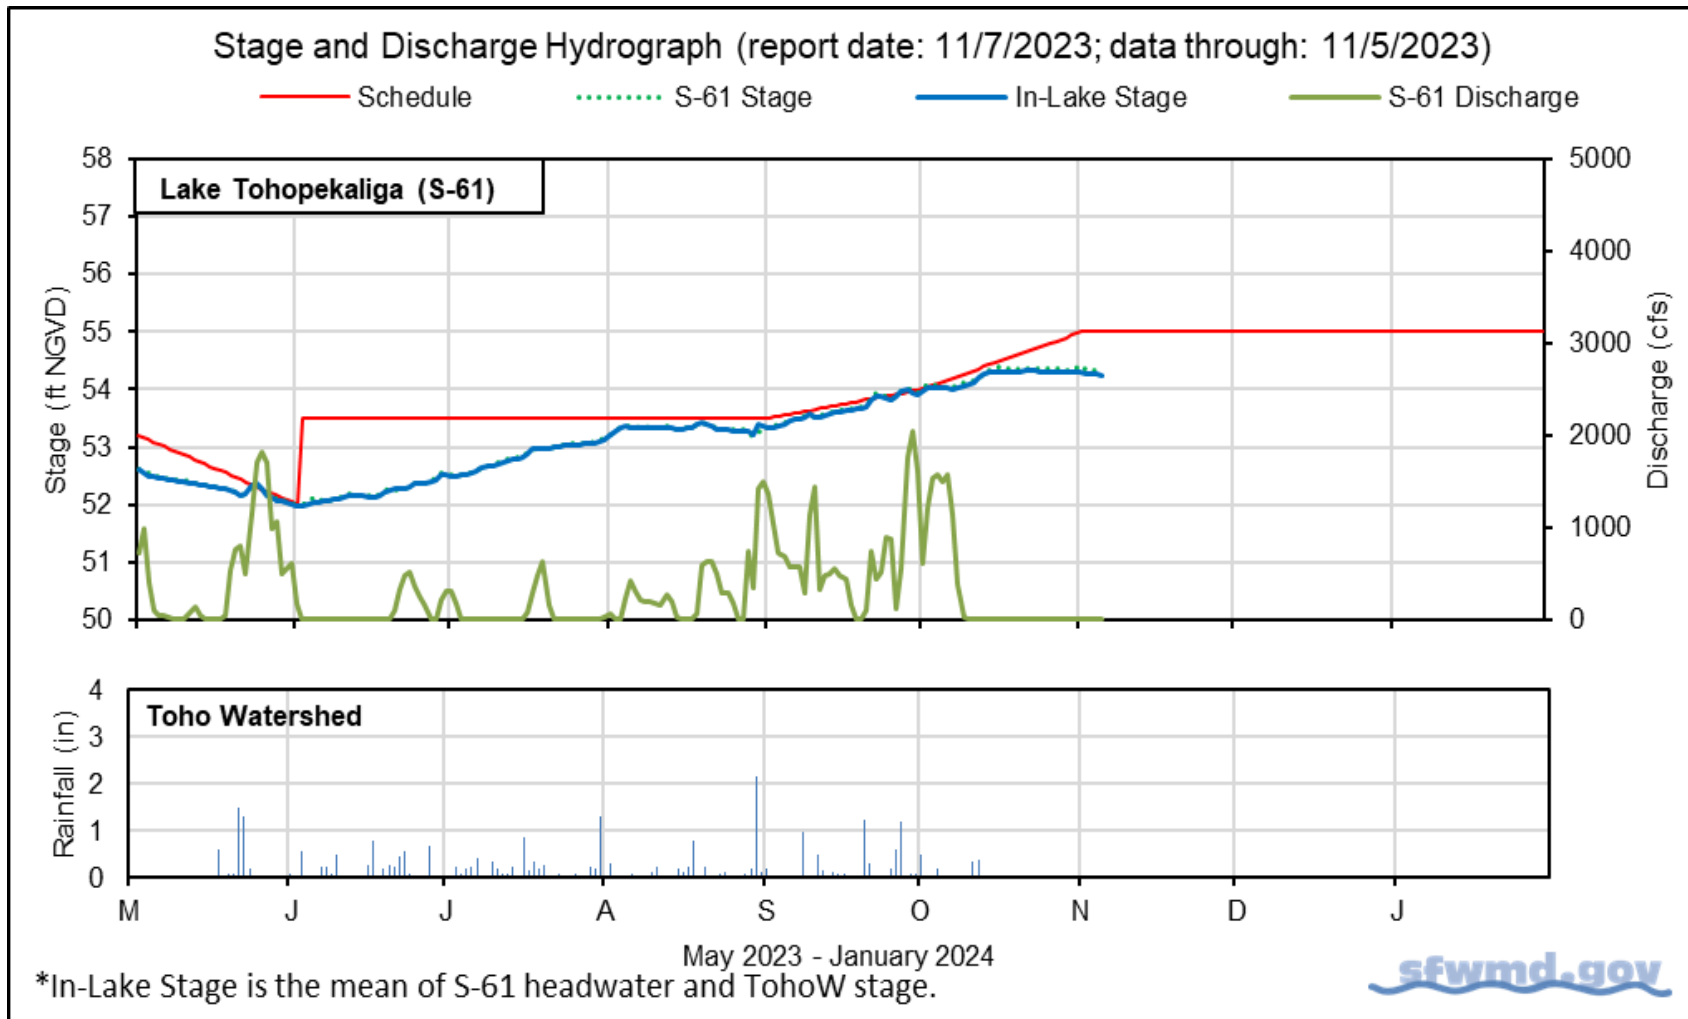
Figure KB-2. Lake Toho regulation schedule, stage, discharge and rainfall.

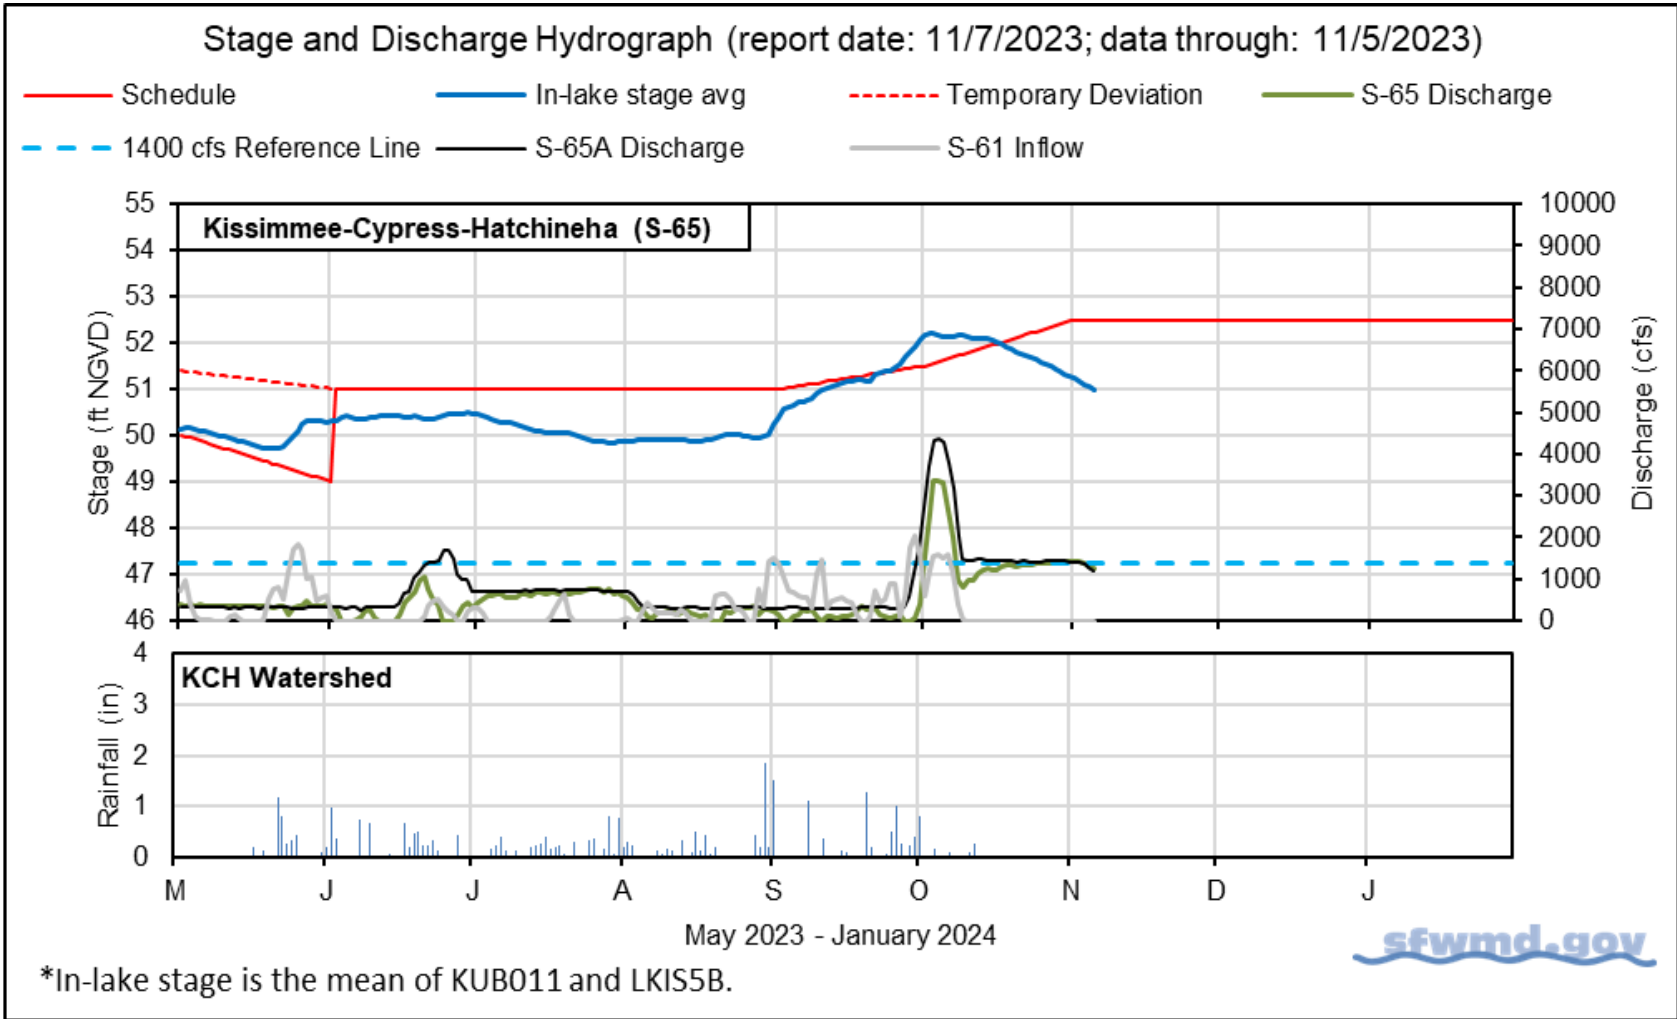
Figure KB-3. Lakes Kissimmee, Cypress and Hatchineha regulation schedule, stage, discharge and rainfall.

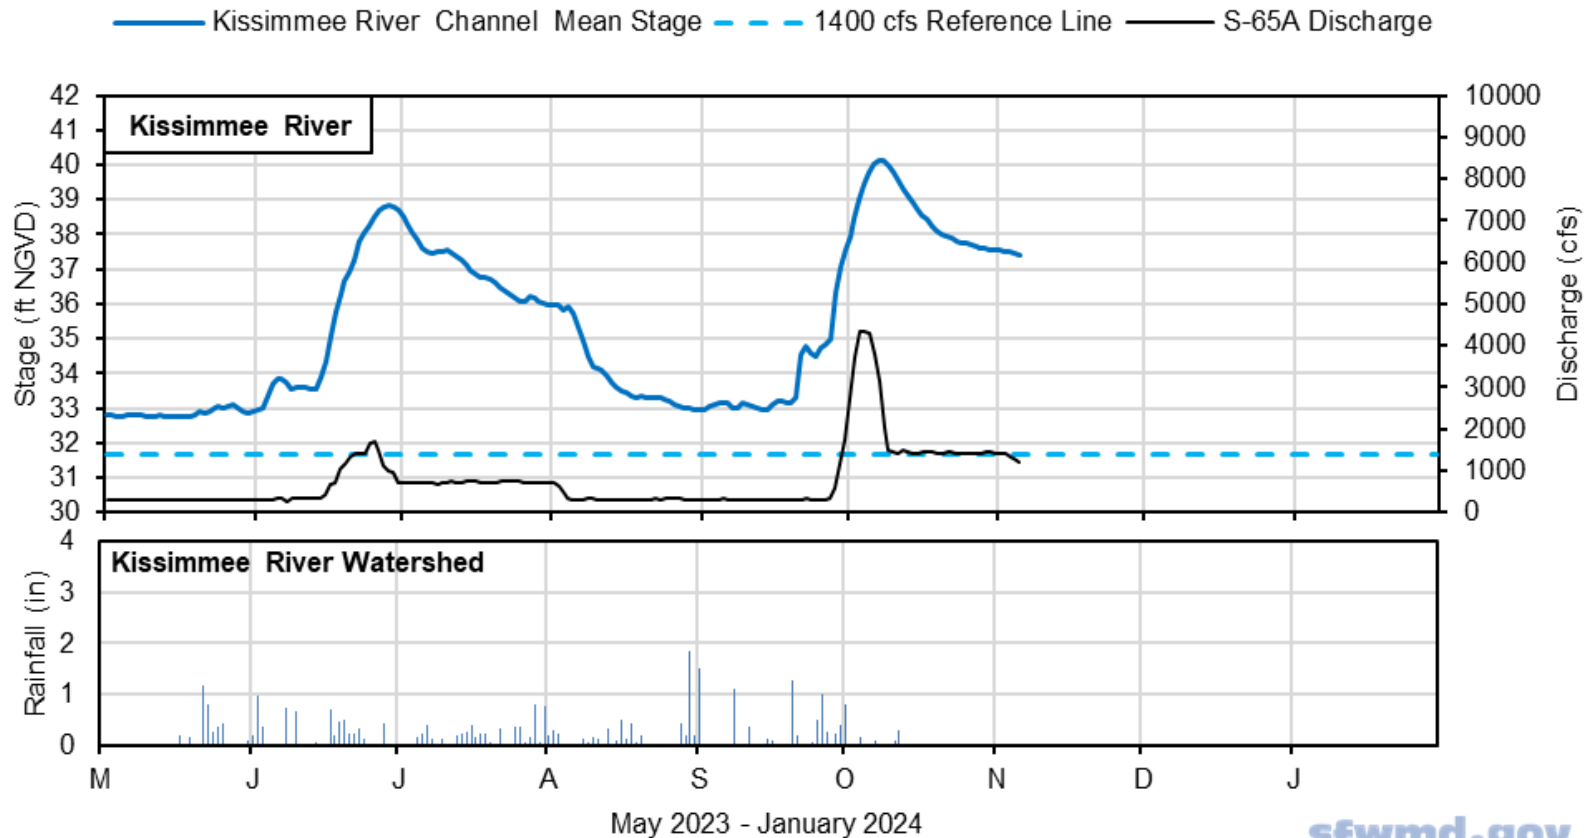
*River Channel Stage is the average for PC62, KRDR02, KRBN, PC33, and PC11.

Figure KB-4. Kissimmee River stage, discharge and rainfall.

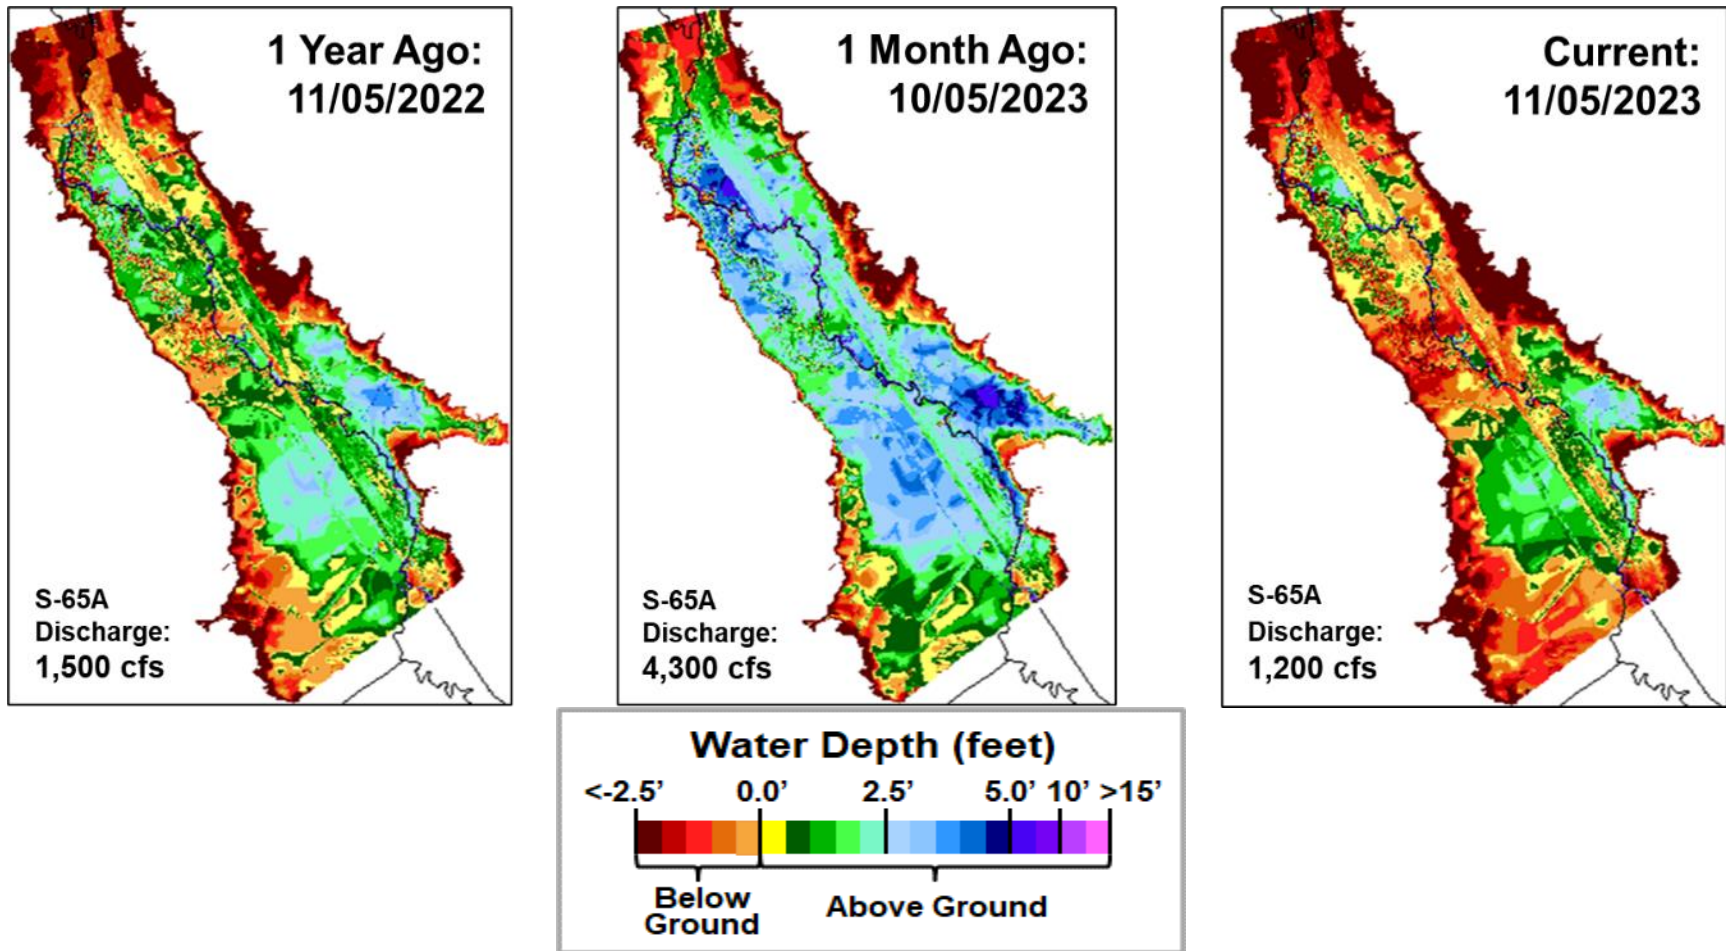
Figure KB-5. Phase I area Kissimmee River floodplain water depths (from left to right) one year ago, one month ago and current.

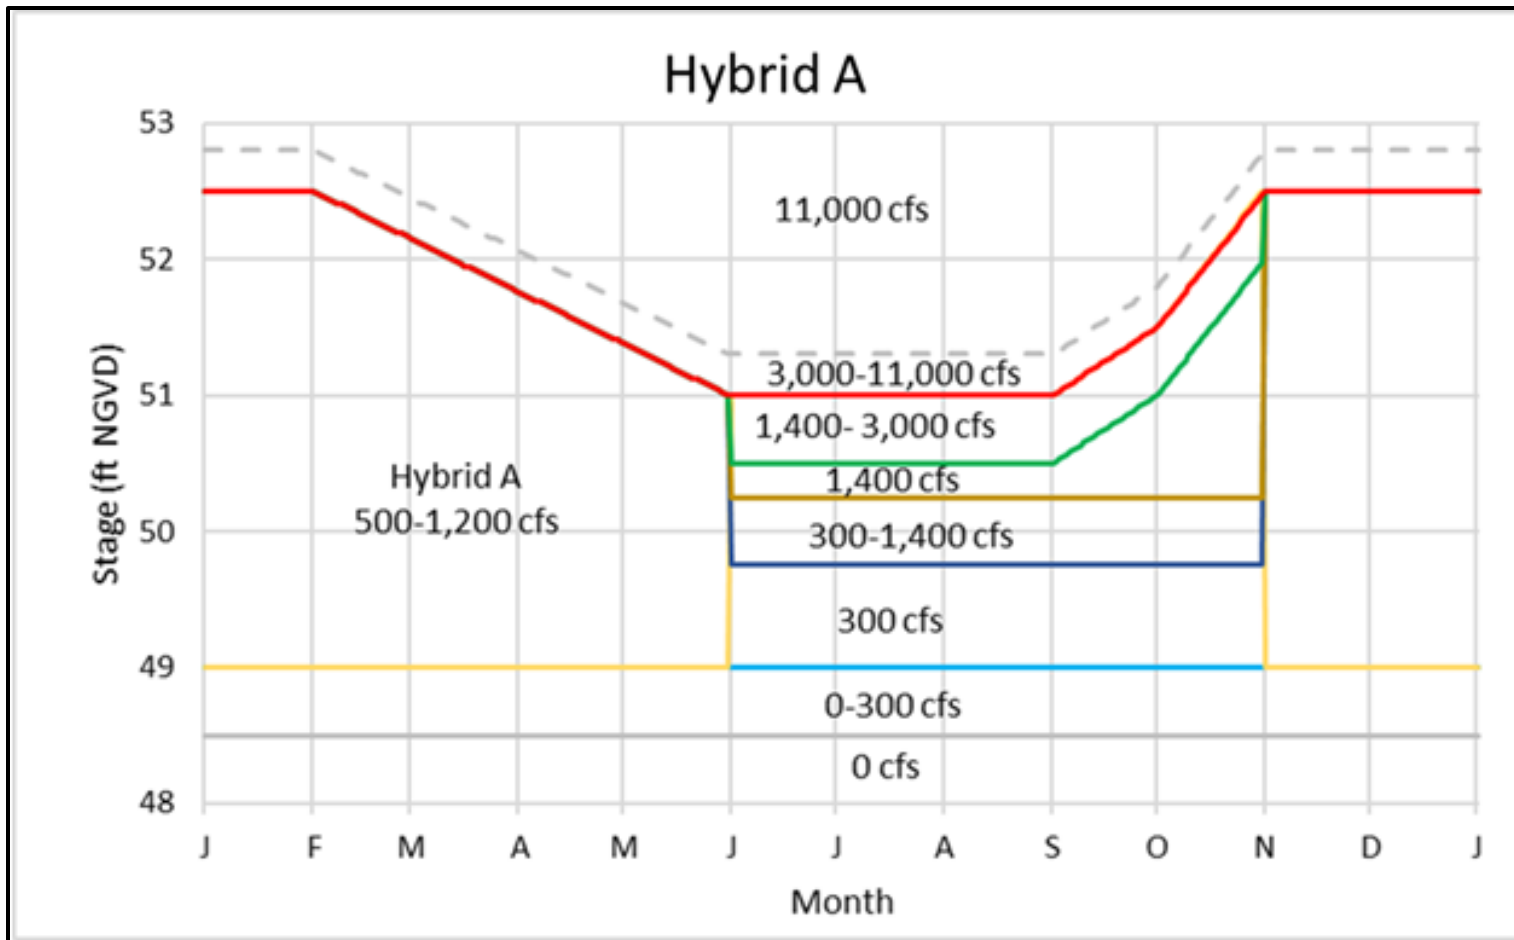
Figure KB-7. Hybrid A Discharge Plan for S65/S65A. Use discharge rate of change limits from IS-14-50 (Fig. KB-8).

Follow the IS-14-50 discharge plan for S-65/S-65A or transition to Hybrid A (Fig. KB-7) on November 1 to facilitate S-69 repairs through May 31, 2024. Maintain at least minimum flow (250-300 cfs) at S-65A. Begin a stage recession at S-65D headwater to reach 25.8 ft NGVD in early January 2024 at a recession rate of approximately 0.2 ft/week.

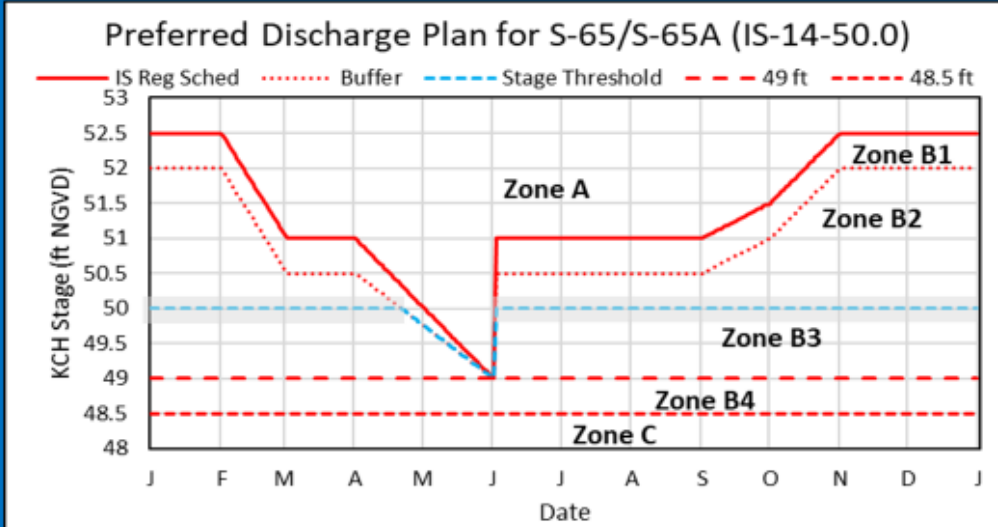
- Other Considerations**
- When possible, limit lake ascension rate in the Jun 1 - Aug 15 window to 0.25 ft per 7 days in Lakes Kissimmee, Cypress, Hatchineha (S-65), East Toho (S-59) and Toho (S-61).
 - If outlook is for extreme dry conditions meet with KB staff to discuss modifications to this plan.

Figure KB-8. IS-14-50 Discharge Plan for S65/S65A with discharge rate of change limits (revised 1/14/19).

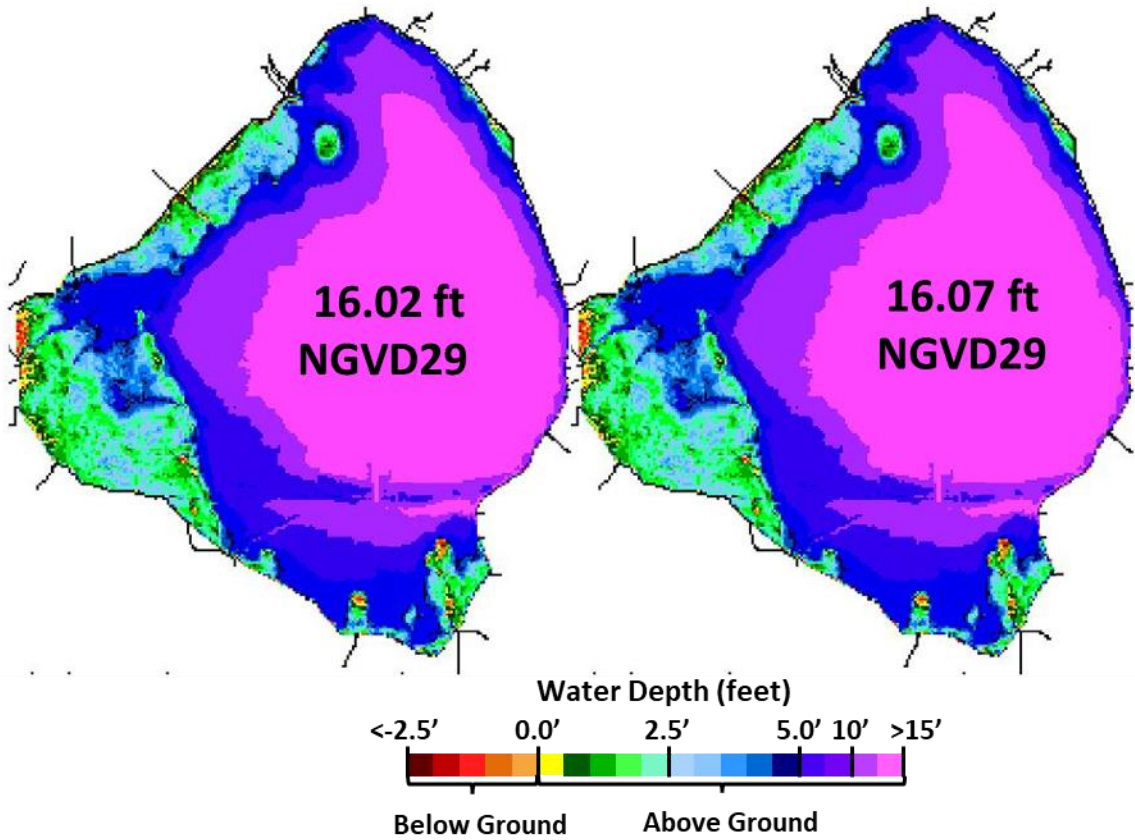
Figure LO-1. Lake Okeechobee water depth estimates based on South Florida Water Depth Assessment Tool (SFWDAT).

Lake Okeechobee stage was 16.07 feet NGVD on November 5, 2023, which was 0.14 feet lower than the previous week and 0.05 feet higher than a month ago (**Figure LO-1**). Lake stage was in the low sub-band on November 5th (**Figure LO-2**) and was 0.57 feet above the upper limit of the ecological envelope (**Figure LO-3**). According to NEXRAD, for the third consecutive week, no rainfall was recorded over the Lake.

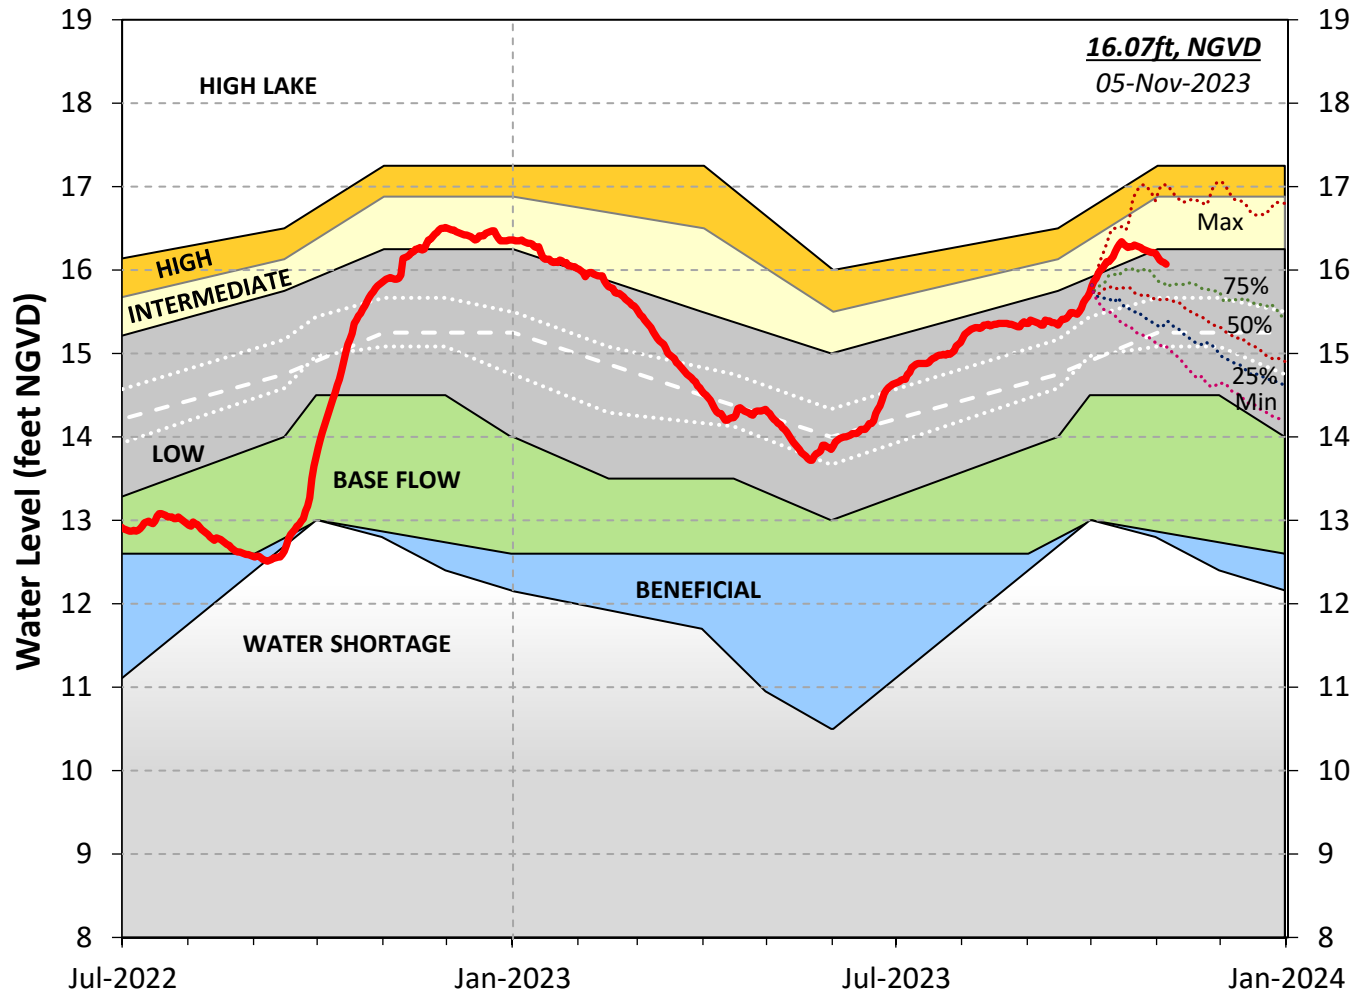
Figure LO-2. Recent Lake Okeechobee stages with projected stages based on a dynamic position analysis.

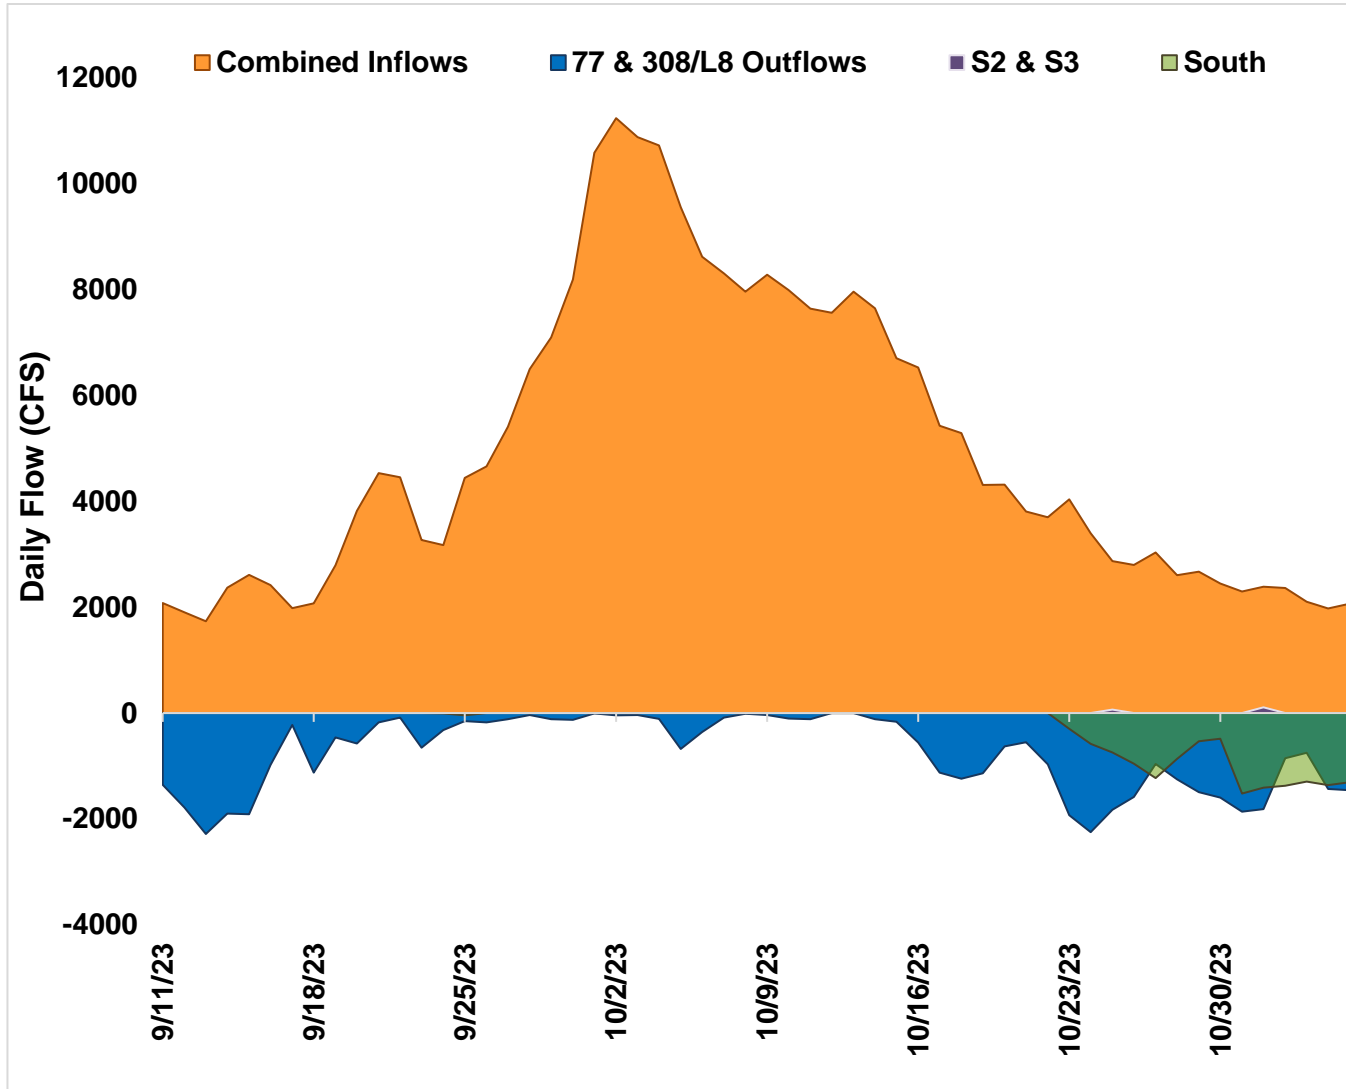
Figure LO-4. Major inflows (orange) to and outflows east and west (blue) from Lake Okeechobee. Outflows south are shown in green. Flows into Lake Okeechobee from the L-8 canal through S-271 (formerly Culvert 10A) or from the C-44 canal through the S-308 are included as inflows. Conversely, flows from Lake Okeechobee into the L-8 or C-44 canals are included with outflows. Inflows are shown as positive values; outflows are negative. Outflows through the S-77 (Caloosahatchee) and S-308 (C-44 Canal) structures are based on downstream gauges to include flows to lock openings for navigation.

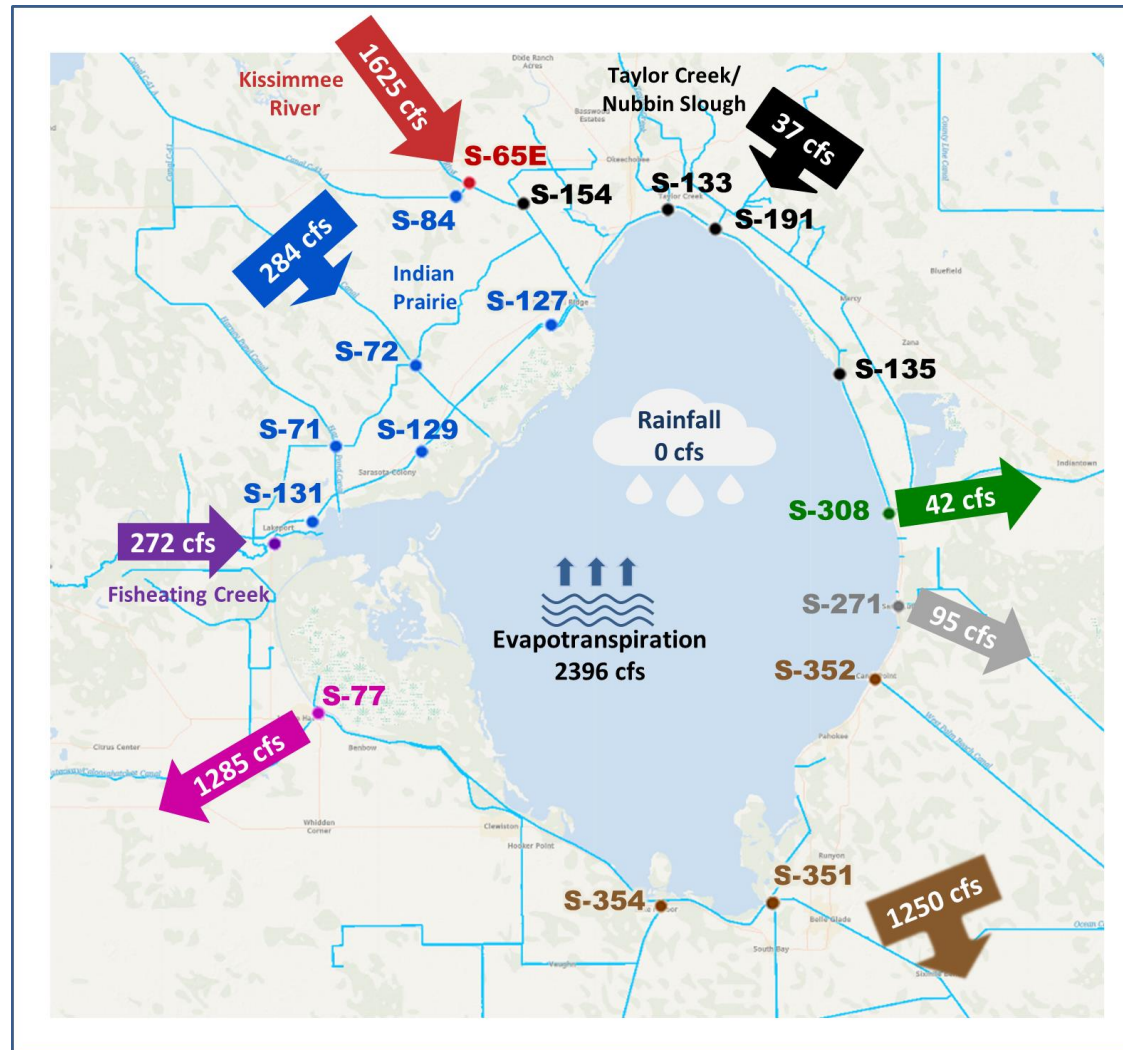
Figure LO-5. Inflows into Lake Okeechobee from Indian Prairie basins, Taylor Creek/Nubbin Slough, Kissimmee River and Fisheating Creek, and outflows to the west via S-77, to the east via S-308, to the south via S-351, S-352, S-354, and to southeast via S-271 (formerly Culvert 10A) for the week of October 30 – November 05, 2023.

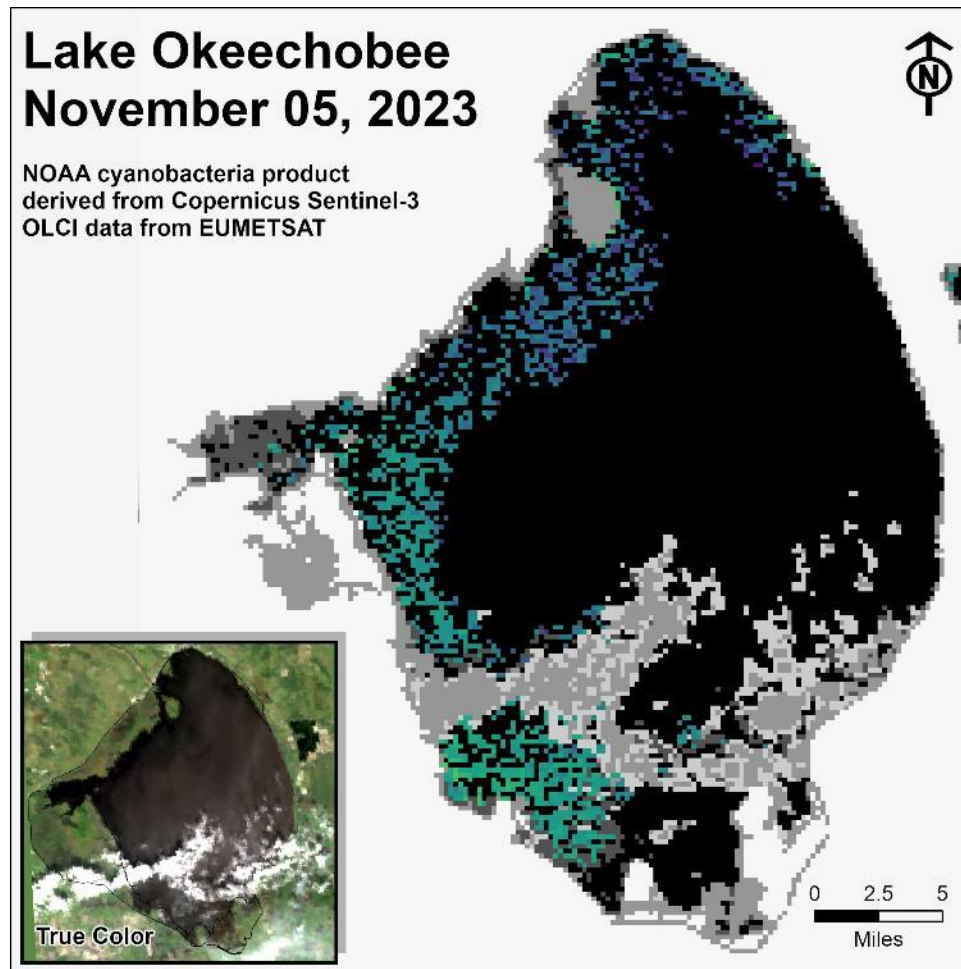
Figure LO-6. Cyanobacteria bloom index level on November 05, 2023, based on NOAA's harmful algal bloom monitoring system. Gray color indicates cloud cover.

The cyanobacteria index level was low to moderate in the southwestern and western regions of the Lake according to the November 05, 2023 satellite image from NOAA's Harmful Algal Bloom Monitoring System (**Figure LO-6**). All data presented in this report are provisional and are subject to change.

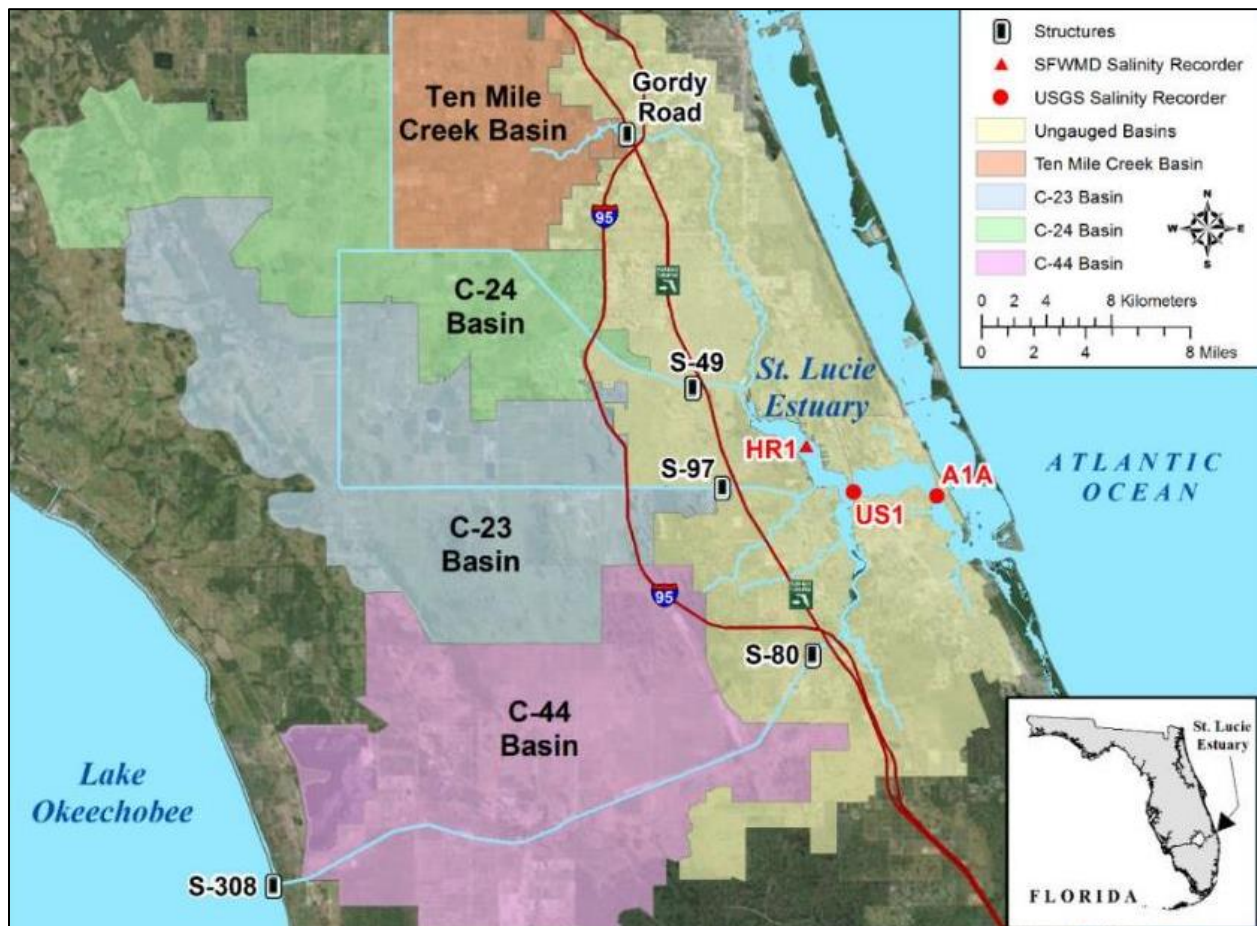
Figure ES-1. Basins, water control structures and salinity monitoring sites in the St. Lucie Estuary.

Over the past week, mean total inflow to the St. Lucie Estuary was 250 cfs (**Figures ES-1 and ES-2**), and the previous 30-day mean inflow was 900 cfs. For comparison, the historical provisional mean inflows from the contributing areas are shown in **Figure ES-2**.

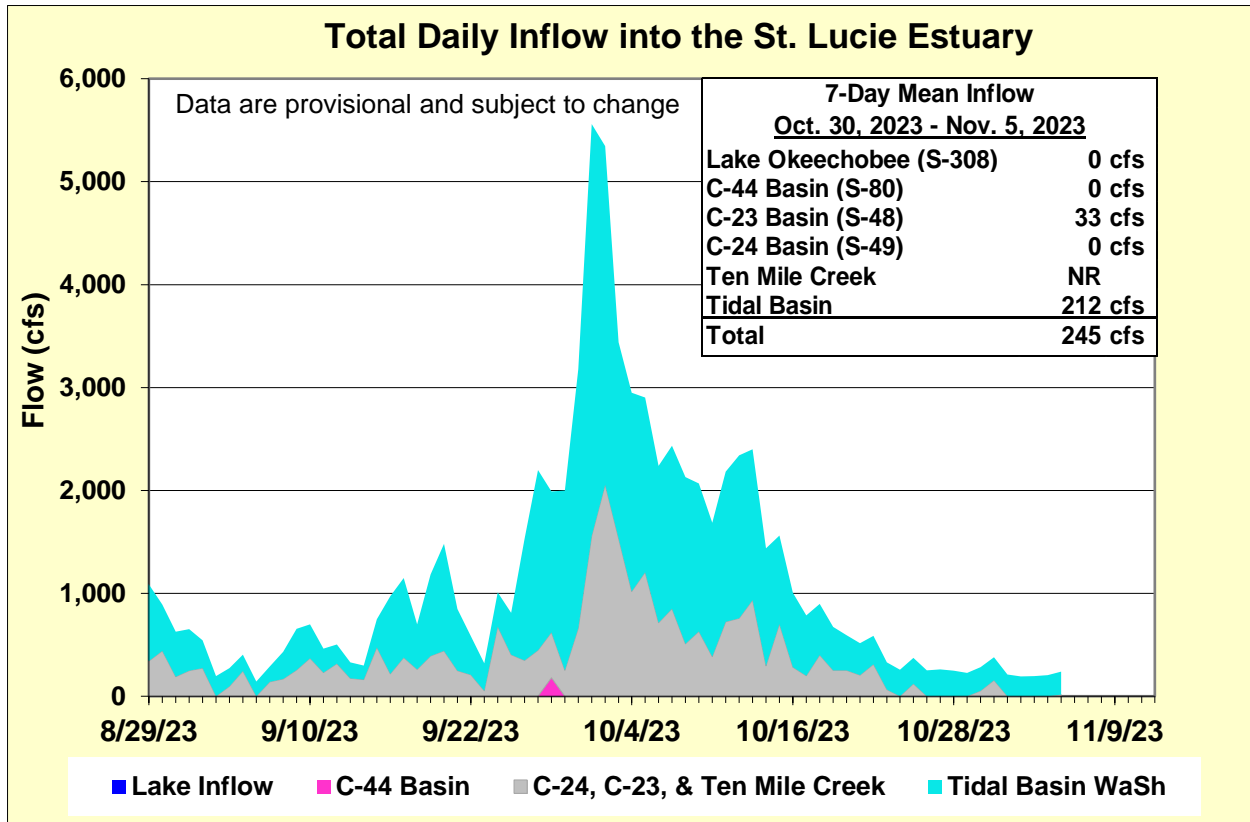
Figure ES-2. Total daily inflows from Lake Okeechobee and runoff from the C-44, C-23, C-24, Ten Mile Creek, and Tidal Basins into the St. Lucie Estuary.

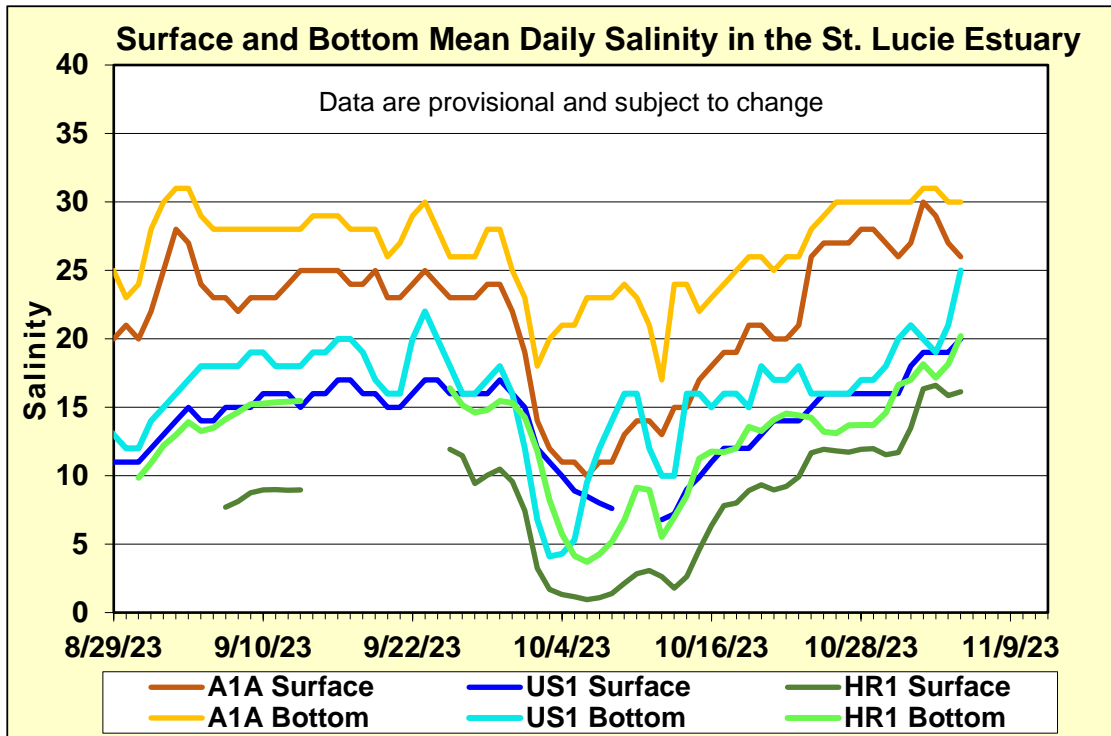
Figure ES-3. Mean daily salinity at the A1A, US1 and HR1 sites in the St. Lucie Estuary.

Over the past week, salinities increased at all sites within the estuary (**Table ES-1 and Figure ES-3**). The seven-day moving average of the surface and bottom salinities at the US1 Bridge was 19.4. Salinity conditions in the middle estuary were estimated to be within the optimal range for adult eastern oysters (**Figure ES-4**). The mean larval oyster recruitment rate reported by the Fish and Wildlife Research Institute (FWRI) was 3.1 spat/shell for October, which was an increase from September (**Figure ES-5**).

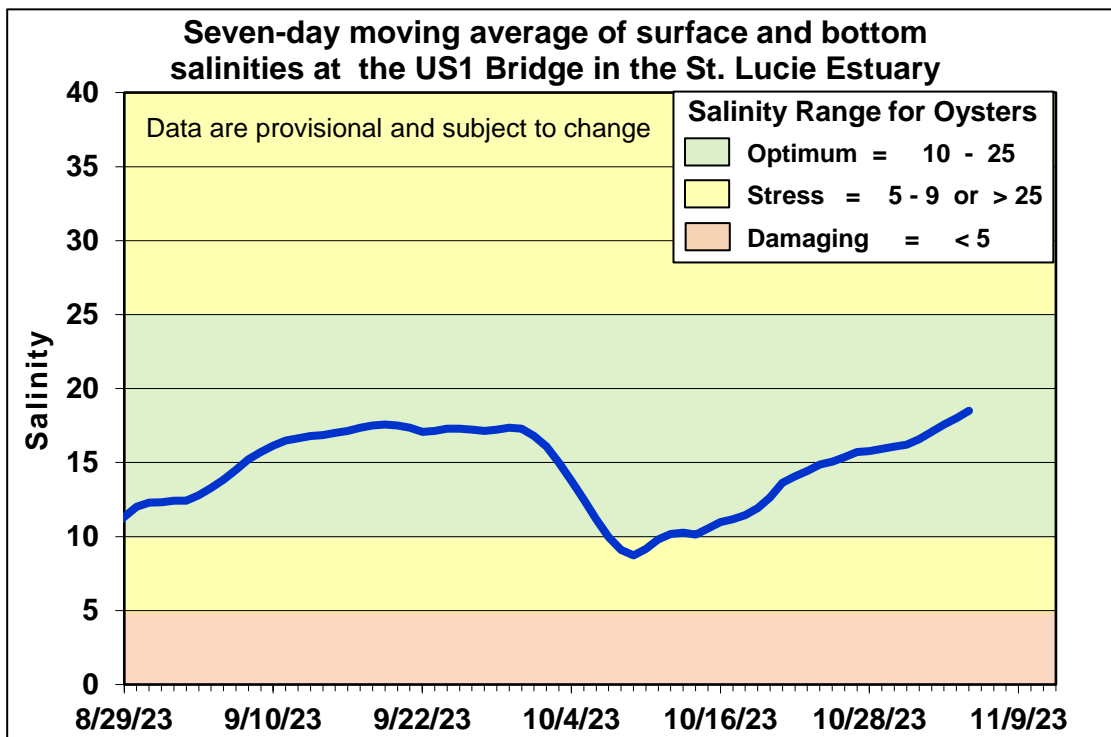
Figure ES-4. Seven-day moving average of the surface and bottom salinities at the US1 Bridge in the St. Lucie Estuary.

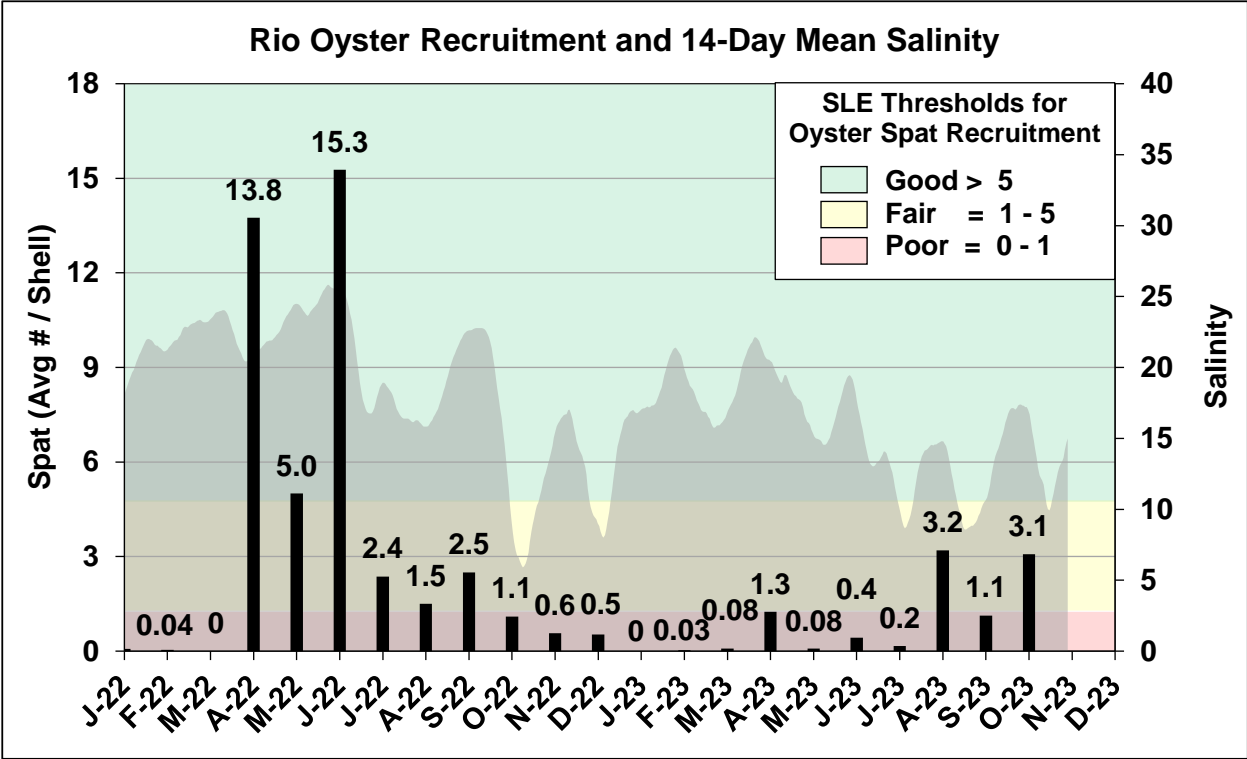
Figure ES-5. Mean oyster recruitment at the Rio oyster monitoring station and 14-day mean salinity at US1 Bridge.
