M E M O R A N D U M

DATE: November 8, 2023

SUBJECT: Weekly Environmental Conditions for Systems Operations

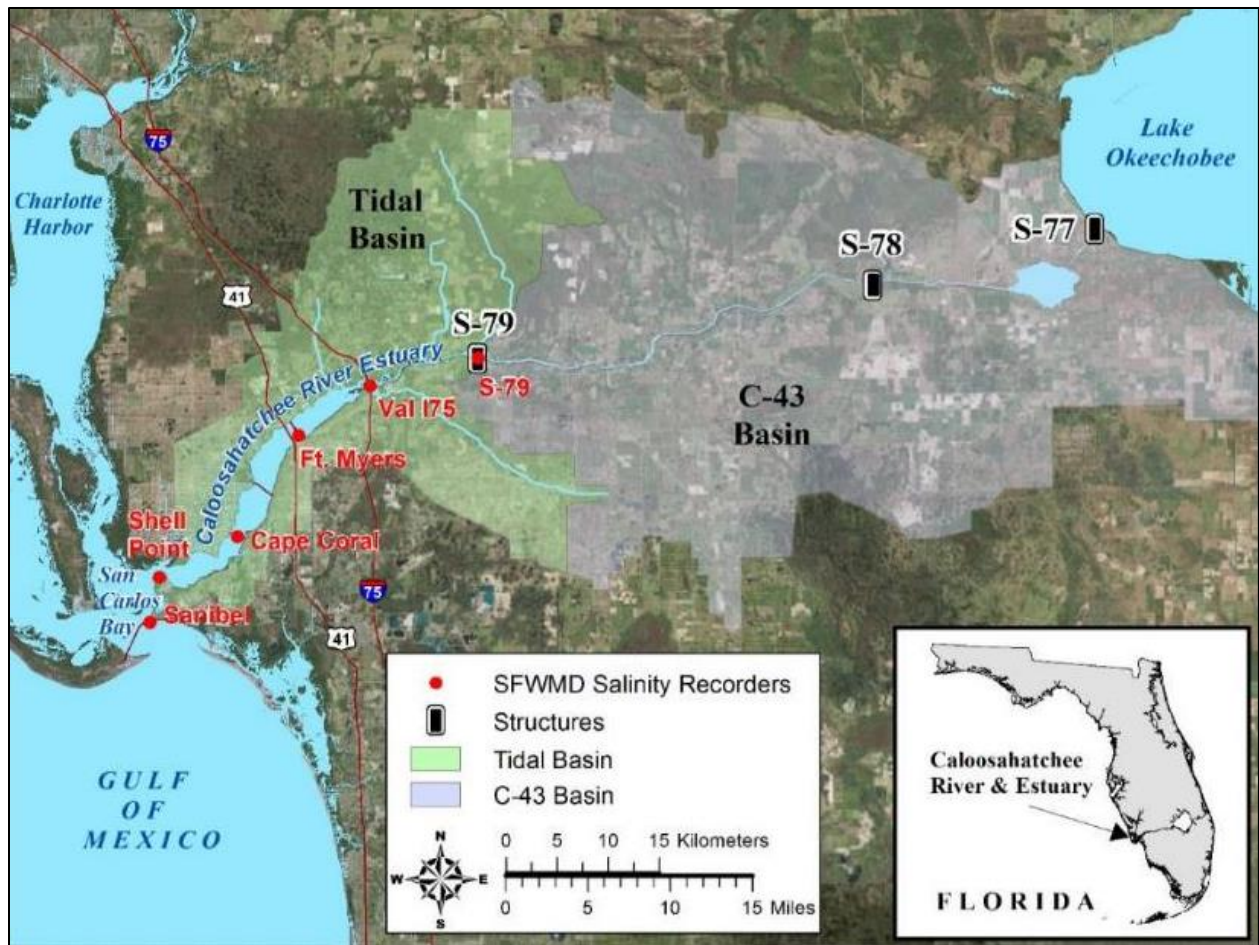
Figure ES-6. Basins, water control structures and salinity monitoring sites in the Caloosahatchee River Estuary.

Over the past week, mean total inflow to the Caloosahatchee River Estuary was 1,910 cfs (**Figures ES-6 and ES-7**), and the previous 30-day mean inflow was 2,570 cfs. For comparison, the historical provisional mean inflows from the contributing areas are shown in **Figure ES-7**.

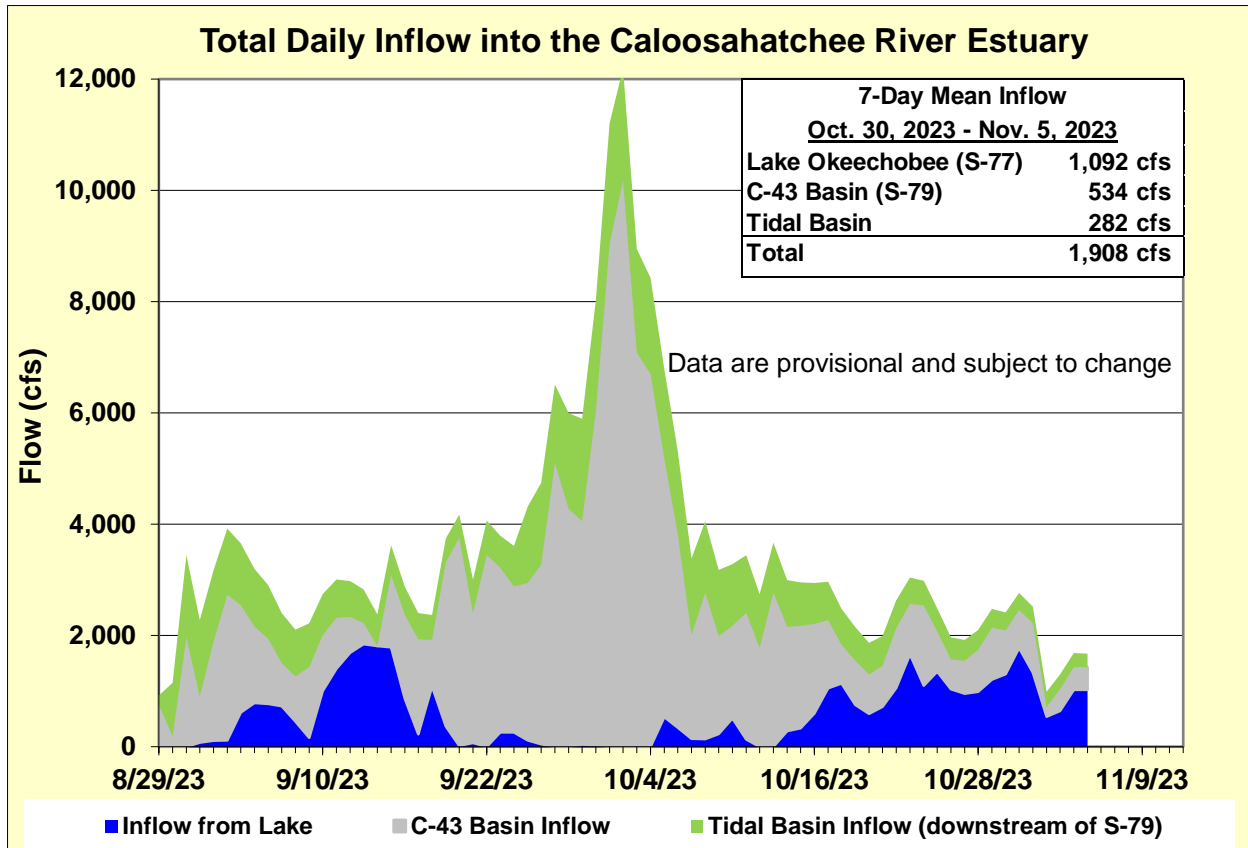
Figure ES-7. Total daily inflows from Lake Okeechobee, and runoff from the C-43 and Tidal basins into the Caloosahatchee River Estuary.

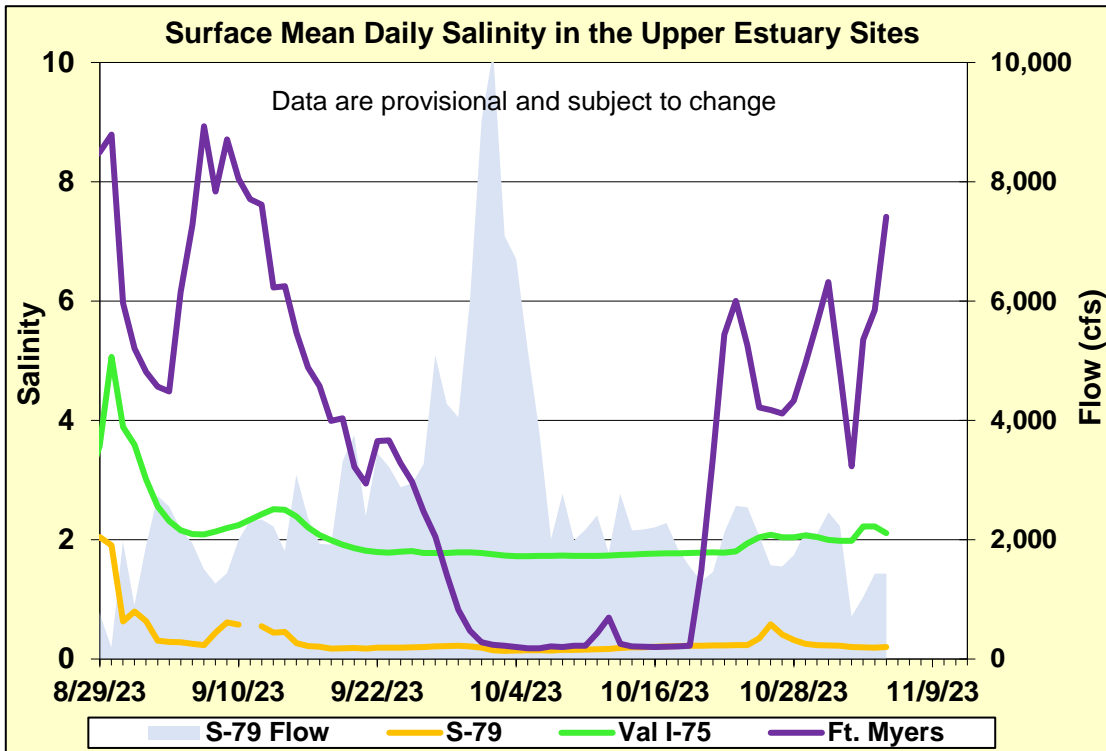
Figure ES-8. Mean daily salinity at upper Caloosahatchee River Estuary monitoring sites and mean daily flow at S-79.

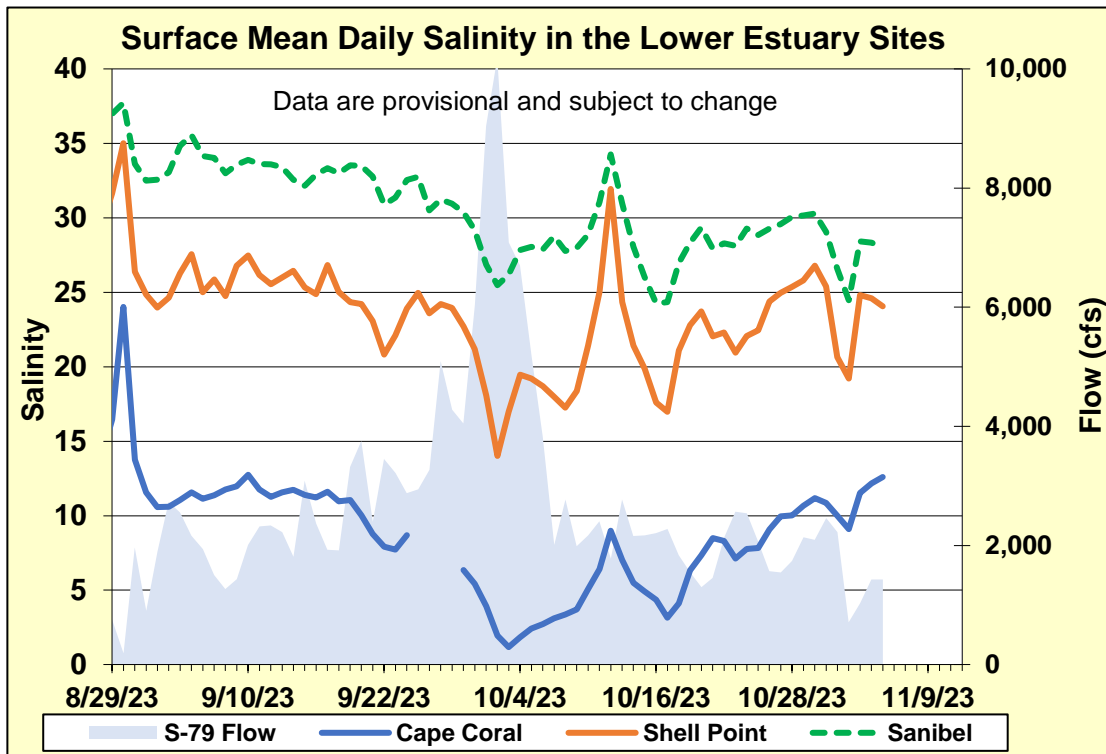
Figure ES-9. Mean daily surface salinity at lower Caloosahatchee River Estuary monitoring sites and mean daily flow at S-79.

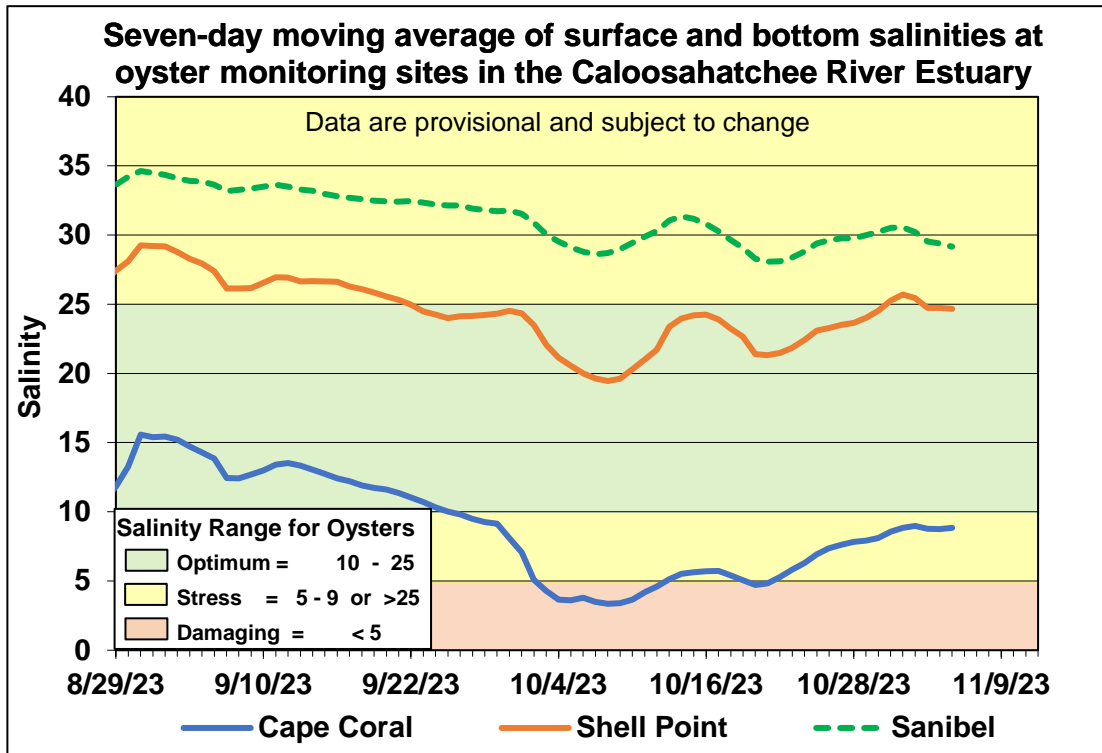
Figure ES-10. Seven-day moving average of surface and bottom salinities at Cape Coral, Shell Point and Sanibel monitoring sites in the Caloosahatchee River Estuary.

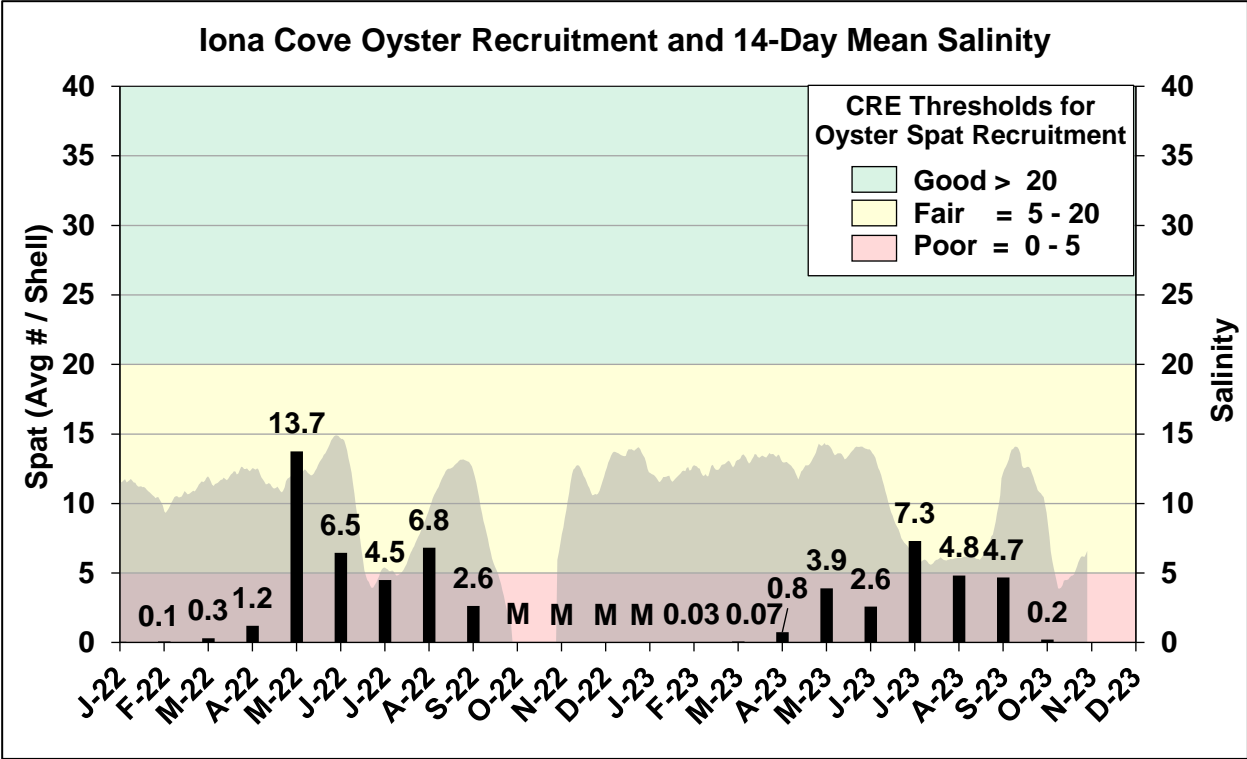
Figure ES-11. Mean oyster recruitment at the Iona Cove oyster monitoring station and 14-day mean salinity at Cape Coral.

Over the past week, salinities increased at Val I-75, Ft. Myers, and only on the surface at Cape Coral, and salinity decreased at the remaining sites in the estuary (**Table ES-2 and Figures ES-8 and ES-9**). The seven-day mean salinities (**Table ES-2**) were in the optimal range (0-10) for tape grass in the upper estuary. The seven-day mean salinity values were within the optimal range for adult eastern oysters at Shell Point, in the lower stressed range at Cape Coral, and in the upper stressed range at Sanibel (**Figure ES-10**). The mean larval oyster recruitment rate reported by the Fish and Wildlife Research Institute was 0.2 spat/shell at Iona Cove and 3.3 spat/shell at Bird Island for October, which was an increase from September (**Figures ES-11 and ES-12**).

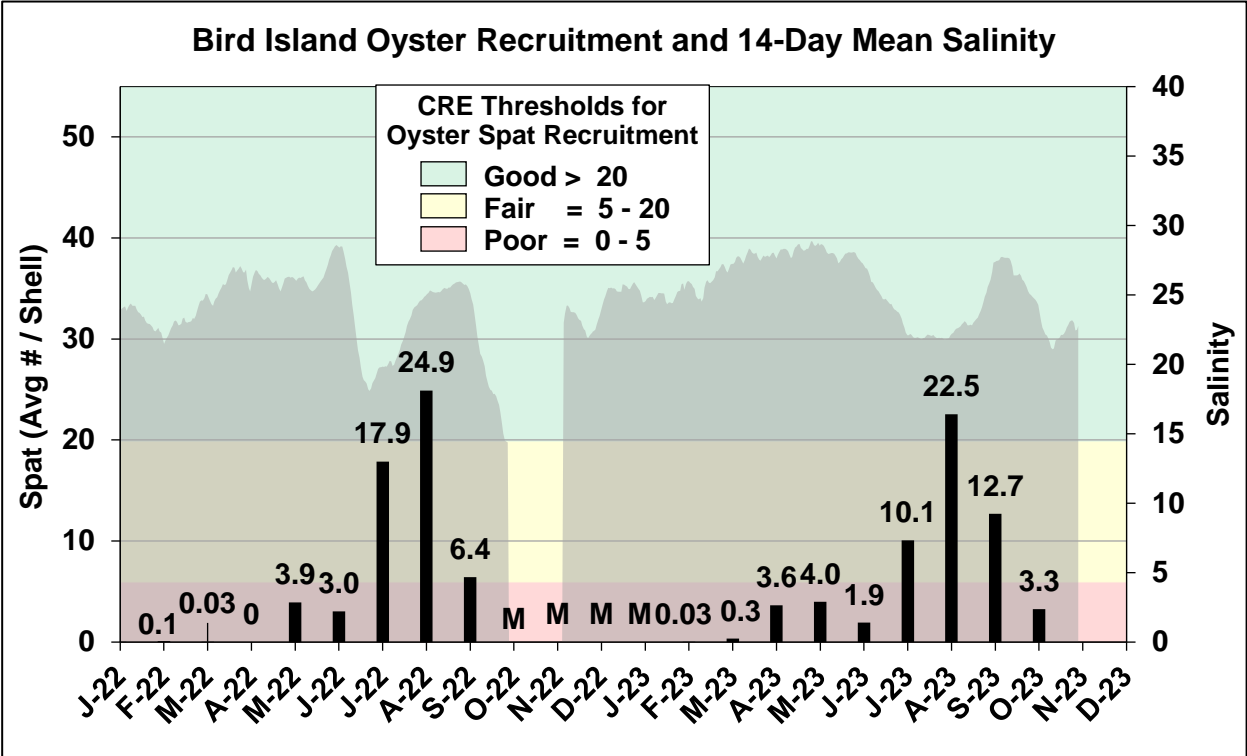
Figure ES-12. Mean oyster recruitment at the Bird Island oyster monitoring station and 14-day mean salinity at Shell Point.

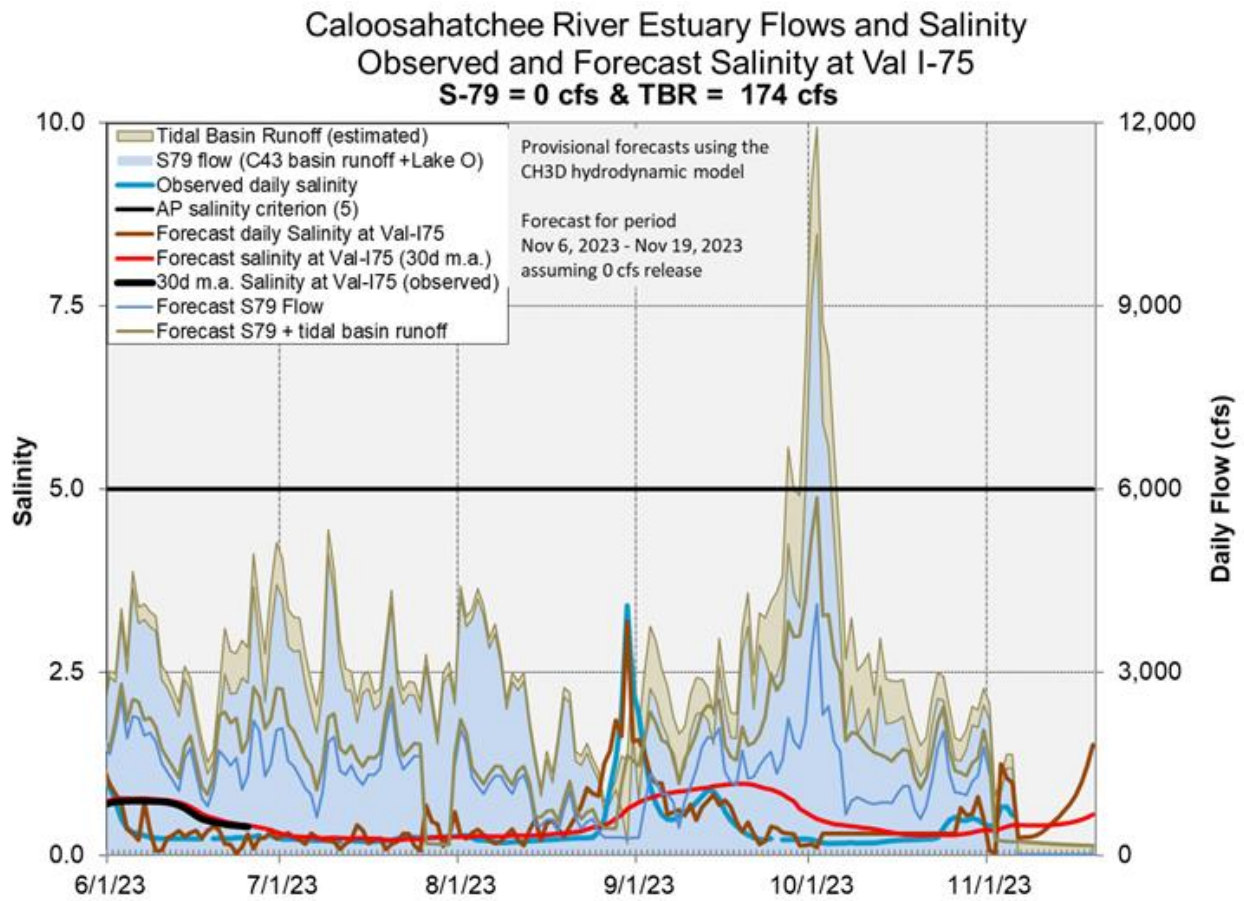
Figure ES-13. Forecasted Val I-75 site surface salinity assuming no pulse release at S-79.

Surface salinity at Val I-75 was forecasted for the next two weeks using an autoregression model (Qiu and Wan, 2013¹) coupled with a linear reservoir model for the tidal basin. Model scenarios included pulse releases at S-79 ranging from 0 to 1,500 cfs, and a steady release at 2,000 cfs with estimated tidal basin inflows of 174 cfs. Model results from all scenarios predict daily salinity to be 1.5 or lower and the 30-day moving average surface salinity to be 0.6 or lower at Val I-75 at the end of the two-week period (**Table ES-3 and Figure ES-13**). This keeps predicted salinities in the upper estuary within the optimal salinity range (0-10) for tape grass.

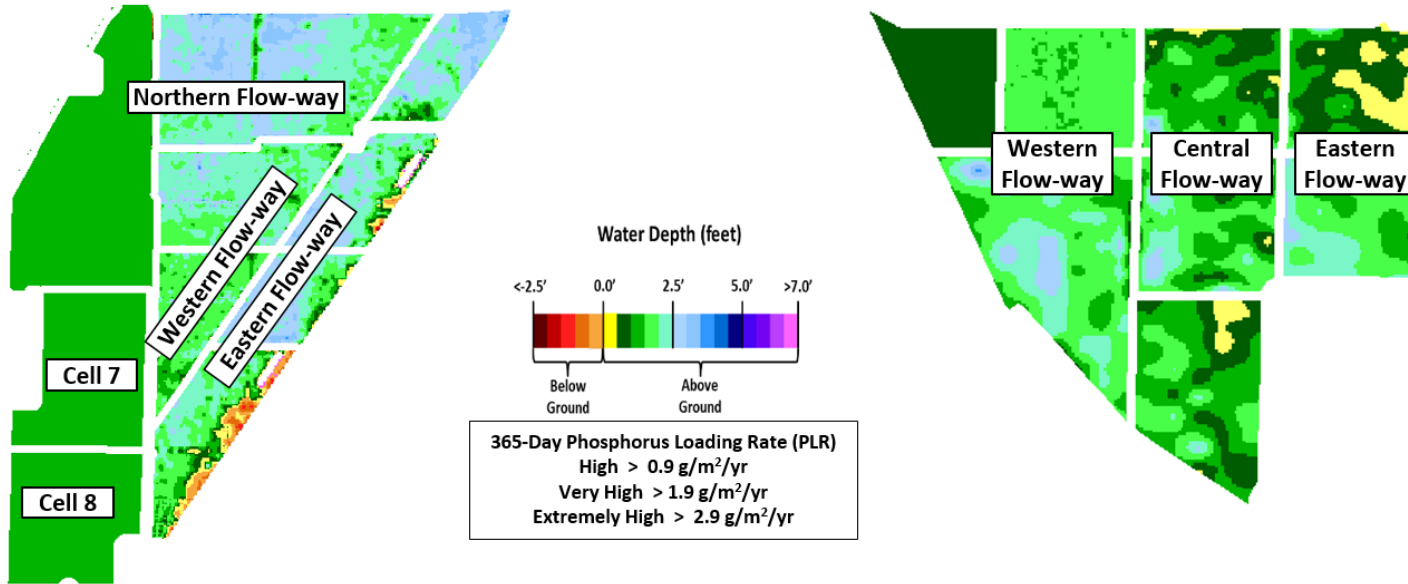
Figure S-1. Eastern Flow Path Weekly Status Report

STA-1W	Flow-way Status
Western	<ul style="list-style-type: none"> • High 365-day PLR • Highly stressed vegetation conditions
Eastern	<ul style="list-style-type: none"> • High 365-day PLR • Highly stressed vegetation conditions
Northern	<ul style="list-style-type: none"> • Highly stressed vegetation conditions • Planting emergent vegetation
Cell 7	<ul style="list-style-type: none"> • Stressed vegetation conditions
Cell 8	<ul style="list-style-type: none"> • Construction activities

STA-1E	Flow-way Status
Western	<ul style="list-style-type: none"> • Offline for post-construction vegetation grow-in
Central	<ul style="list-style-type: none"> • Highly stressed vegetation conditions
Eastern	<ul style="list-style-type: none"> • High 365-day PLR • Stressed vegetation conditions

STA-1E: STA-1E Western Flow-way is offline for post-construction vegetation grow in. Online treatment cells are near target stage. Vegetation in the flow-ways is stressed and highly stressed. The 365-day phosphorus loading rate (PLR) for the Central Flow-way is high and the 365-day PLR for the Eastern Flow-way is below 1.0 g/m²/year. (**Figure S-1**).

STA-1W: An operational restriction is in place in STA-1W Northern Flow-way for vegetation management activities. Treatment cells are near target stage. Vegetation in the flow-ways is stressed and highly stressed. The 365-day PLRs for the Eastern and Western Flow-ways are high, and the 365-day PLR for the Northern Flow-ways is below 1.0 g/m²/year (**Figure S-1**).

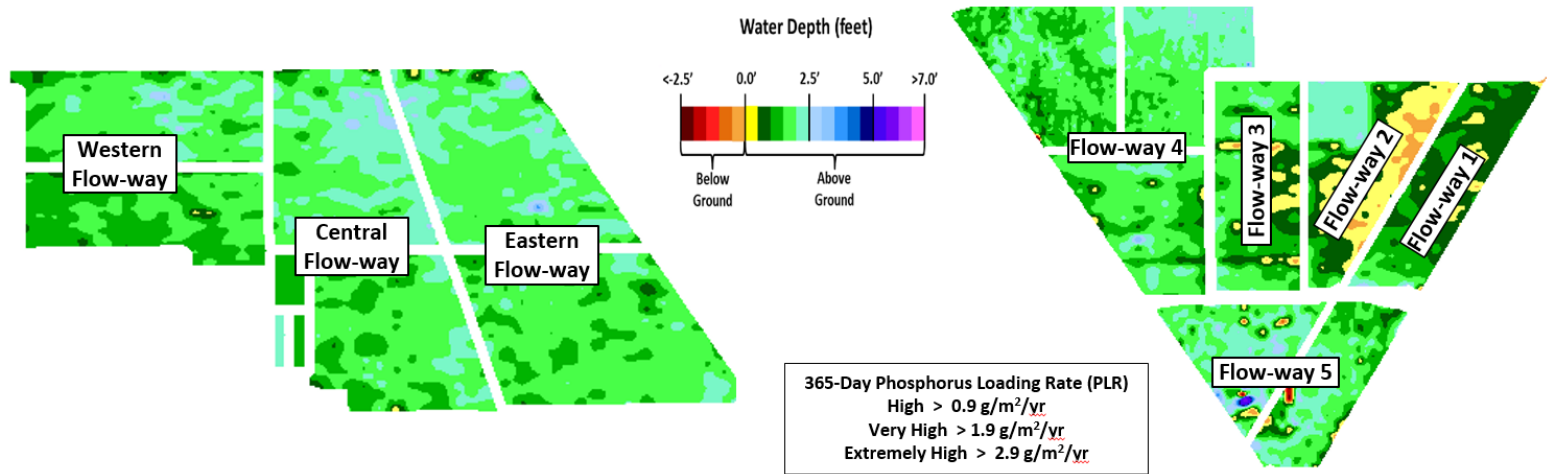
Figure S-2. Central Flow Path Weekly Status Report

STA-3/4	Flow-way Status
Western	<ul style="list-style-type: none"> • Stressed vegetation conditions • Nuisance vegetation control within inflow canal
Central	<ul style="list-style-type: none"> • Highly stressed vegetation conditions • Removal of floating tussocks • Nuisance vegetation control within inflow canal
Eastern	<ul style="list-style-type: none"> • Post-drawdown vegetation grow-in • Nuisance vegetation control within inflow canal

STA-2	Flow-way Status
Flow-way 1	<ul style="list-style-type: none"> • High 365-day PLR • Stressed vegetation conditions
Flow-way 2	<ul style="list-style-type: none"> • Post-construction vegetation grow-in • Planting emergent vegetation
Flow-way 3	<ul style="list-style-type: none"> • Stressed vegetation conditions
Flow-way 4	<ul style="list-style-type: none"> • Planting emergent vegetation • Nuisance vegetation control • Highly stressed vegetation conditions
Flow-way 5	<ul style="list-style-type: none"> • Highly stressed vegetation conditions

STA-2: Operational restrictions are in place in Flow-ways 2 and 4 for vegetation management activities. Most online treatment cells are near target stage. Vegetation in Flow-ways 1 and 3 is stressed, and in Flow-ways 4 and 5 is highly stressed. The 365-day PLRs for Flow-ways 3, 4, and 5 are below 1.0 g/m²/year. The 365-day PLR for Flow-way 1 is high (**Figure S-2**).

STA-3/4: An operational restriction is in place in the Eastern Flow-way for post-drawdown vegetation grow-in. Online treatment cells are at or above target stage. Vegetation in the Central Flow-way is highly stressed and in the Western Flow-way is stressed. The 365-day PLRs for the Central and Western Flow-ways are below 1.0 g/m²/year (**Figure S-2**).

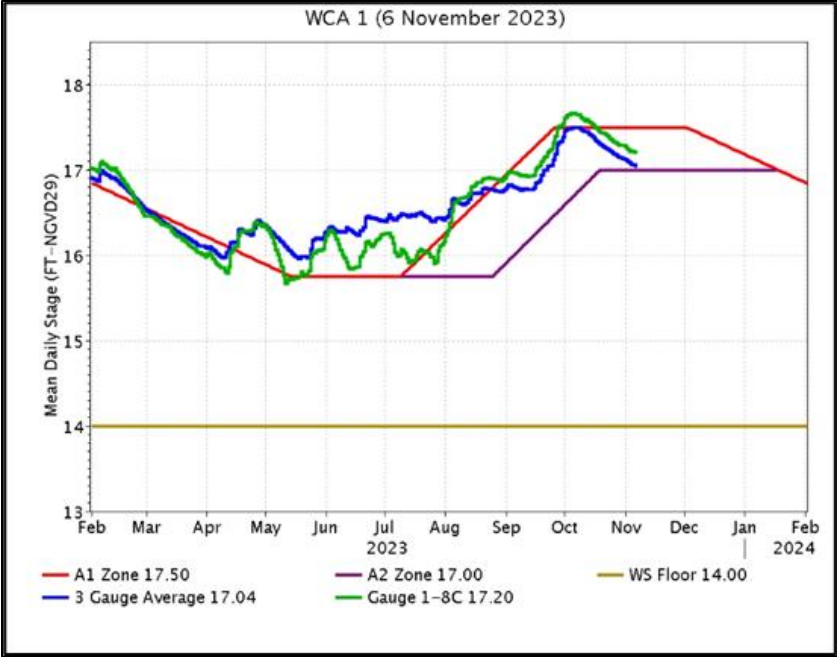
Figure EV-1. WCA-1 stage hydrographs and regulation schedule.

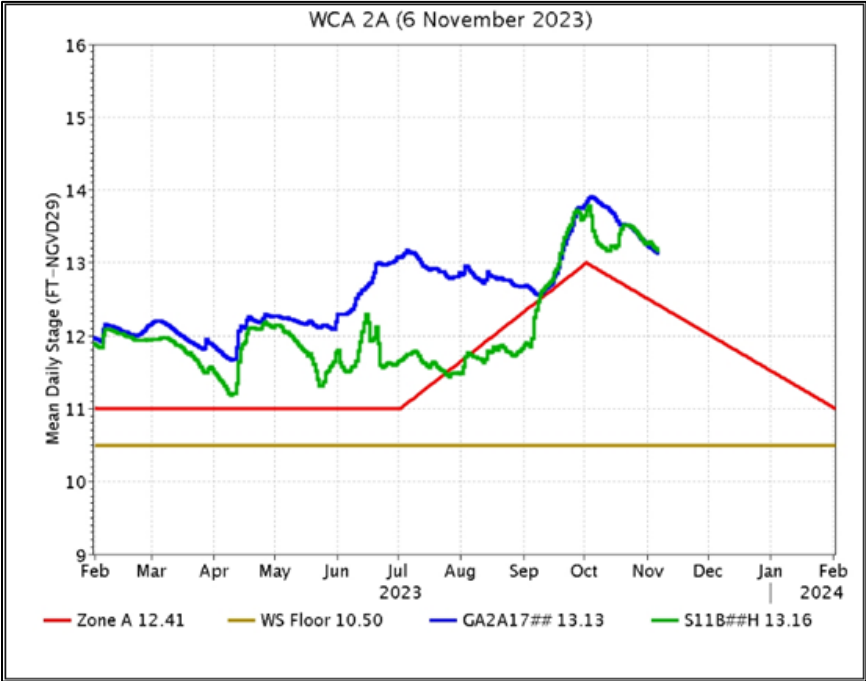
Figure EV-2. WCA-2A stage hydrographs and regulation schedule.

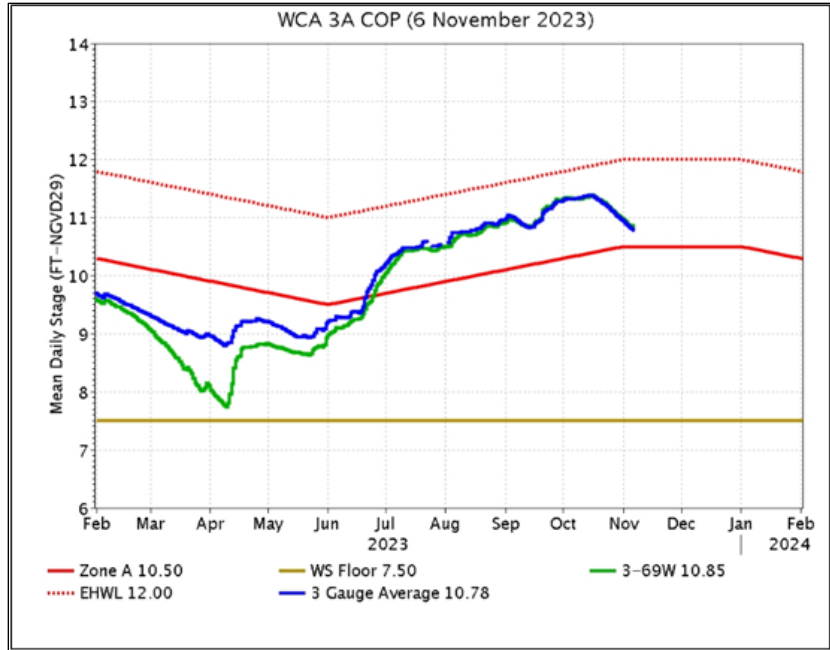
Figure EV-3. WCA-3A stage hydrographs (three-gauge average, 3-69W) and regulation schedule.

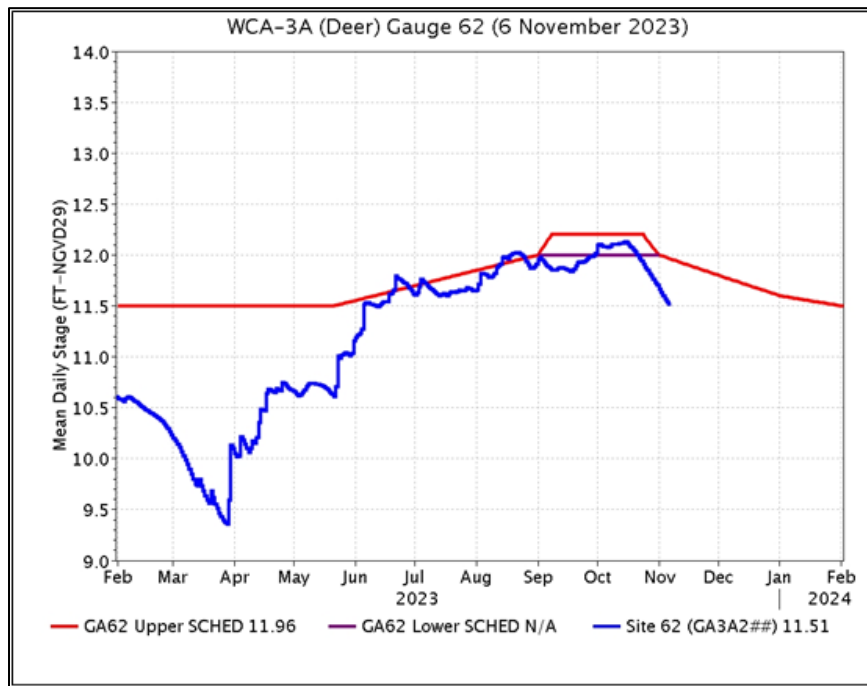
Figure EV-4. WCA-3A stage hydrograph (Deer gauge; Site 62) and GA62 regulation schedule.

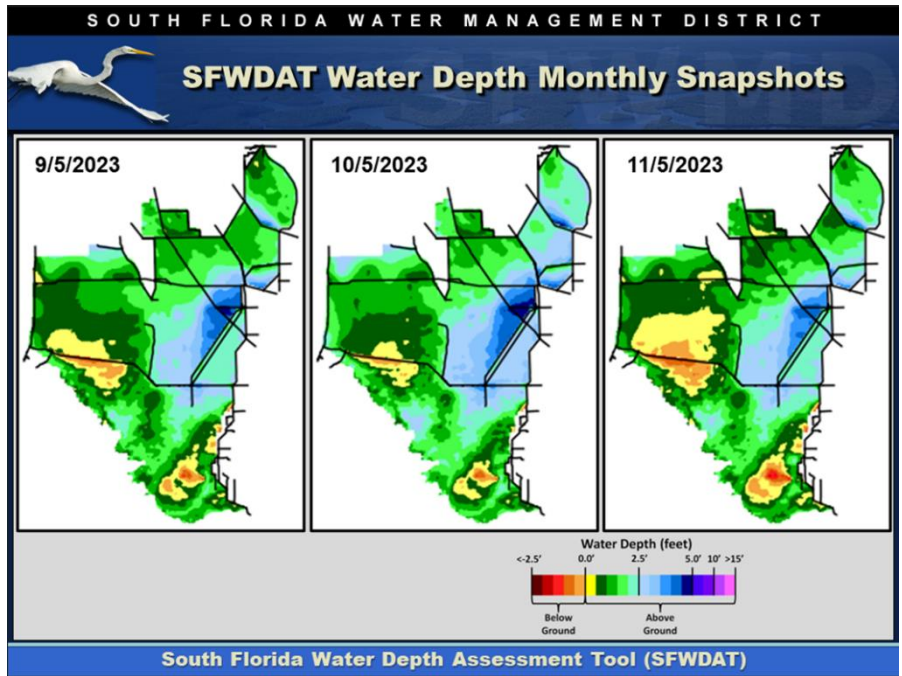
Figure EV-5. Everglades water depths from two months ago (left), one month ago (center) and present (right), based on SFWDAT.

The SFWDAT tool illustrates water depths have receded slightly along the upper reaches of the L-67s and southern WCA-3A. However, conditions remain ponded in the southern portions of WCA-3A. Hydrologic connectivity is strong within all the major sloughs of ENP. The area with the potential for significantly below ground stages in southern BCNP has expanded. Comparing current WDAT water depths to one month ago conditions across the Everglades are significantly drier especially in northern WCA-2A. Looking back a year ago, conditions are slightly wetter in WCA-3A and central ENP; slightly drier in WCA-2A and to the west. (**Figure EV-5** and **Figure EV-6**).

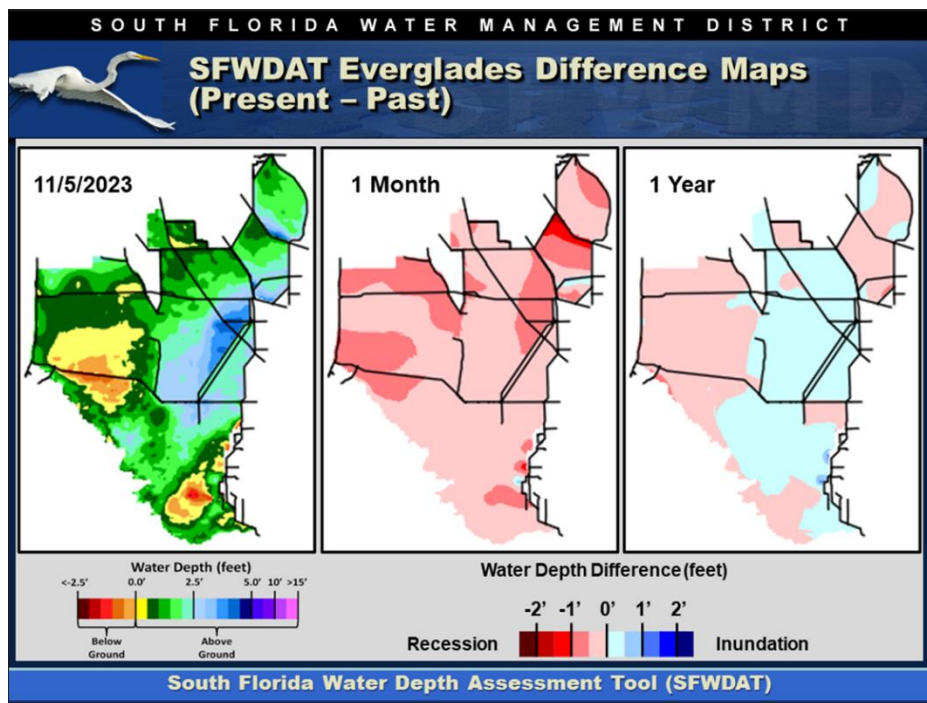
Figure EV-6. Present Everglades water depths (left) and water depth changes from one month (center) and one year (right) ago, based on SFWDAT.

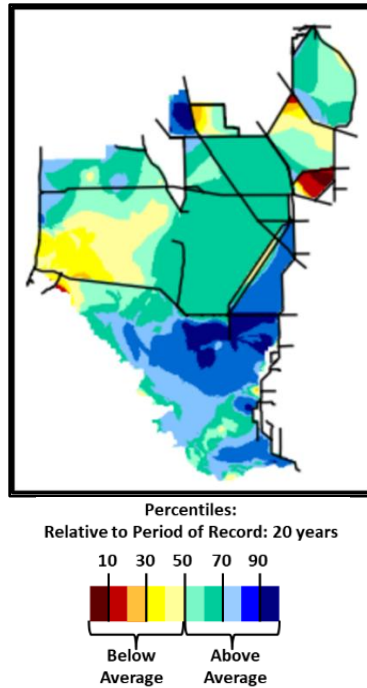
Figure EV-7. Present water depths (10/29/2023) compared to the day of year average over the previous 20 years.

Comparing current conditions to the 20-year average on November 5th: Well above average depths conditions continue in WCA-3B and northeastern ENP, but to the north conditions are trending towards average or below ecologically problematic in historically overdried regions like northern WCA-2A and -3A. (**Figure EV-7**).

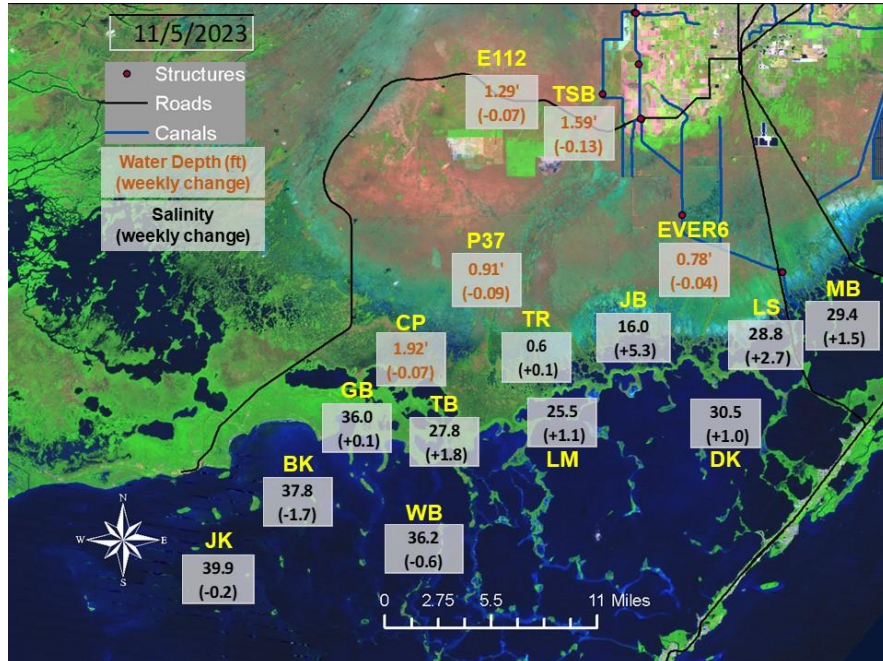
Figure EV-8. Taylor Slough water depths with changes since a week ago and Florida Bay salinities with changes since a week ago.

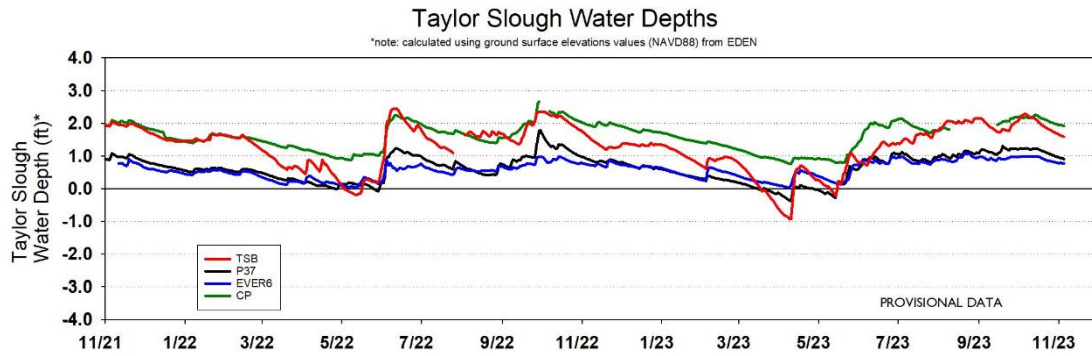
Figure EV-9. Taylor Slough water depth time series.

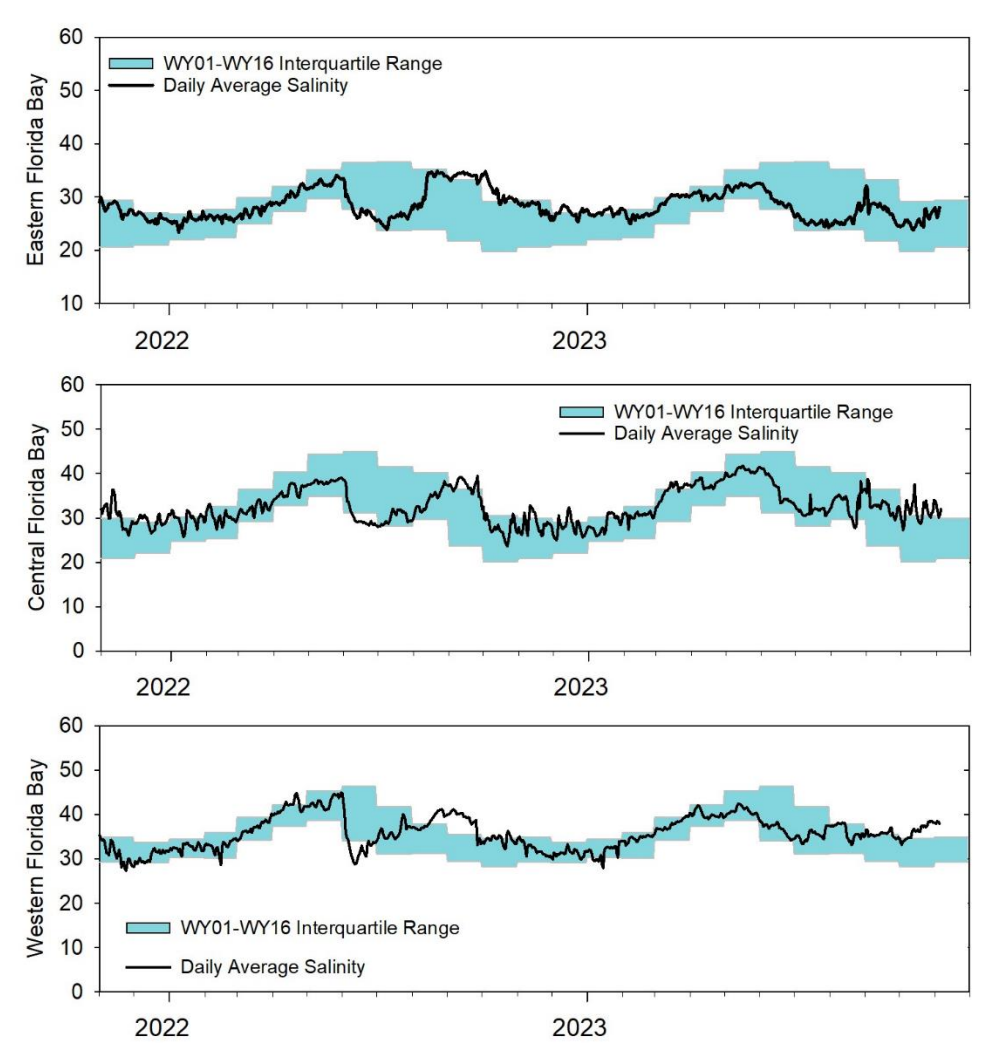
Figure EV-10. Eastern (top panel), Central (middle panel) and Western (bottom panel) Florida Bay daily average salinities with interquartile (25-75 percentile) ranges.

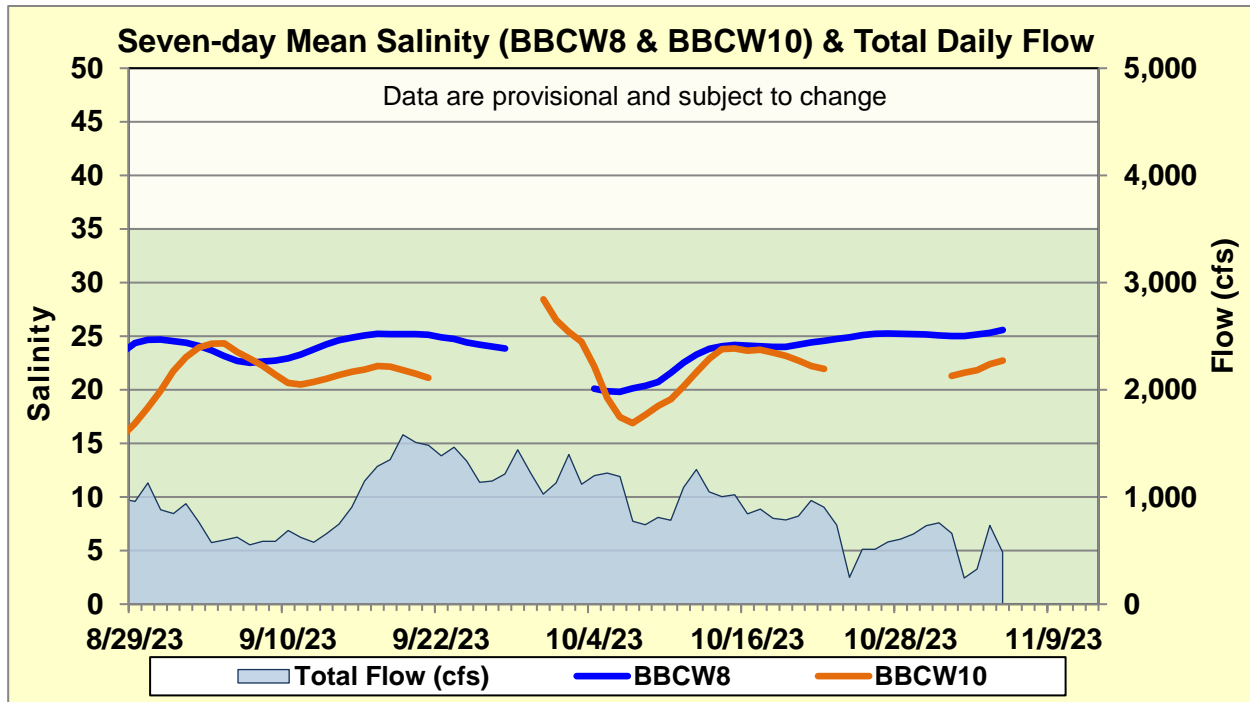
Figure BB-1. Seven-day mean salinity at BBCW8 and BBCW10 and total daily flow in Biscayne Bay. Total daily flow was calculated using flow from structures S20G, S20F, S21, S21A, S123, and S700P.

As shown in **Figure BB-1**, mean total inflow to Biscayne Bay was 564 cfs, and the previous 30-day mean inflow was 745 cfs. The seven-day mean salinity was 25.9 at BBCW8 and 23.0 at BBCW10, both within the ideal salinity range for estuarine organisms in this region (salinity less than 35). Data were provided by Biscayne National Park.
