## **M E M O R A N D U M**

**FROM:** SFWMD Staff Environmental Advisory Team

**DATE:** November 15, 2023

**SUBJECT:** Weekly Environmental Conditions for Systems Operations

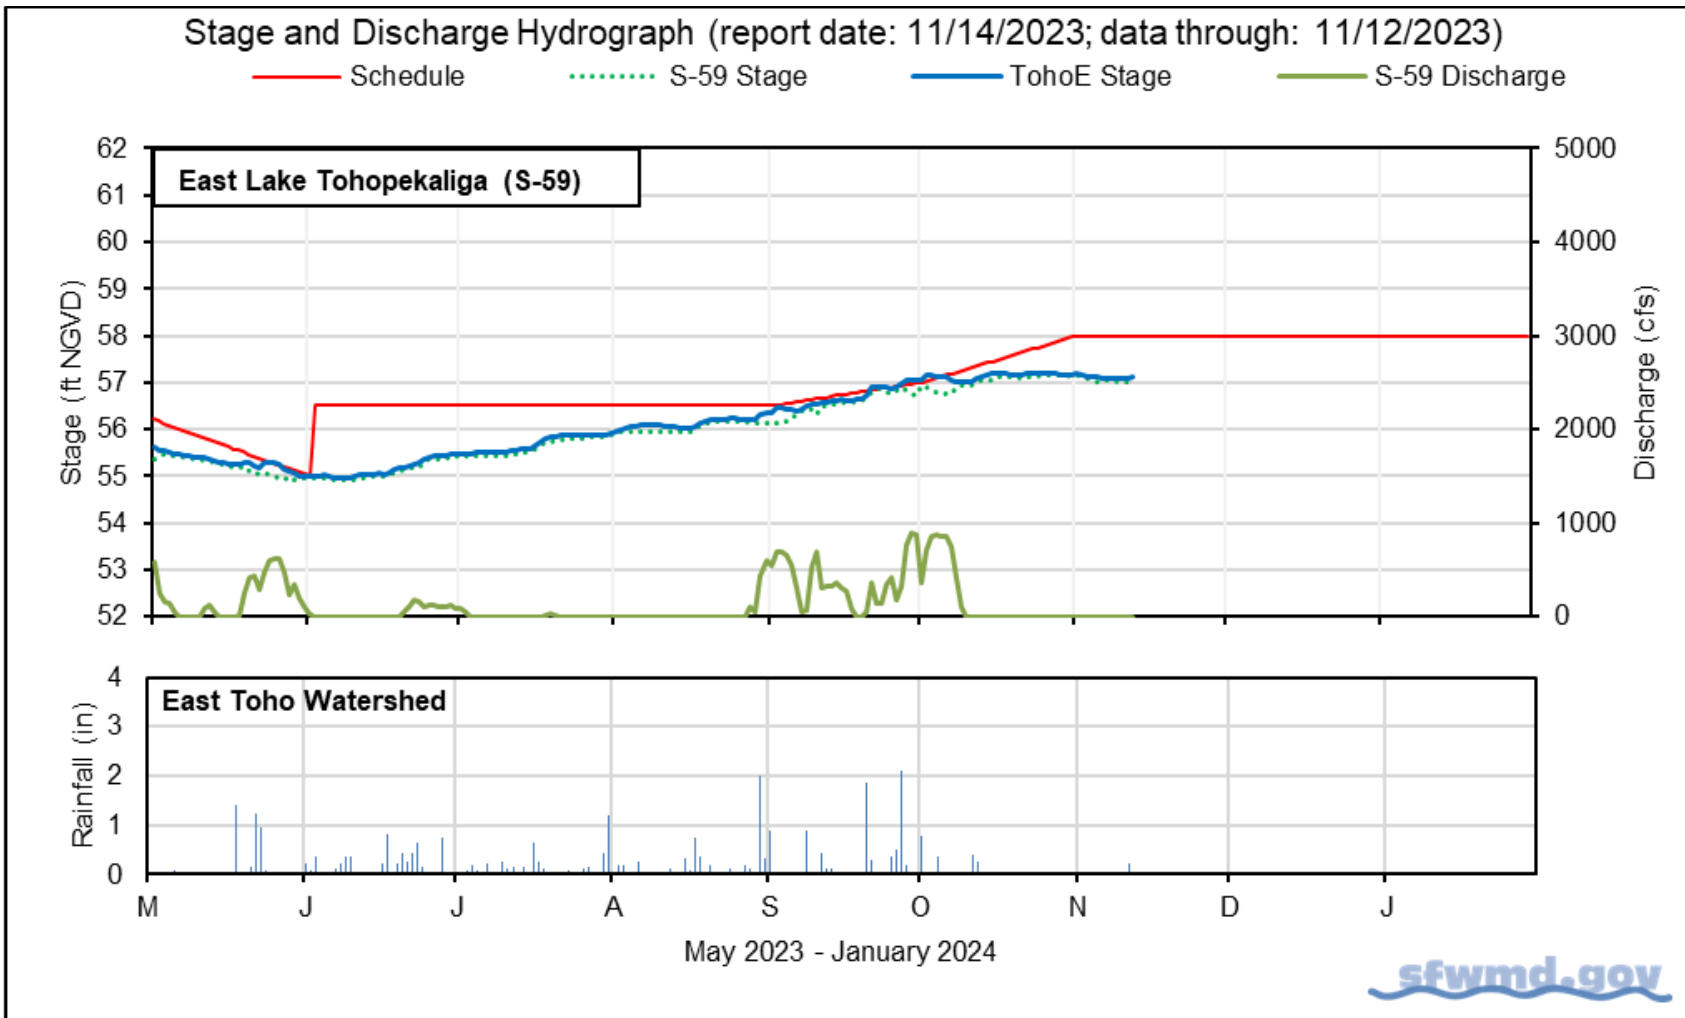
**Figure KB-1.** East Lake Toho regulation schedule, stage, discharge and rainfall.

On November 12, 2023, mean daily lake stages were 57.1 feet NGVD (0.9 feet below schedule) in East Lake Toho, 54.3 feet NGVD (0.7 feet below schedule) in Lake Toho, and 50.8 feet NGVD (1.7 feet below schedule) in Lakes Kissimmee-Cypress-Hatchineha (KCH) (**Table KB-1, Figures KB-1-3**).

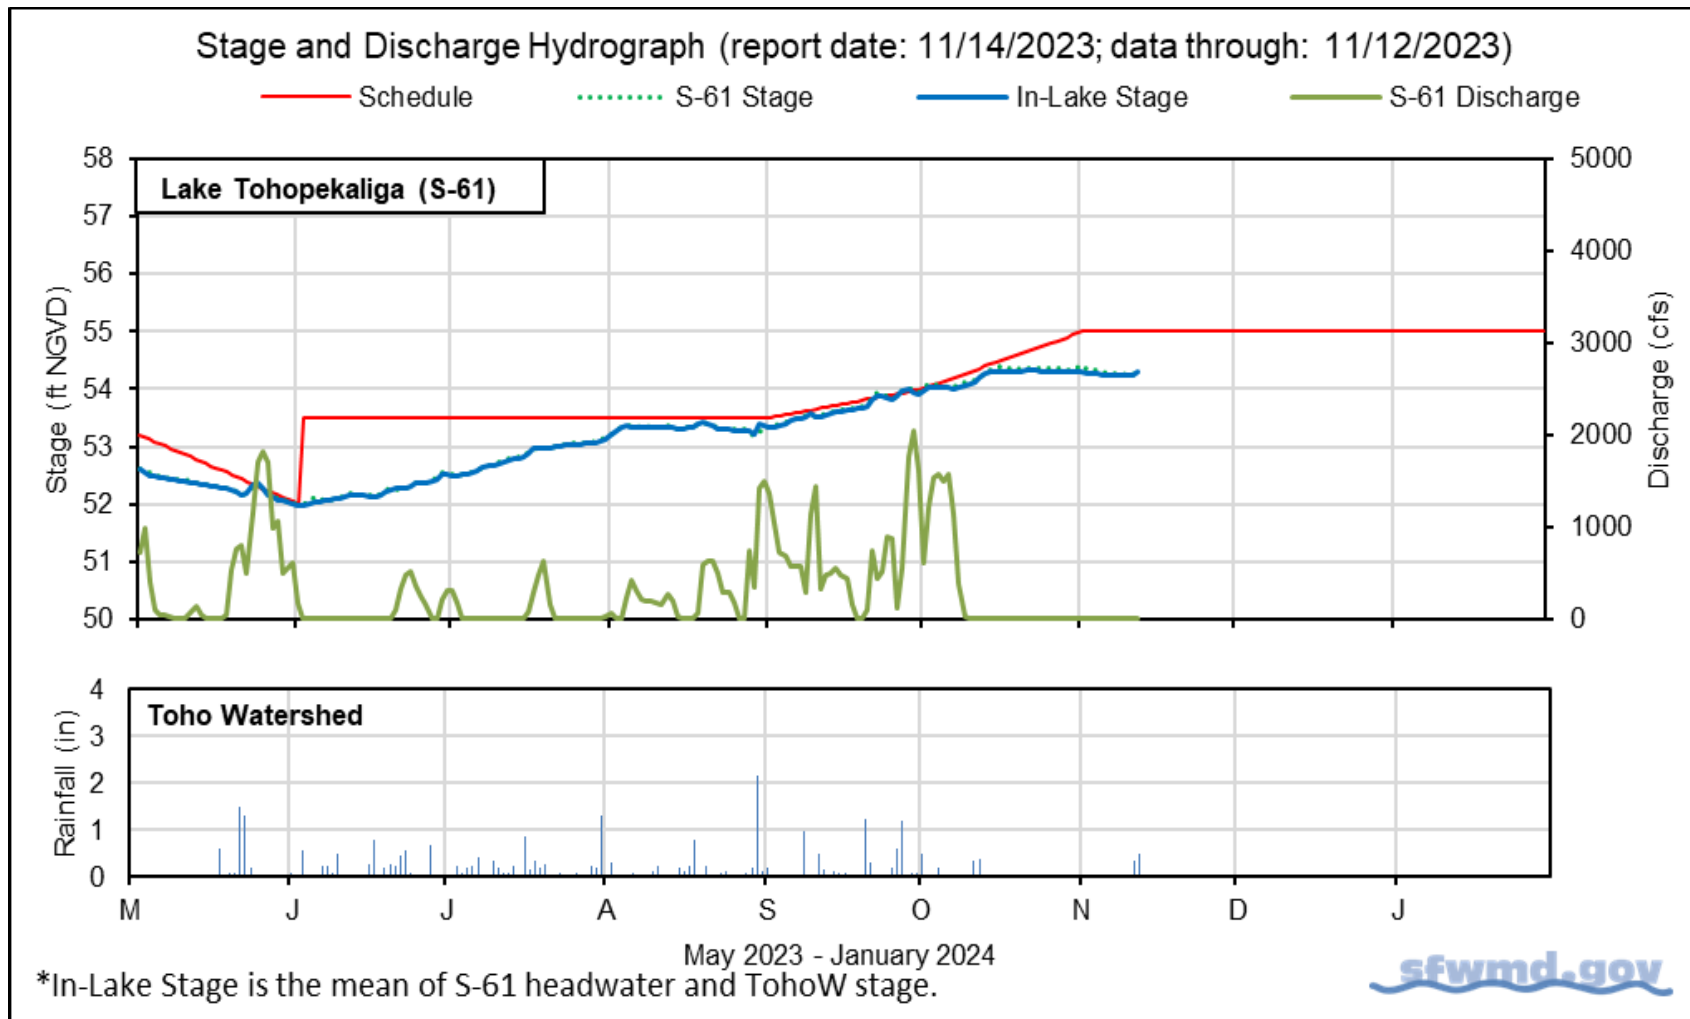
**Figure KB-2.** Lake Toho regulation schedule, stage, discharge and rainfall.

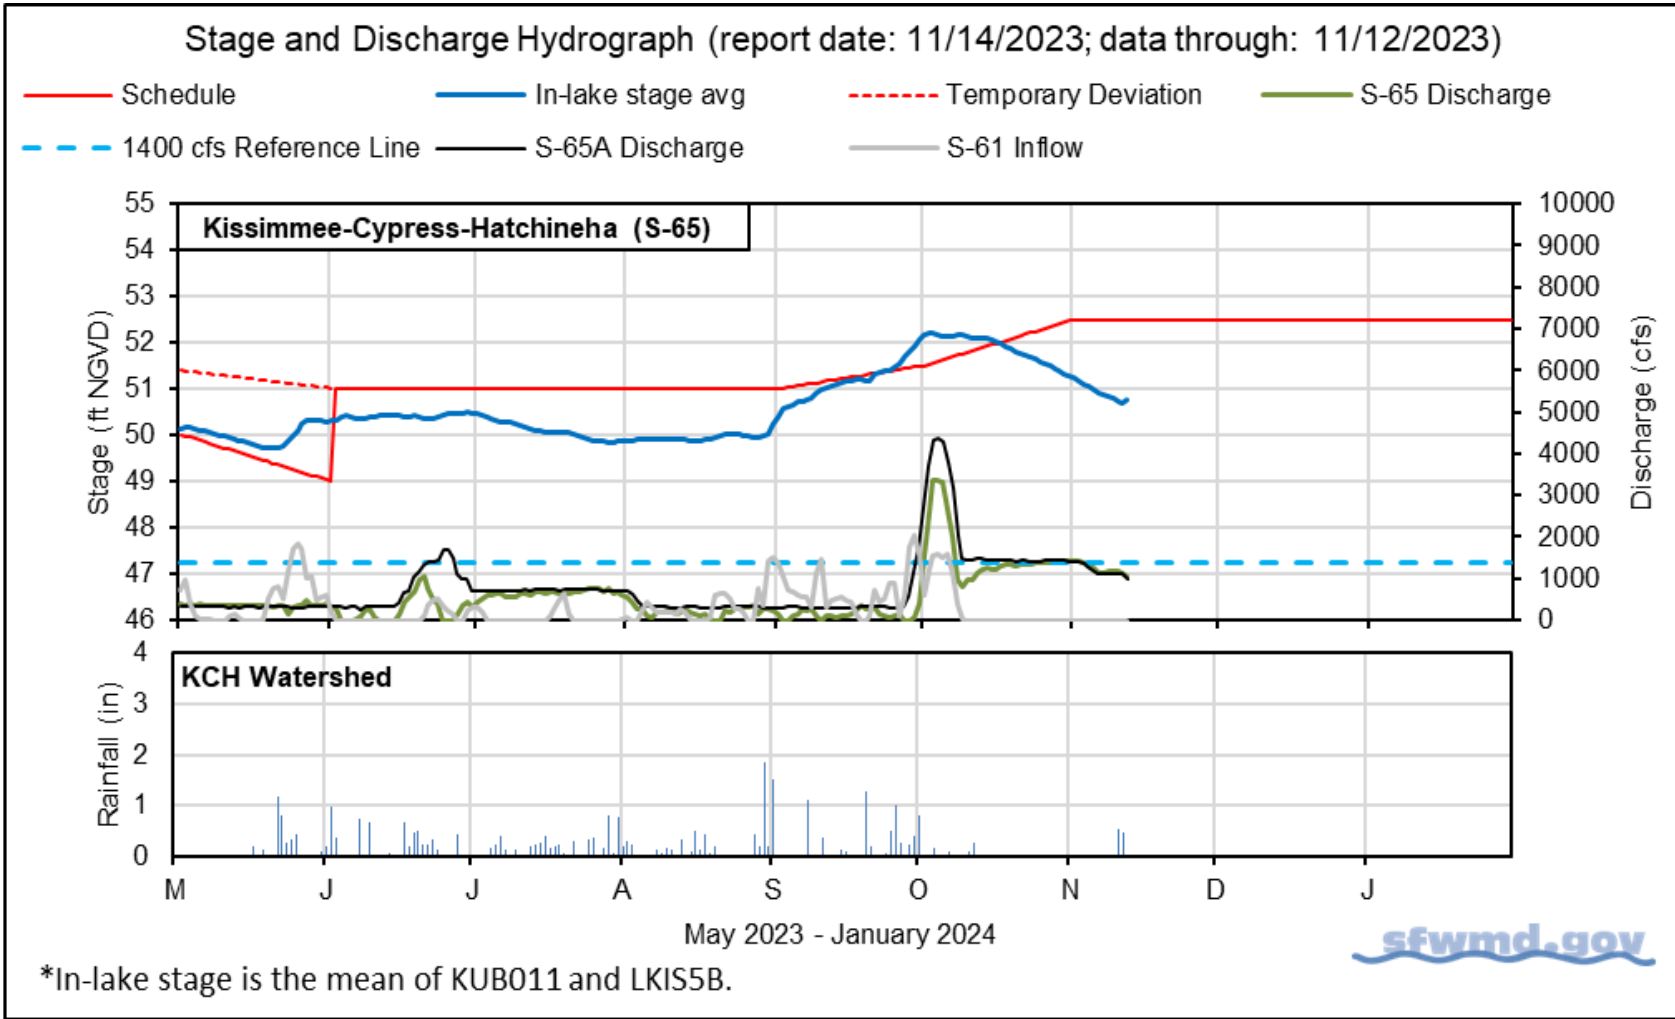
**Figure KB-3.** Lakes Kissimmee, Cypress and Hatchineha regulation schedule, stage, discharge and rainfall.

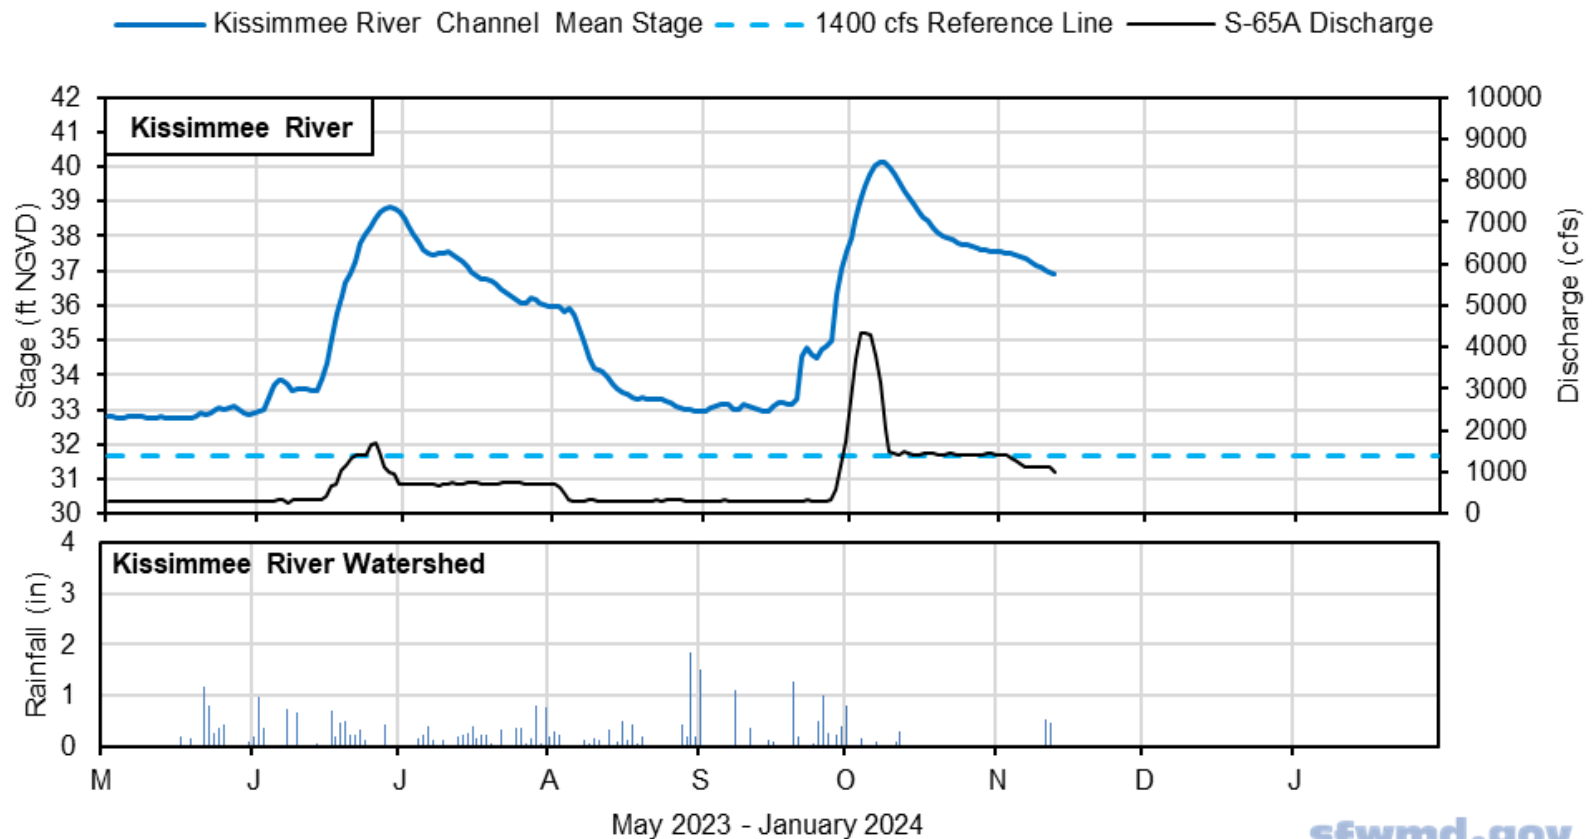
\*River Channel Stage is the average for PC62, KRDR02, KRBN, PC33, and PC11.

Figure KB-4. Kissimmee River stage, discharge and rainfall.

For the week ending November 12, 2023, mean weekly discharge was 1,100 cfs at both S-65 and S-65A. Mean weekly discharge from the Kissimmee River was 1,400 cfs at S-65D and 1,600 cfs at S-65E (**Table KB-2**). Mean weekly headwater stages were 46.2 feet NGVD at S-65A and 27.4 feet NGVD at S-65D on November 12, 2023, a reduction of about 0.2 ft at S-65D. Mean weekly river channel stage decreased by 0.4 feet to 37.1 feet NGVD over the week ending on November 12, 2023 (**Figure KB-4**). Mean weekly water depth on the Kissimmee River floodplain decreased by 0.10 ft to 0.42 feet over the week ending November 12, 2023 (**Table KB-2, Figure KB-5**). The weekly average concentration of dissolved oxygen in the Kissimmee River increased from 5.7 mg/L the previous week to 6.3 mg/L for the week ending November 12, 2023 (**Table KB-2, Figure KB-6**).

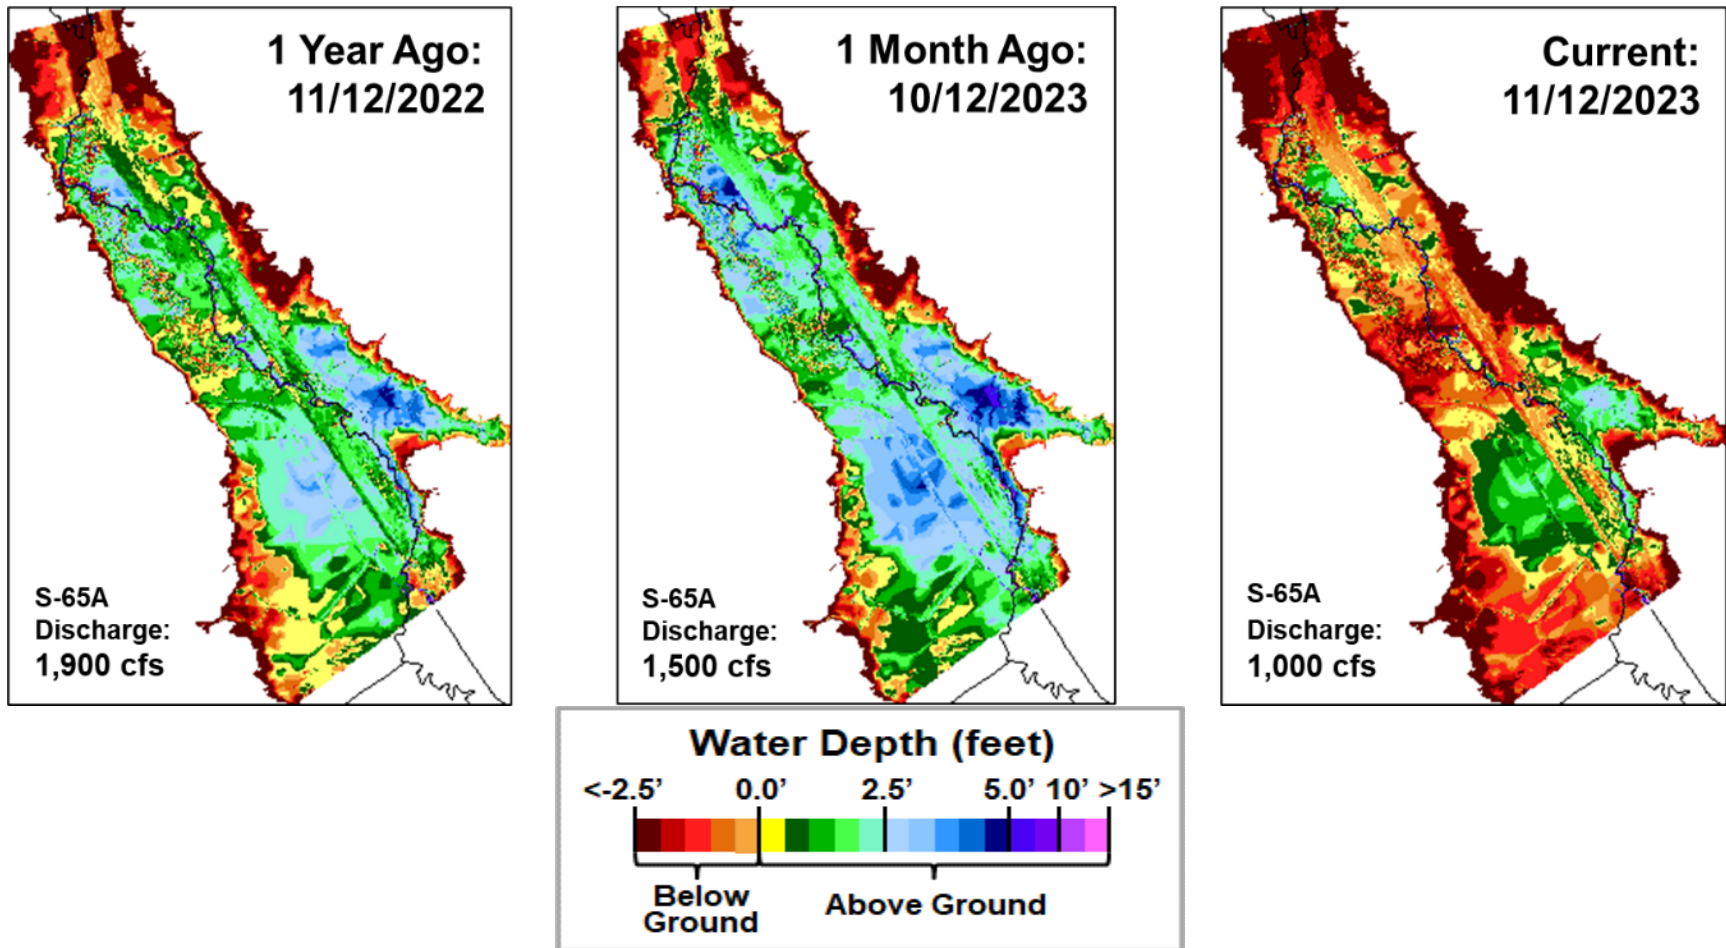
**Figure KB-5.** Phase I area Kissimmee River floodplain water depths (from left to right) one year ago, one month ago and current.

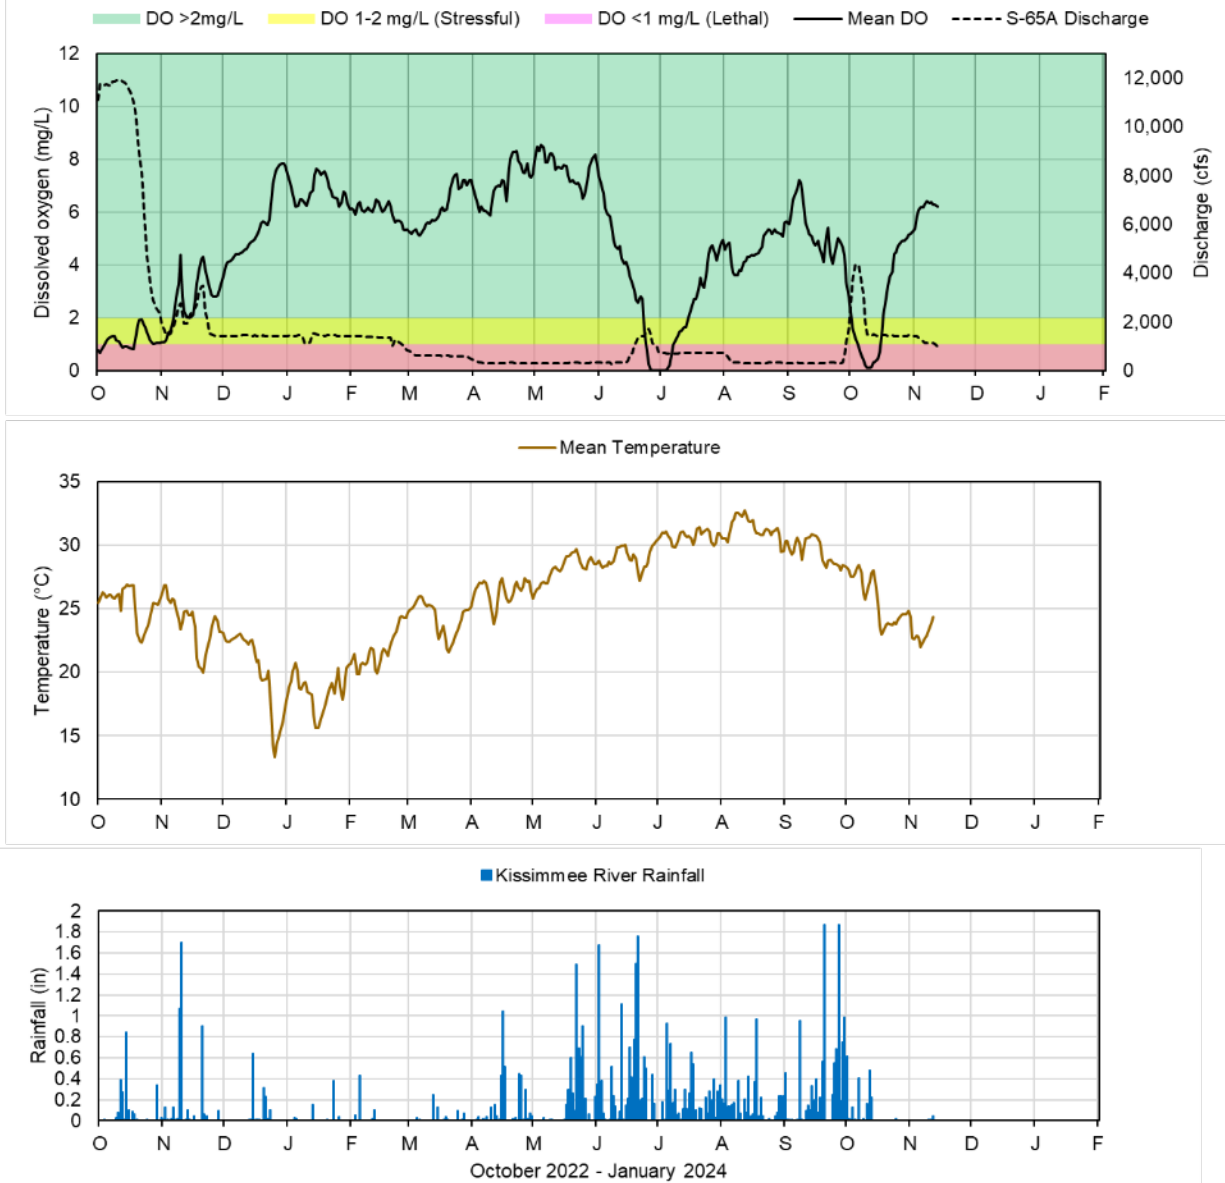
**Figure KB-6.** Restored Kissimmee River channel mean daily dissolved oxygen concentration (mg/L), S-65A discharge (cfs), temperature (°C) and rainfall (inches). Dissolved oxygen (DO) and temperature are mean daily values averaged for PC62, KRDR02, KRBN, PC33, PC11, PD62R, and PD42R with an average of six stations reporting this week. Rainfall values are daily totals for Kissimmee River (Pool BCD) AHED watershed.

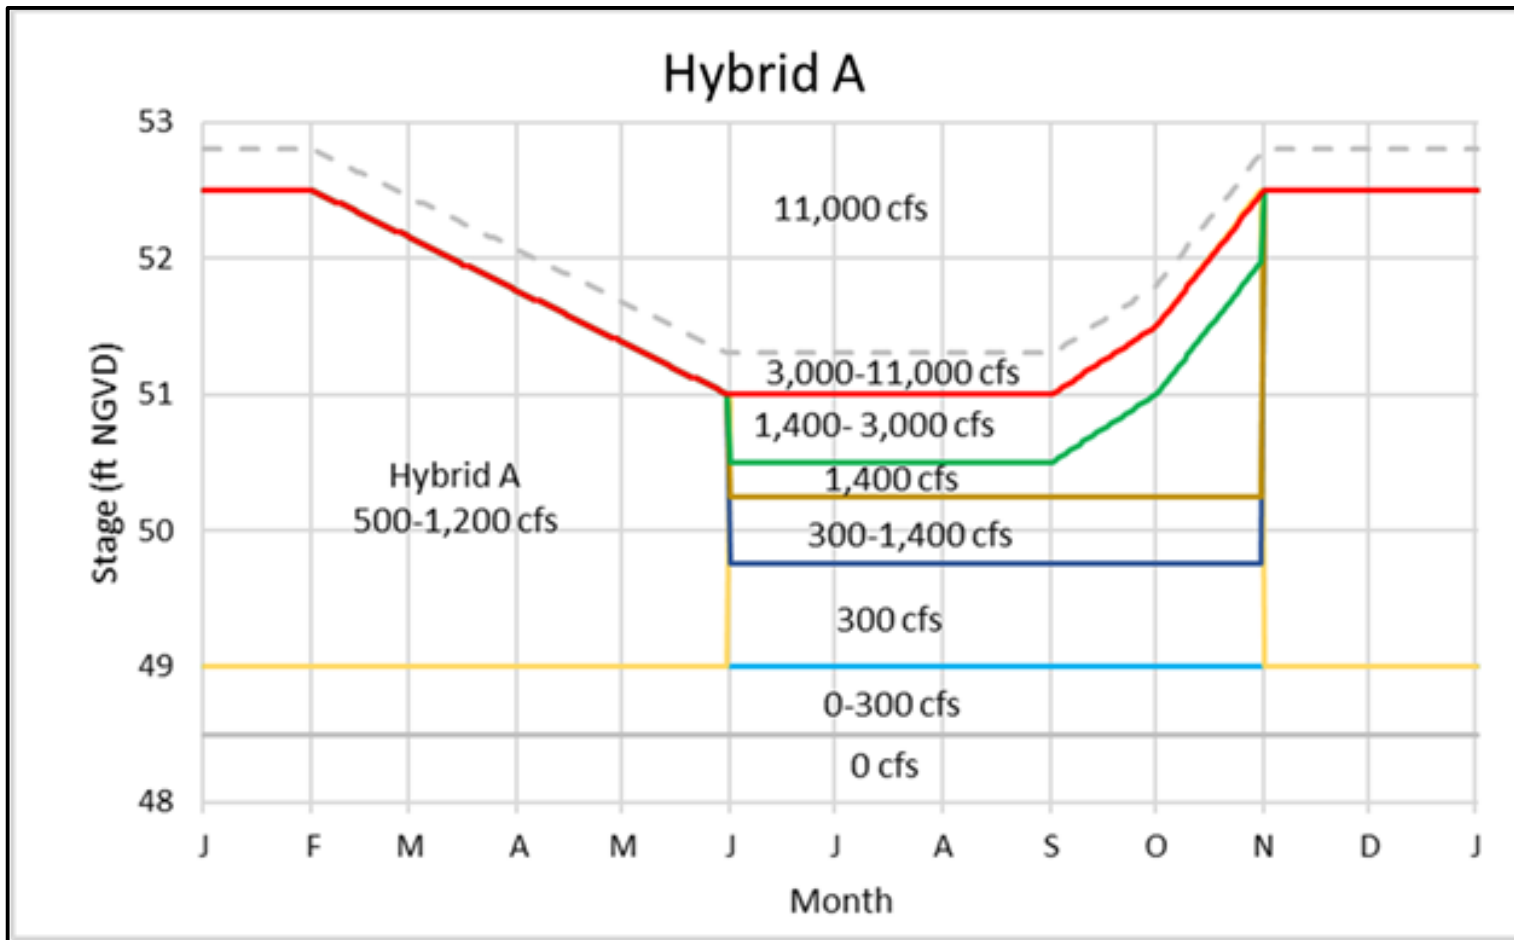
**Figure KB-7.** Hybrid A Discharge Plan for S-65/S-65A. Use discharge rate of change limits from IS-14-50 (Fig. KB-8).

Stage and Discharge Guidance for 2021-2023.		
Zone	KCH Stage (ft NGVD)	S-65/S-65A Discharge*
A	Above regulation schedule line.	Flood control releases as needed with no limits on the rate of discharge change.
B1	In flood control buffer zone (0.5 ft below the schedule line).	Adjust S-65 discharge so that S-65A discharge is between 1400 cfs at the buffer zone line and 3000 cfs at the schedule line.
B2	Between the Flood Control Buffer and the 50.0 ft line.	Adjust S-65 discharge to maintain at least 1400 cfs at S-65A. Use $\pm 0.2$ ft buffer (gray band) above and below the 50.0 ft line to decide when to begin ramping up to 1400 cfs or down to 300 cfs; do not continue reducing discharge if stage rises back to or above the threshold stage line.
B3	Between the 50.0 ft line and 49 ft.	Adjust S-65 discharge to maintain at least 300 cfs at S-65A.
B4	Between 48.5 ft to 49 ft.	Adjust S-65 discharge to maintain S-65A discharge between 0 cfs at 48.5 ft and 300 cfs at 49 ft.

C	Below 48.5 ft.	0 cfs.

\*Changes in discharge should not exceed limits in inset table below.

Q (cfs)	Maximum rate of INCREASE (cfs/day)	Maximum rate of DECREASE (cfs/day)
0-300	100	-50
301-650	150	-75
651-1400	300	-150
1401-3000	600	-600
>3000	1000	-2000

Follow the Hybrid A discharge plan (Fig. KB-7) to facilitate S-69 repairs through May 31, 2024. Maintain at least minimum flow (250-300 cfs) at S-65A. Continue the stage recession at S-65D headwater to reach 25.8 ft NGVD in early January 2024 at a recession rate of approximately 0.2 ft/week.

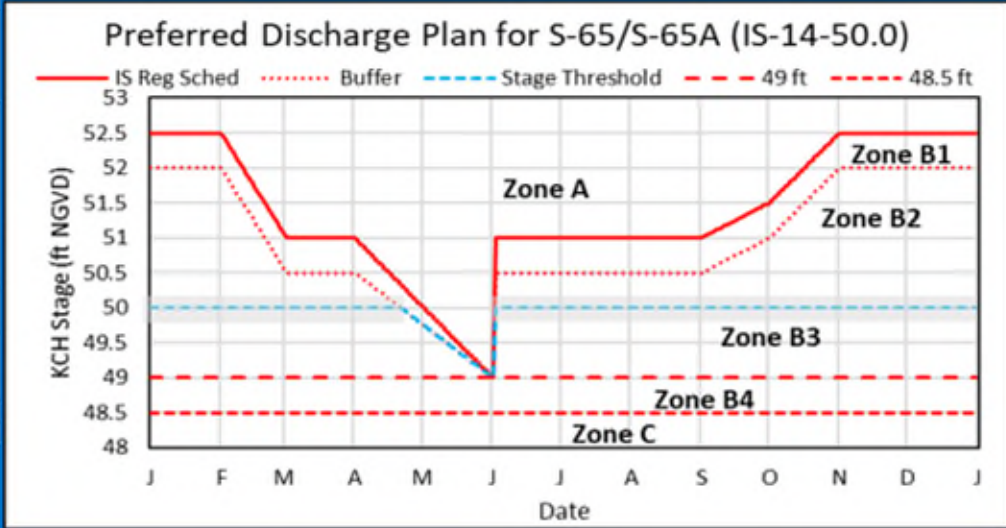
- Other Considerations**
- When possible, limit lake ascension rate in the Jun 1 - Aug 15 window to 0.25 ft per 7 days in Lakes Kissimmee, Cypress, Hatchineha (S-65), East Toho (S-59) and Toho (S-61).
  - If outlook is for extreme dry conditions meet with KB staff to discuss modifications to this plan.

Figure KB-8. IS-14-50 Discharge Plan for S65/S65A with discharge rate of change limits (revised 1/14/19).

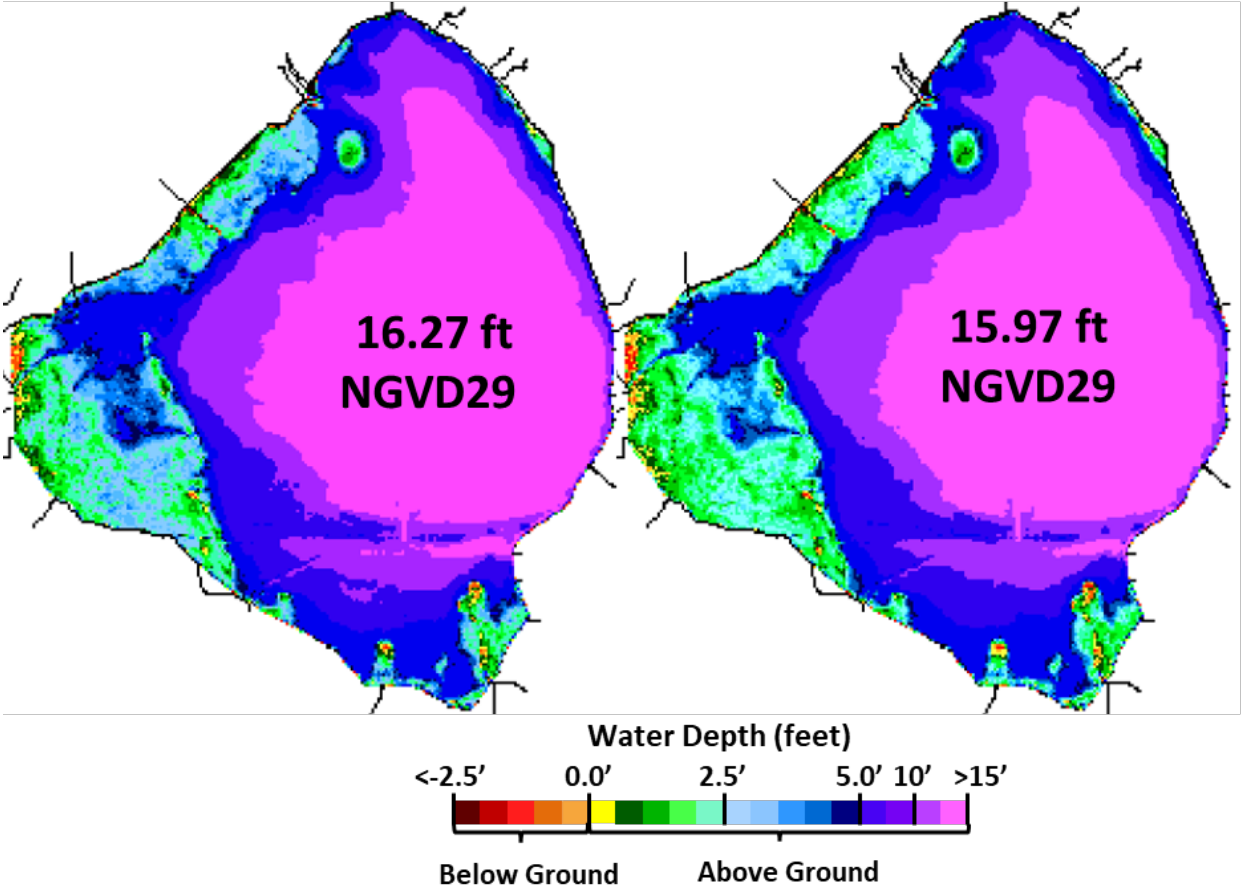
**Figure LO-1.** Lake Okeechobee water depth estimates based on South Florida Water Depth Assessment Tool (SFWDAT).

Lake Okeechobee stage was 15.97 feet NGVD on November 12, 2023, which was 0.10 feet lower than the previous week and 0.30 feet lower than a month ago (**Figure LO-1**). Lake stage was in the low sub-band on November 12<sup>th</sup> (**Figure LO-2**) and was 0.47 feet above the upper limit of the ecological envelope (**Figure LO-3**). According to NEXRAD, 0.07 inches of rain fell directly over the Lake.

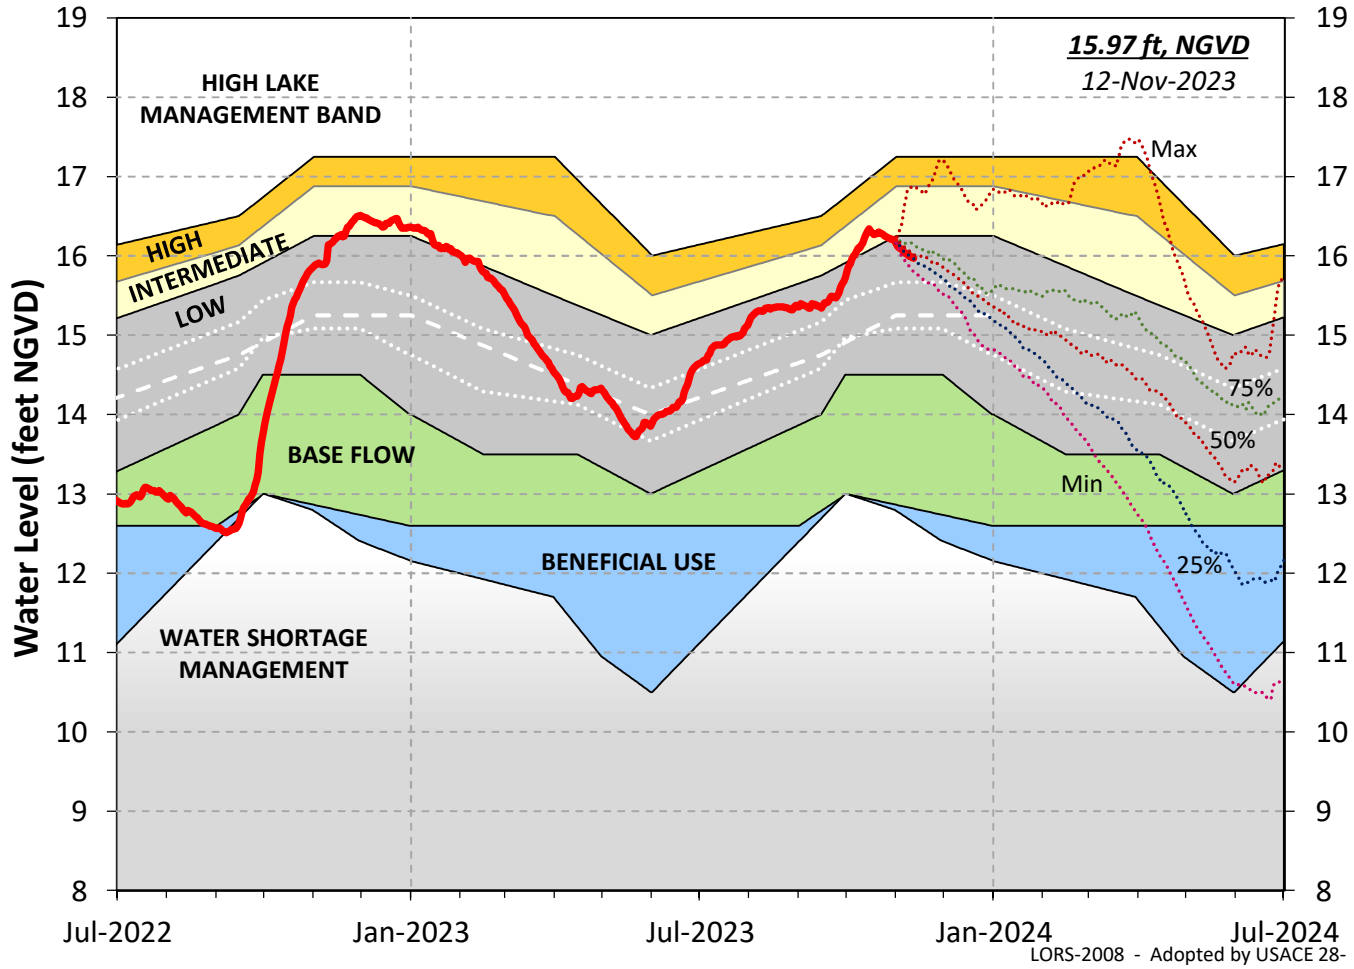
**Figure LO-2.** Recent Lake Okeechobee stages with projected stages based on a dynamic position analysis.

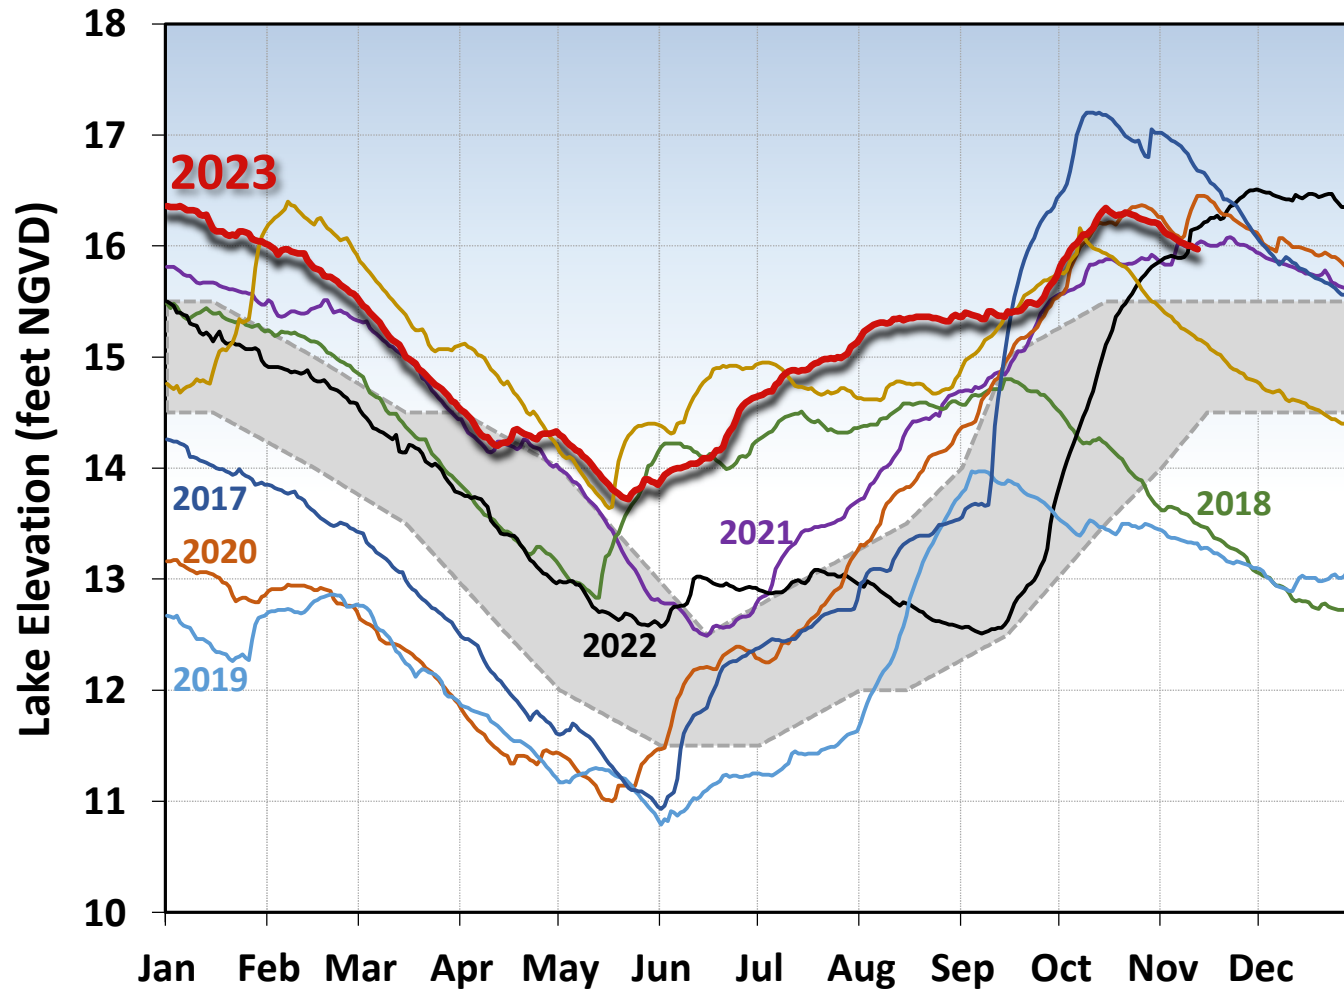
**Figure LO-3.** The selected prior years within the ten-year period of annual stage hydrographs for Lake Okeechobee in comparison to the ecological envelope.

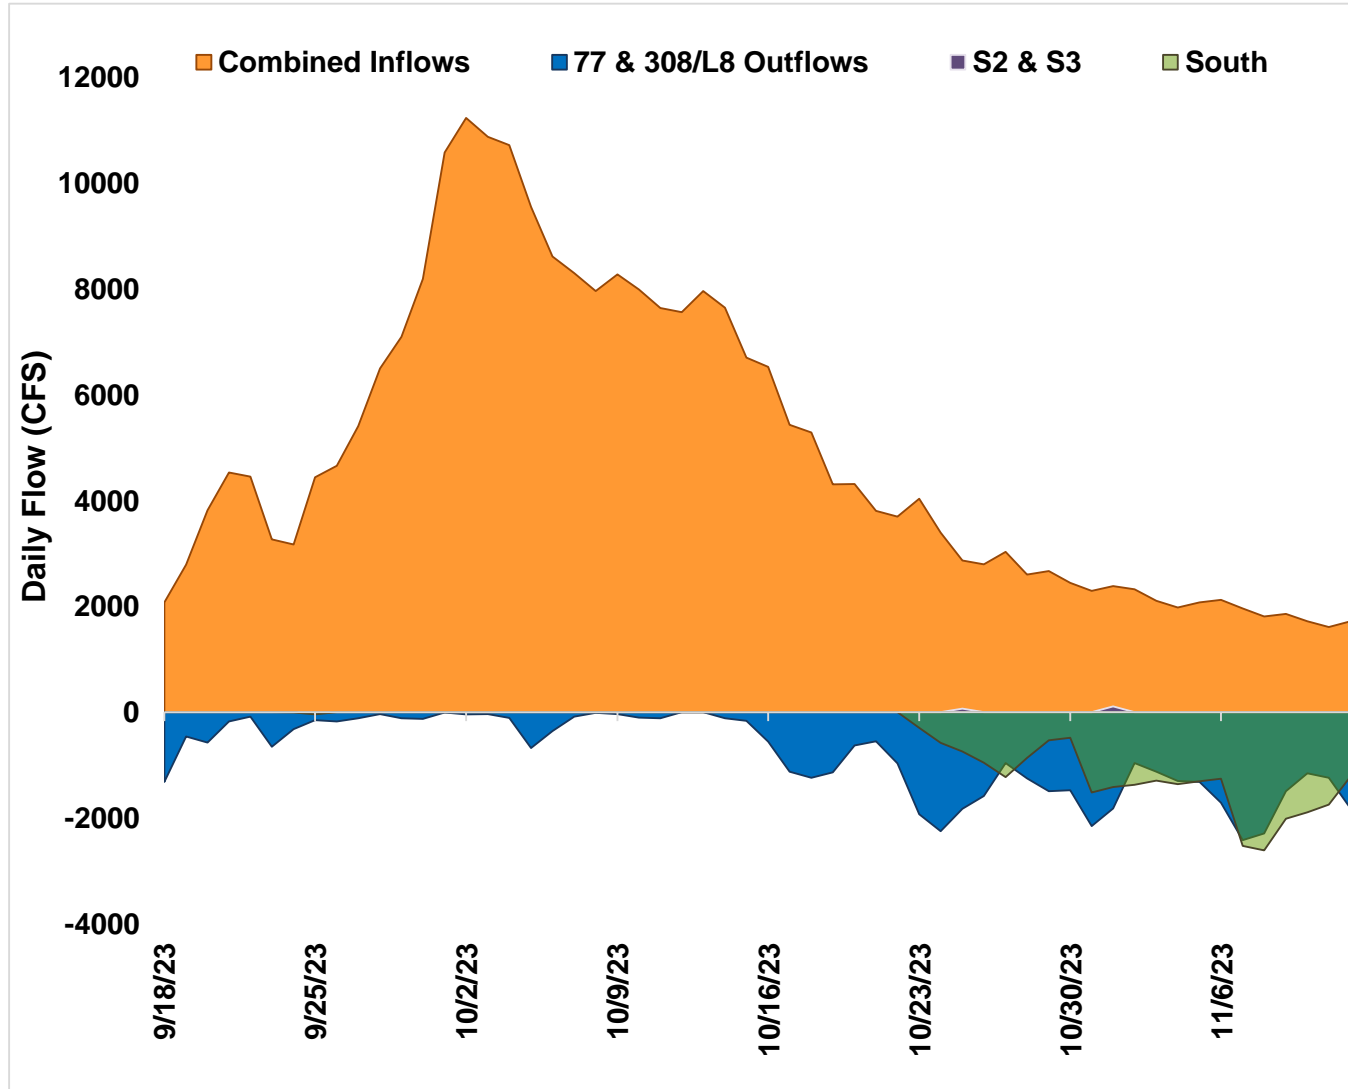
**Figure LO-4.** Major inflows (orange) to and outflows east and west (blue) from Lake Okeechobee. Outflows south are shown in green. Flows into Lake Okeechobee from the L-8 canal through S-271 (formerly Culvert 10A) or from the C-44 canal through the S-308 are included as inflows. Conversely, flows from Lake Okeechobee into the L-8 or C-44 canals are included with outflows. Inflows are shown as positive values; outflows are negative. Outflows through the S-77 (Caloosahatchee) and S-308 (C-44 Canal) structures are based on downstream gauges to include flows to lock openings for navigation.

Average daily inflows (excluding rainfall) decreased from the previous week, going from 2,230 cfs to 1,820 cfs. The highest structure inflow came from the C-38 Canal via the S-65E/65EX1 structure (1,570 cfs). Average daily outflows (excluding evapotranspiration) increased from the previous week, going from 2,670 cfs to 3,580 cfs. The highest average single structure outflow was recorded at the S-77 structure into the C-43 Canal (1,560 cfs). **Figures LO-4 and LO-5** show the combined average daily inflows and outflows for the Lake over the past eight weeks, and average inflows and outflows last week, respectively. These data are provisional and are subject to change.

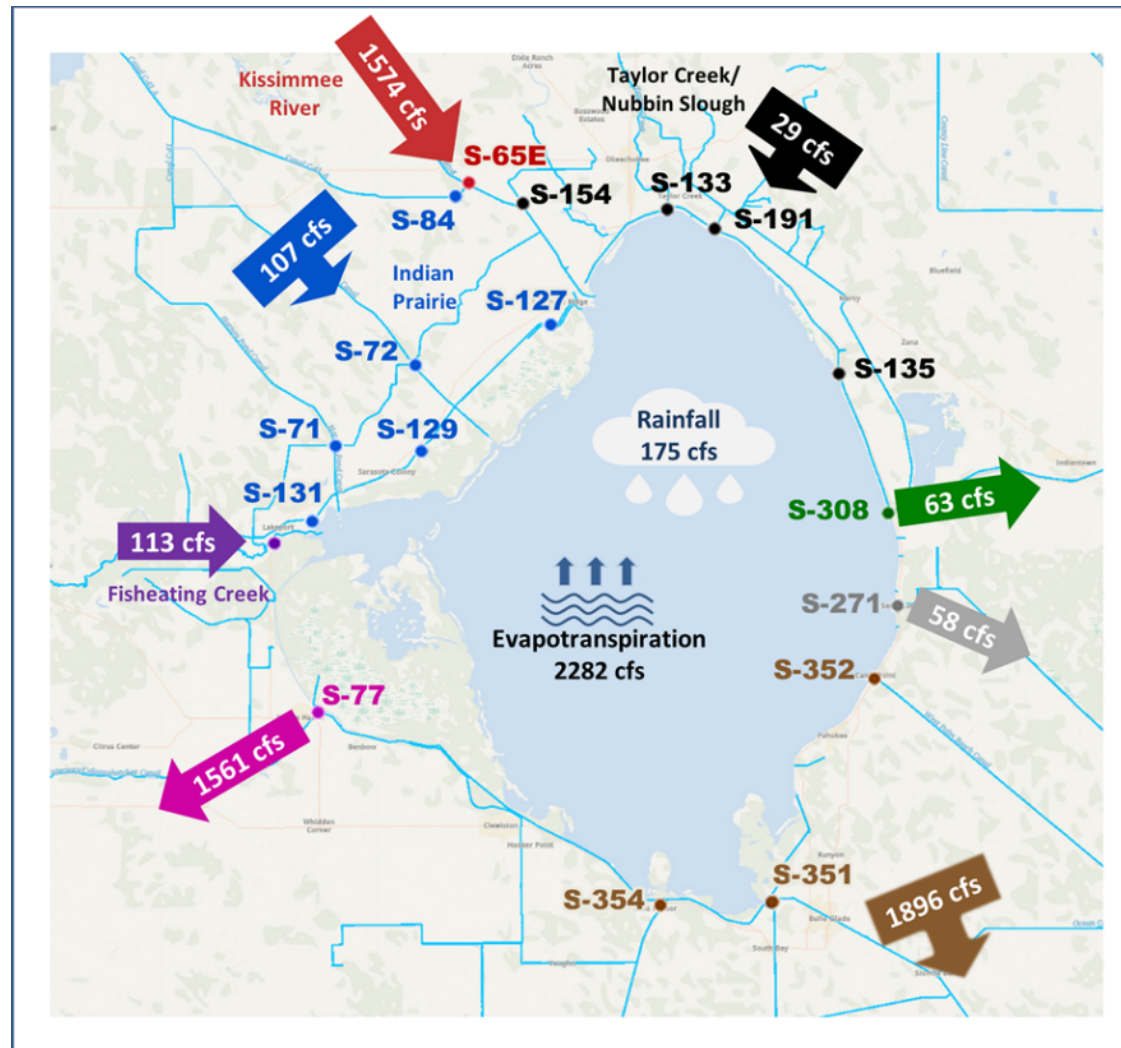
**Figure LO-5.** Inflows into Lake Okeechobee from Indian Prairie basins, Taylor Creek/Nubbin Slough, Kissimmee River and Fisheating Creek, and outflows to the west via S-77, to the east via S-308, to the south via S-351, S-352, S-354, and to southeast via S-271 (formerly Culvert 10A) for the week of November 06 – November 12, 2023.

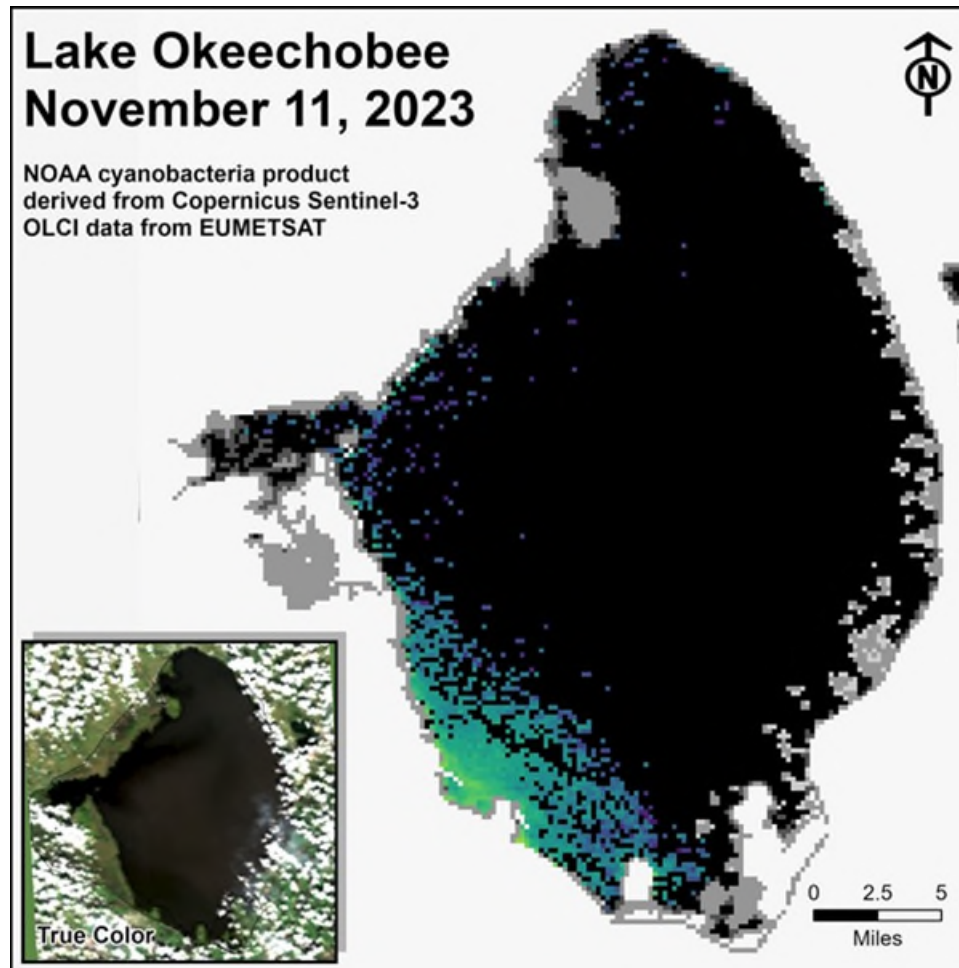
**Figure LO-6.** Cyanobacteria bloom index level on November 11, 2023, based on NOAA's harmful algal bloom monitoring system. Gray color indicates cloud cover.

The cyanobacteria index level was low to moderate in the southwestern and western regions of the Lake according to the November 11, 2023, satellite image from NOAA's Harmful Algal Bloom Monitoring System (**Figure LO-6**). All data presented in this report are provisional and are subject to change.

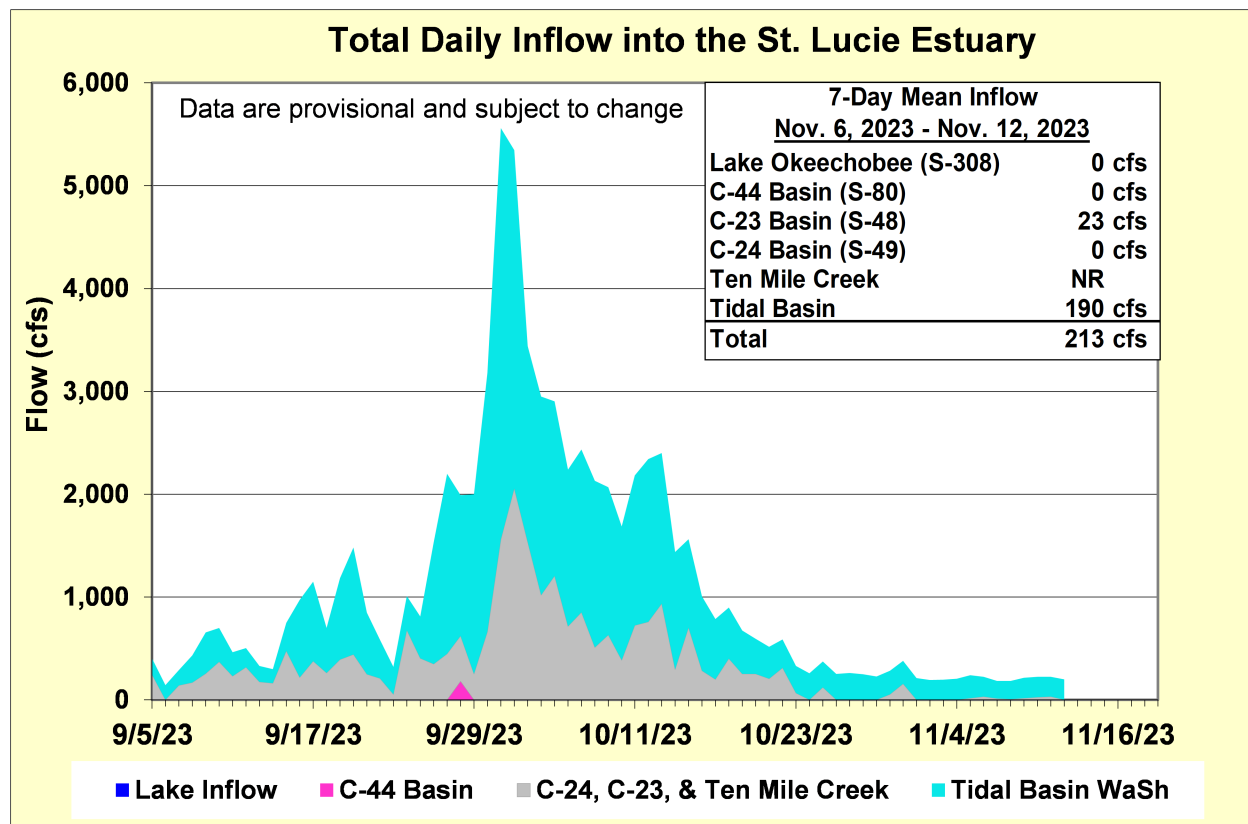
**Figure ES-2.** Total daily inflows from Lake Okeechobee and runoff from the C-44, C-23, C-24, Ten Mile Creek, and Tidal Basins into the St. Lucie Estuary.

Over the past week, mean total inflow to the St. Lucie Estuary was 213 cfs (**Figures ES-1 and ES-2**), and the previous 30-day mean inflow was 440 cfs. For comparison, the historical provisional mean inflows from the contributing areas are shown in **Figure ES-2**.

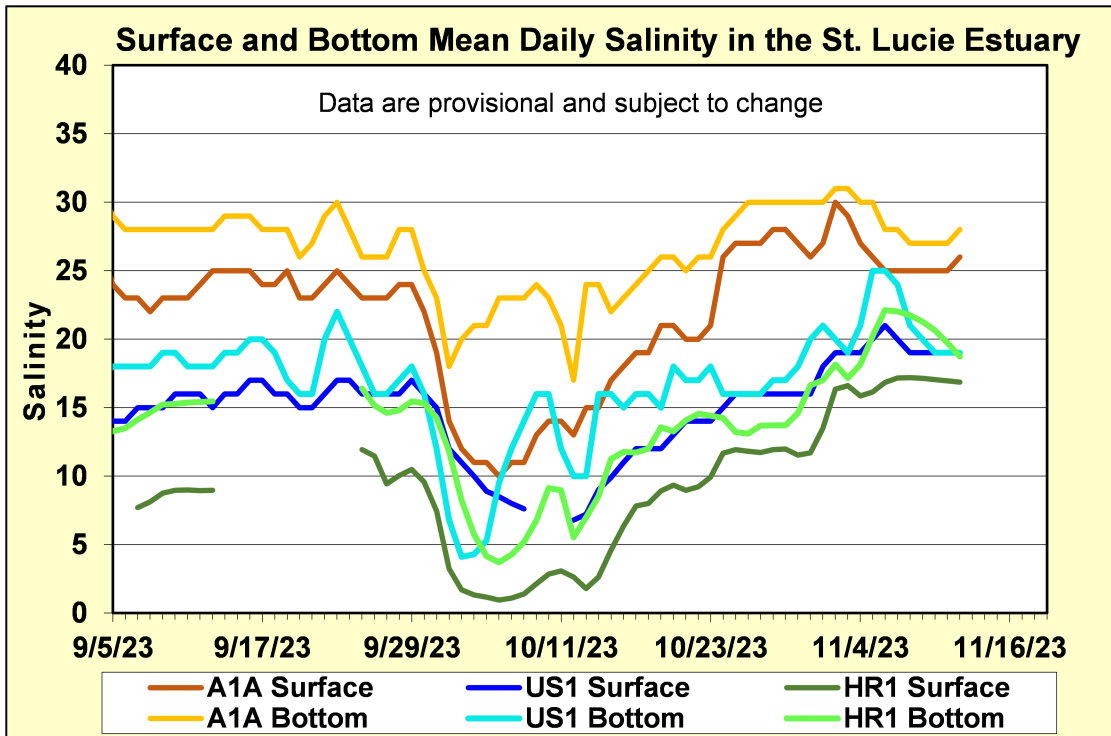
**Figure ES-3.** Mean daily salinity at the A1A, US1 and HR1 sites in the St. Lucie Estuary.

Over the past week, salinities increased at the HR1 and US1 Bridge sites and decreased at the A1A Bridge site (**Table ES-1 and Figure ES-3**). The seven-day moving average of the surface and bottom salinities at the US1 Bridge was 20.2. Salinity conditions in the middle estuary were estimated to be within the optimal range for adult eastern oysters (**Figure ES-4**). The mean larval oyster recruitment rate reported by the Fish and Wildlife Research Institute (FWRI) was 3.1 spat/shell for October, which was an increase from September (**Figure ES-5**).
