## **M E M O R A N D U M**

**FROM:** SFWMD Staff Environmental Advisory Team

**DATE:** November 15, 2023

**SUBJECT:** Weekly Environmental Conditions for Systems Operations

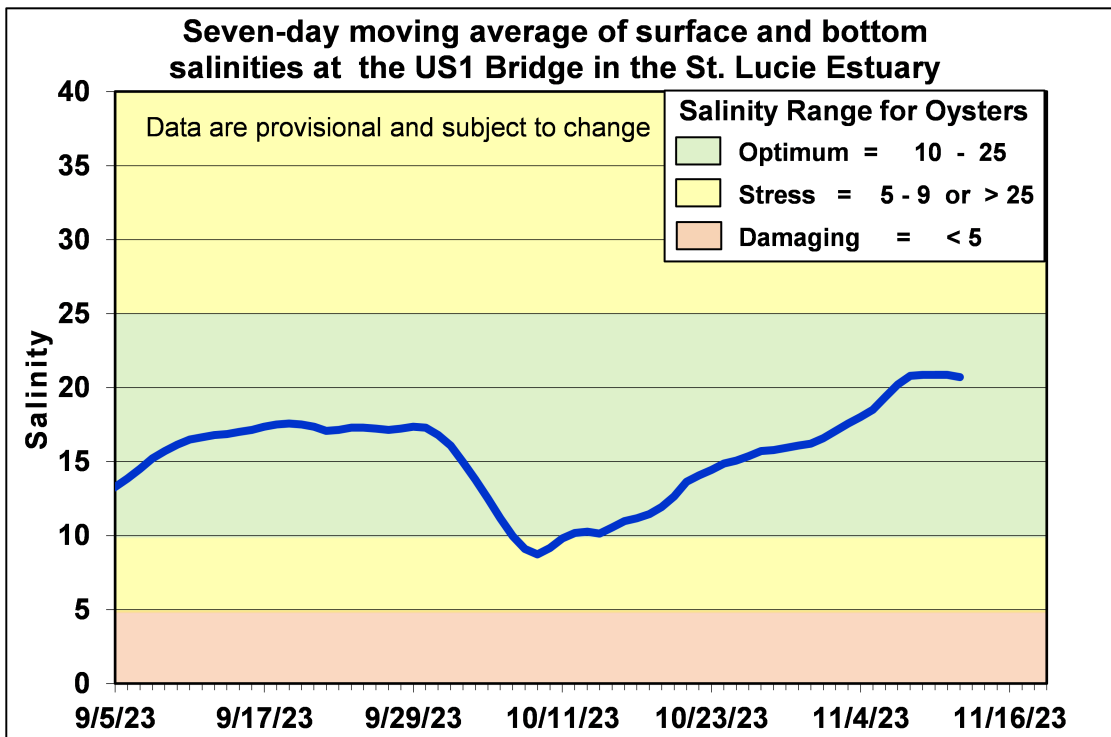
**Figure ES-4.** Seven-day moving average of the surface and bottom salinities at the US1 Bridge in the St. Lucie Estuary.

Over the past week, salinities increased at the HR1 and US1 Bridge sites and decreased at the A1A Bridge site (**Table ES-1 and Figure ES-3**). The seven-day moving average of the surface and bottom salinities at the US1 Bridge was 20.2. Salinity conditions in the middle estuary were estimated to be within the optimal range for adult eastern oysters (**Figure ES-4**). The mean larval oyster recruitment rate reported by the Fish and Wildlife Research Institute (FWRI) was 3.1 spat/shell for October, which was an increase from September (**Figure ES-5**).

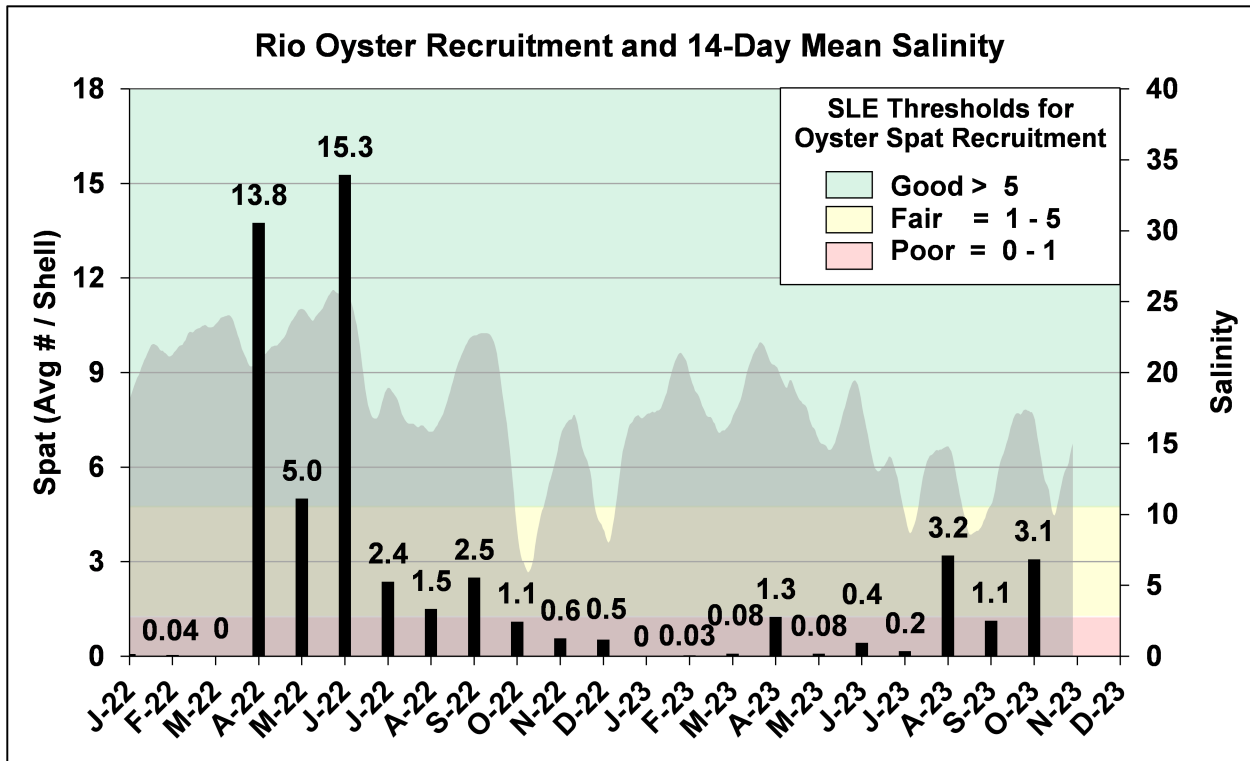
**Figure ES-5.** Mean oyster recruitment at the Rio oyster monitoring station and 14-day mean salinity at US1 Bridge.

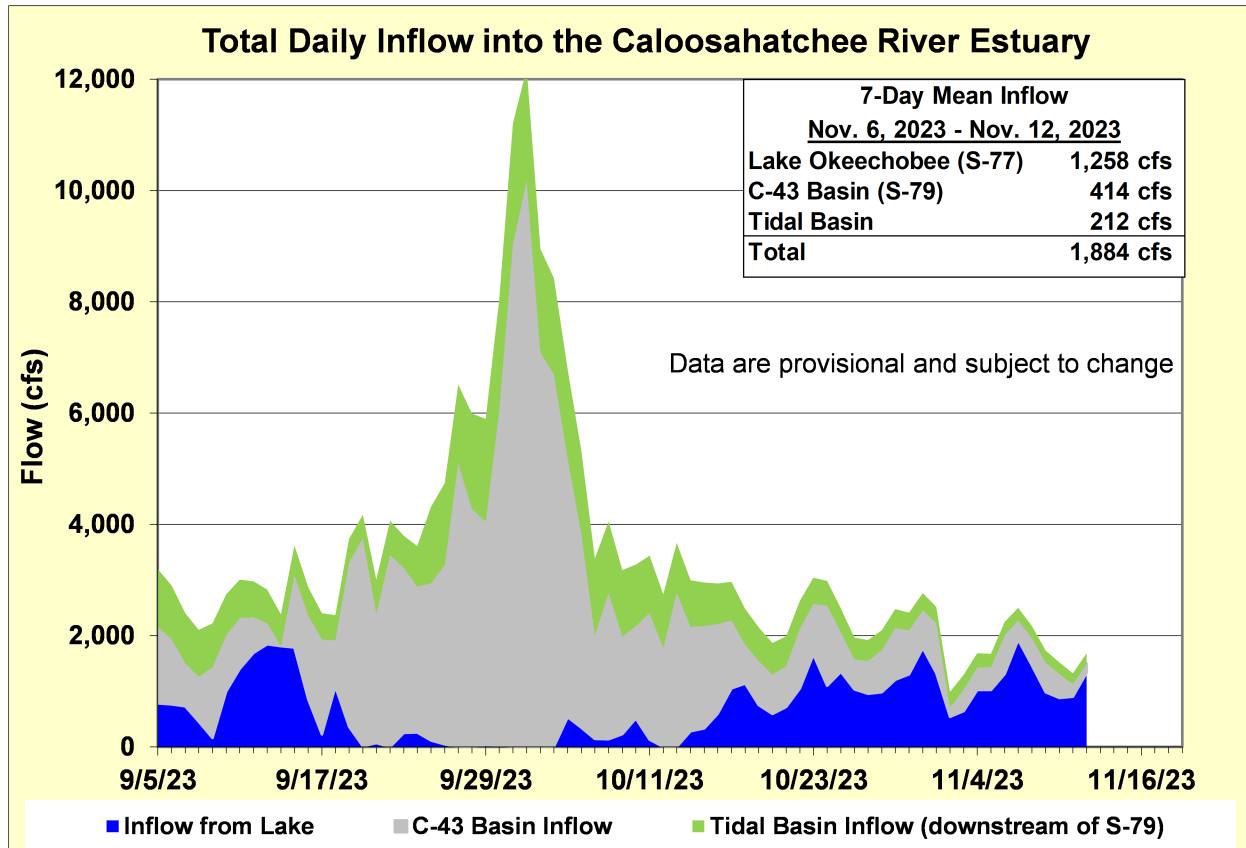
**Figure ES-7.** Total daily inflows from Lake Okeechobee, and runoff from the C-43 and Tidal basins into the Caloosahatchee River Estuary.

Over the past week, mean total inflow to the Caloosahatchee River Estuary was 1,884 cfs (**Figures ES-6 and ES-7**), and the previous 30-day mean inflow was 2,216 cfs. For comparison, the historical provisional mean inflows from the contributing areas are shown in **Figure ES-7**.

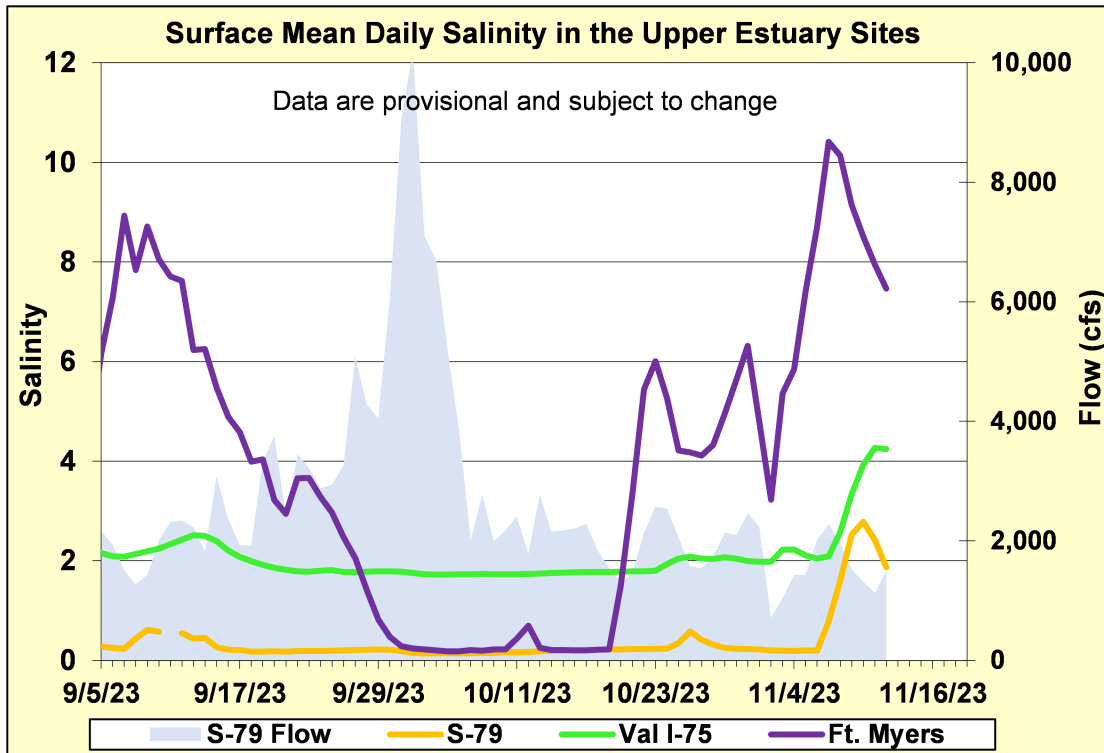
**Figure ES-8.** Mean daily salinity at upper Caloosahatchee River Estuary monitoring sites and mean daily flow at S-79.

Over the past week, salinities increased at all sites in the estuary (**Table ES-2 and Figures ES-8 and ES-9**). The seven-day mean salinities (**Table ES-2**) were in the optimal range (0-10) for tape grass in the upper estuary. The seven-day mean salinity values were within the optimal range for adult eastern oysters at Cape Coral and in the upper stressed range at Shell Point and Sanibel (**Figure ES-10**). The mean larval oyster recruitment rate reported by the Fish and Wildlife Research Institute was 0.2 spat/shell at Iona Cove and 3.3 spat/shell at Bird Island for October, which was an increase from September (**Figures ES-11 and ES-12**).

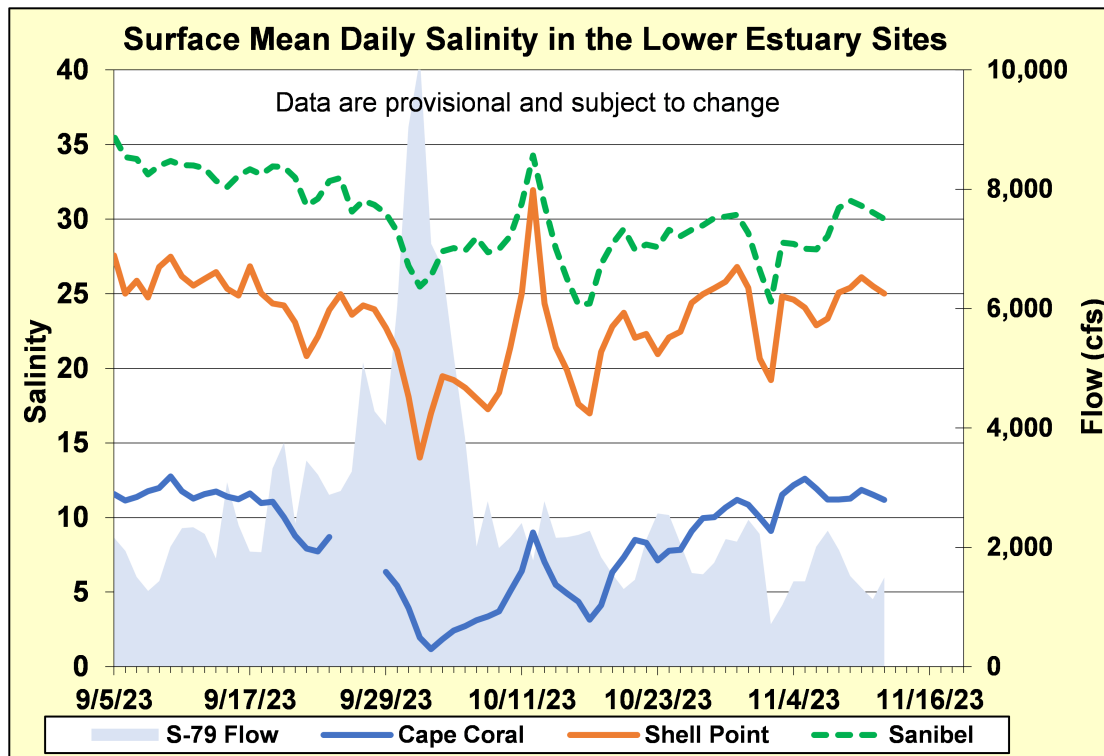
**Figure ES-9.** Mean daily surface salinity at lower Caloosahatchee River Estuary monitoring sites and mean daily flow at S-79.

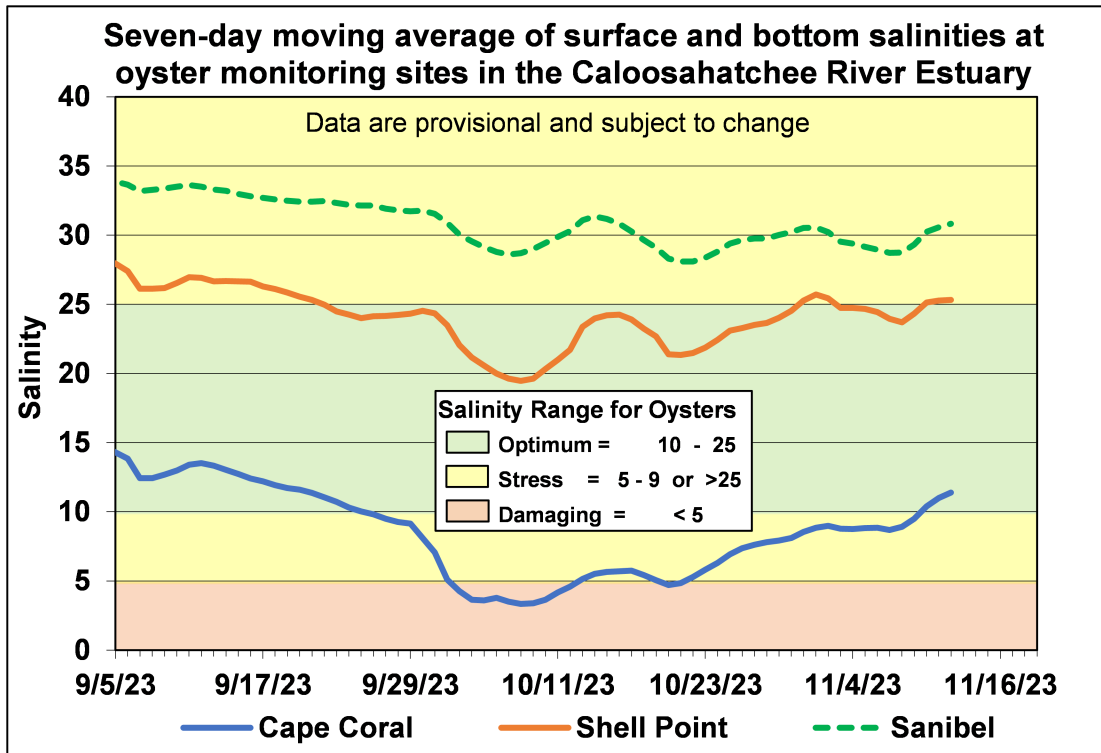
**Figure ES-10.** Seven-day moving average of surface and bottom salinities at Cape Coral, Shell Point and Sanibel monitoring sites in the Caloosahatchee River Estuary.

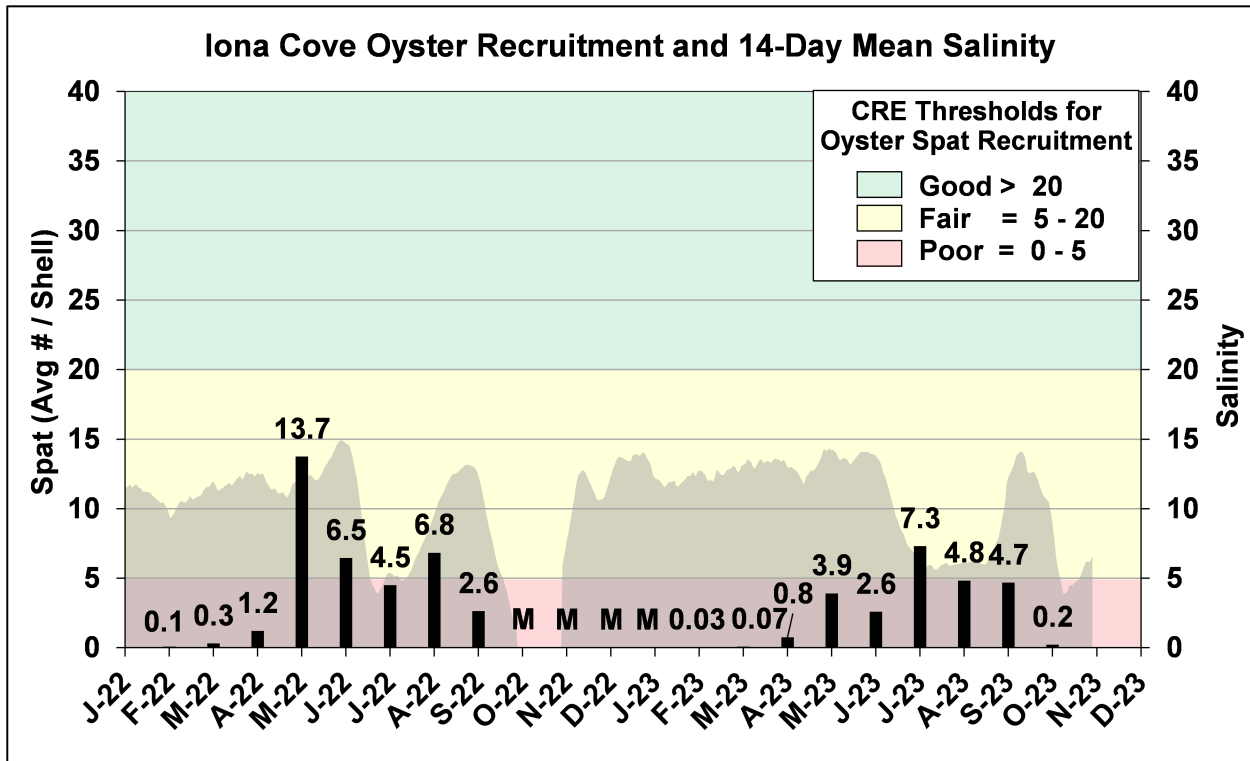
**Figure ES-11.** Mean oyster recruitment at the Iona Cove oyster monitoring station and 14-day mean salinity at Cape Coral.

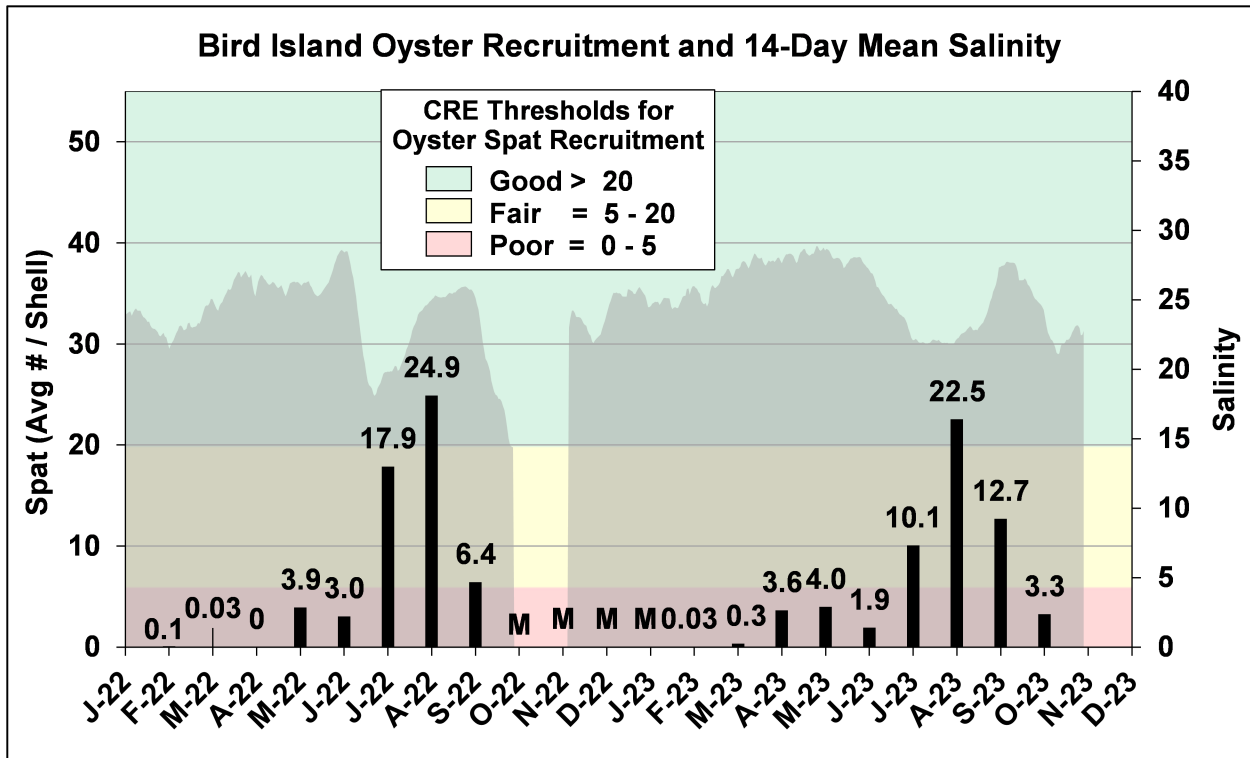
**Figure ES-12.** Mean oyster recruitment at the Bird Island oyster monitoring station and 14-day mean salinity at Shell Point.

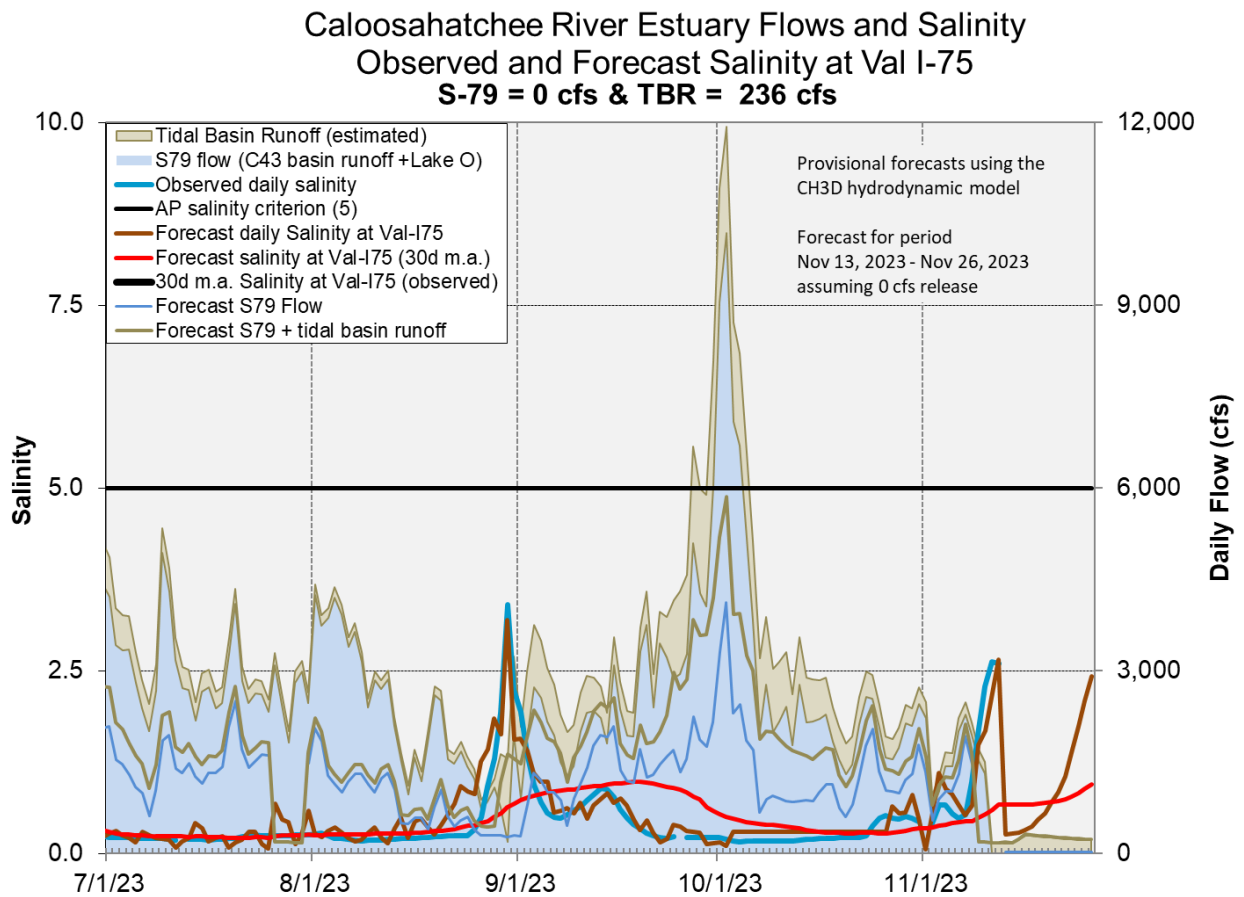
**Figure ES-13.** Forecasted Val I-75 site surface salinity assuming no pulse release at S-79.

Surface salinity at Val I-75 was forecasted for the next two weeks using an autoregression model (Qiu and Wan, 2013<sup>1</sup>) coupled with a linear reservoir model for the tidal basin. Model scenarios included pulse releases at S-79 ranging from 0 to 1,500 cfs, and a steady release at 2,000 cfs with estimated tidal basin inflows of 236 cfs. Model results from all scenarios predict daily salinity to be 2.4 or lower and the 30-day moving average surface salinity to be 0.9 or lower at Val I-75 at the end of the two-week period (**Table ES-3 and Figure ES-13**). This keeps predicted salinities in the upper estuary within the optimal salinity range (0-10) for tape grass.

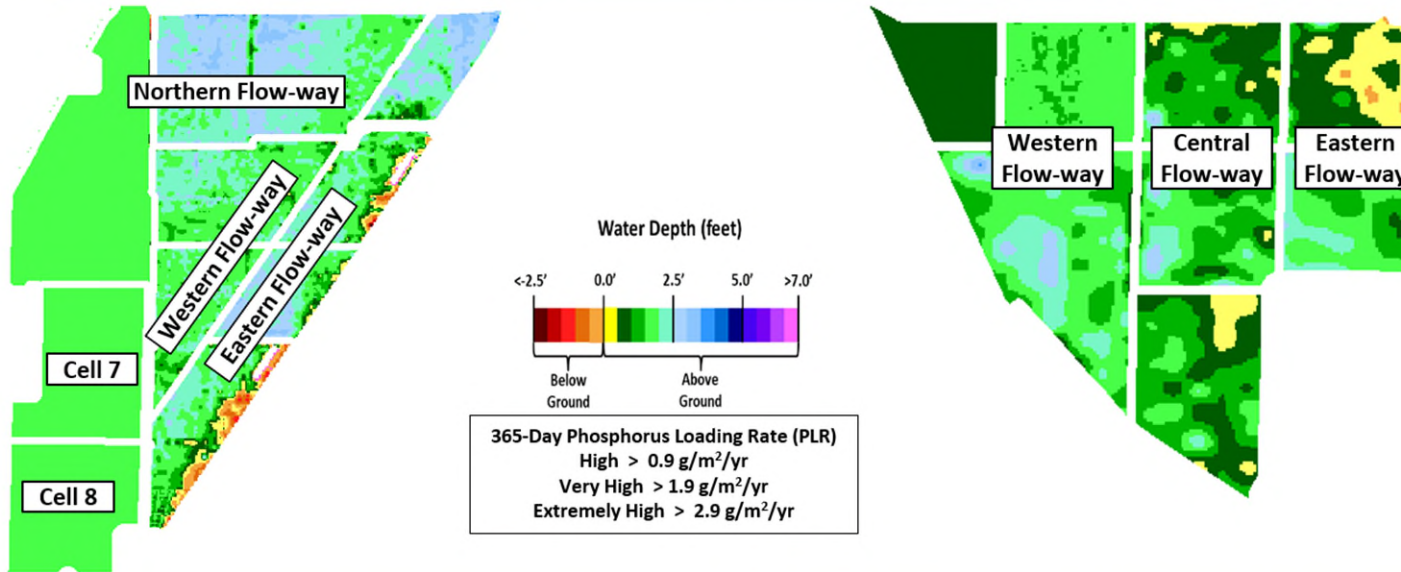
STA-1W	Flow-way Status
<b>Western</b>	<ul style="list-style-type: none"> <li>High 365-day PLR</li> <li>Highly stressed vegetation conditions</li> </ul>
<b>Eastern</b>	<ul style="list-style-type: none"> <li>High 365-day PLR</li> <li>Highly stressed vegetation conditions</li> </ul>
<b>Northern</b>	<ul style="list-style-type: none"> <li>Highly stressed vegetation conditions</li> <li>Planting emergent vegetation</li> </ul>
<b>Cell 7</b>	<ul style="list-style-type: none"> <li>Stressed vegetation conditions</li> </ul>
<b>Cell 8</b>	<ul style="list-style-type: none"> <li>Construction activities</li> </ul>

STA-1E	Flow-way Status
<b>Western</b>	<ul style="list-style-type: none"> <li>Offline for post-construction vegetation grow-in</li> </ul>
<b>Central</b>	<ul style="list-style-type: none"> <li>Highly stressed vegetation conditions</li> </ul>
<b>Eastern</b>	<ul style="list-style-type: none"> <li>High 365-day PLR</li> <li>Stressed vegetation conditions</li> </ul>

**Figure S-1.** Eastern Flow Path Weekly Status Report

**STA-1E:** STA-1E Western Flow-way is offline for post-construction vegetation grow in. Online treatment cells are near target stage. Vegetation in the flow-ways is stressed and highly stressed. The 365-day phosphorus loading rate (PLR) for the Central Flow-way is high and the 365-day PLR for the Eastern Flow-way is below 1.0 g/m<sup>2</sup>/year. (**Figure S-1**).

**STA-1W:** An operational restriction is in place in STA-1W Northern Flow-way for vegetation management activities. Treatment cells are near target stage. Vegetation in the flow-ways is stressed and highly stressed. The 365-day PLRs for the Eastern and Western Flow-ways are high, and the 365-day PLR for the Northern Flow-ways is below 1.0 g/m<sup>2</sup>/year (**Figure S-1**).

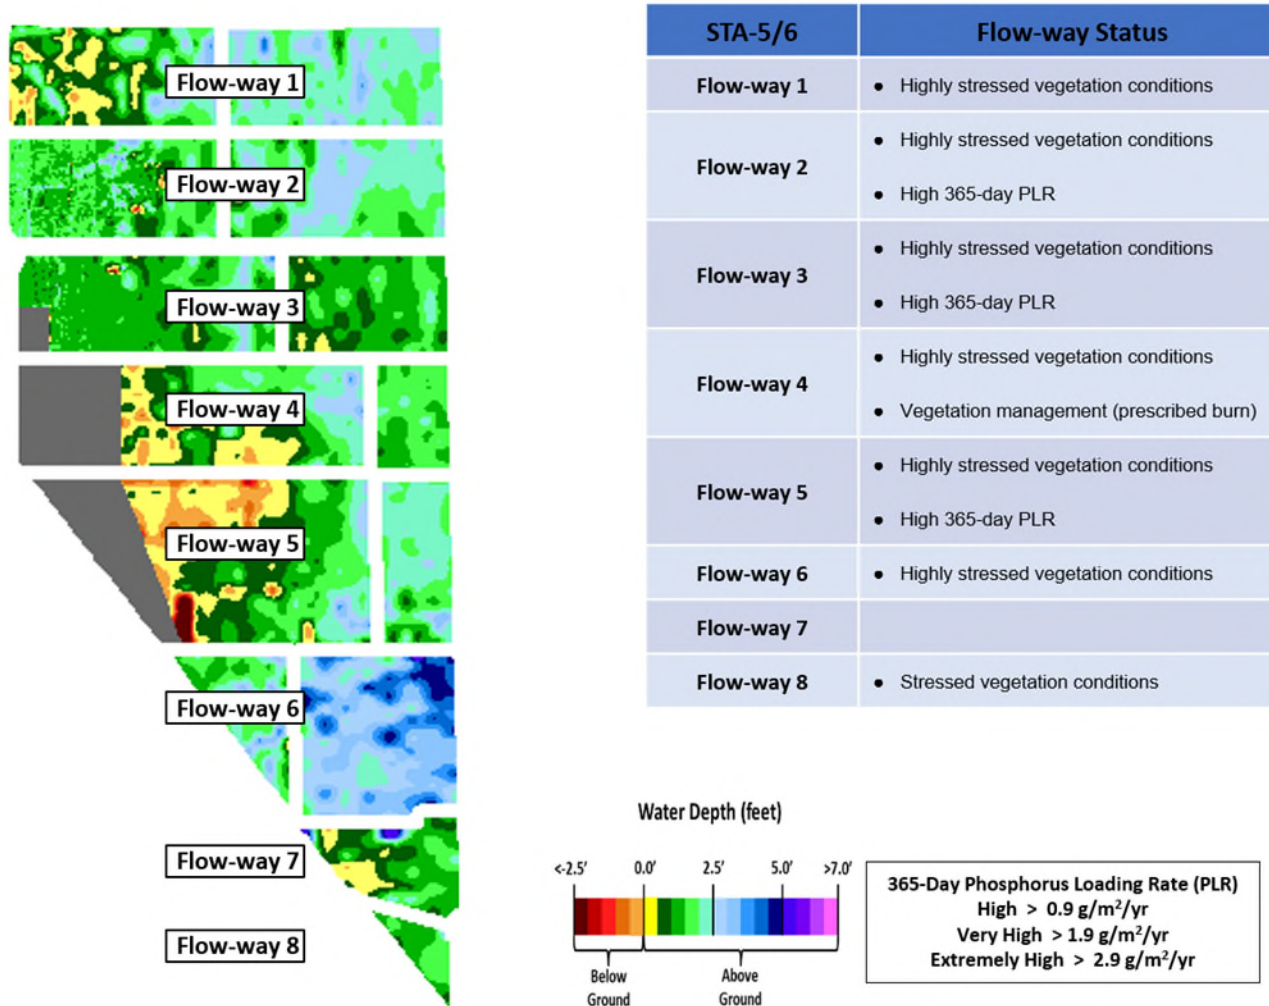
**Figure S-3.** Western Flow Path Weekly Status Report

**STA-5/6:** An operational restriction is in place in Flow-way 4 for vegetation management (prescribed burn). Most treatment cells are near target stage. All treatment cells have highly stressed or stressed vegetation conditions except Flow-ways 7 which is healthy. The 365-day PLRs for Flow-ways 1, 4, 6, 7, and 8 are below 1.0 g/m<sup>2</sup>/year, and the 365-day PLRs for Flow-ways 2, 3, and 5 are high. (**Figure S-3**).

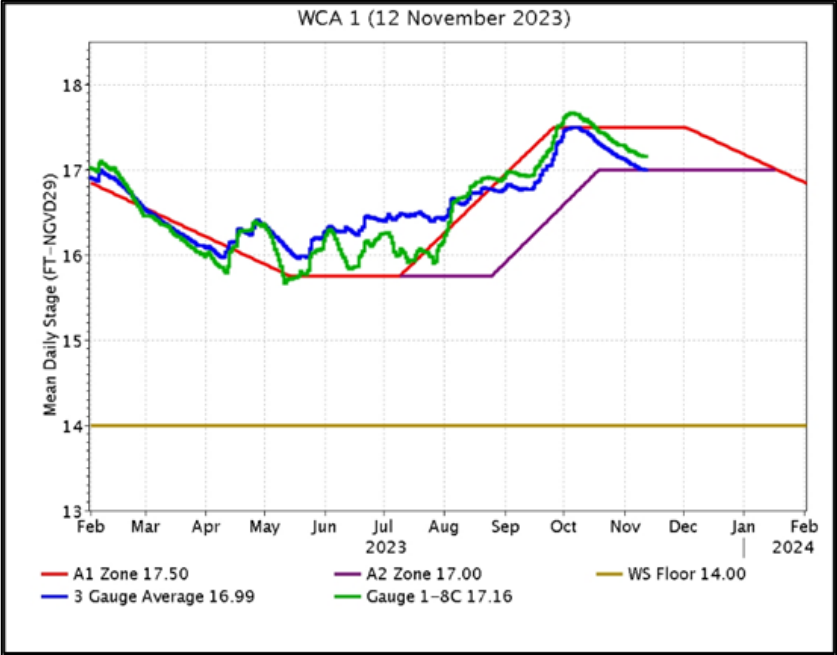
Figure EV-1. WCA-1 stage hydrographs and regulation schedule.

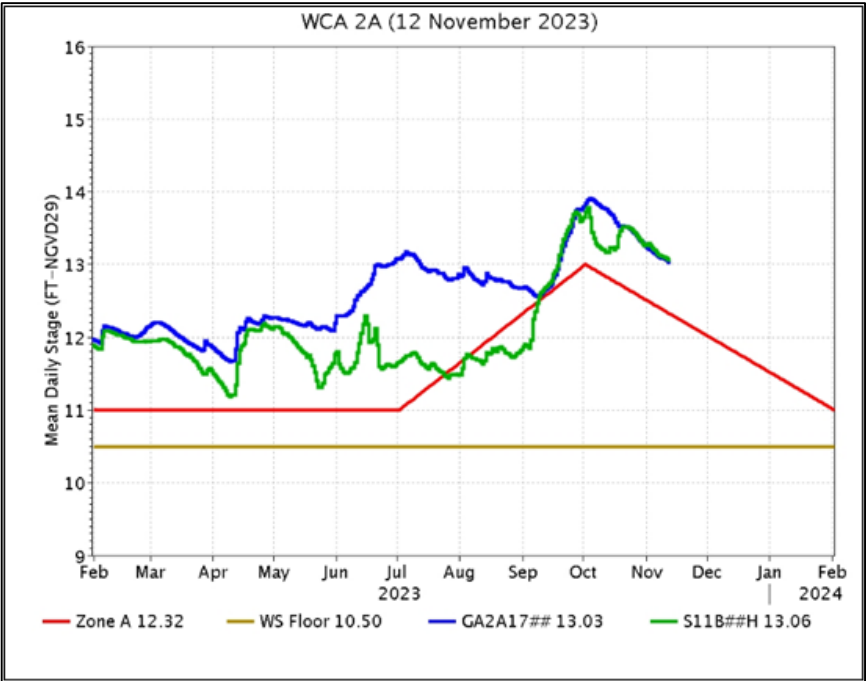
Figure EV-2. WCA-2A stage hydrographs and regulation schedule.

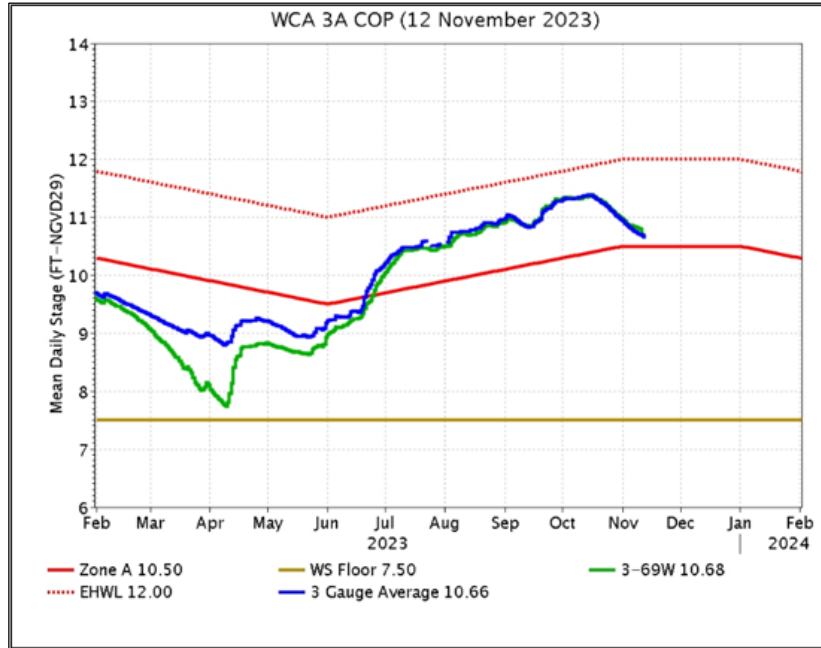
**Figure EV-3.** WCA-3A stage hydrographs (three-gauge average, 3-69W) and regulation schedule.

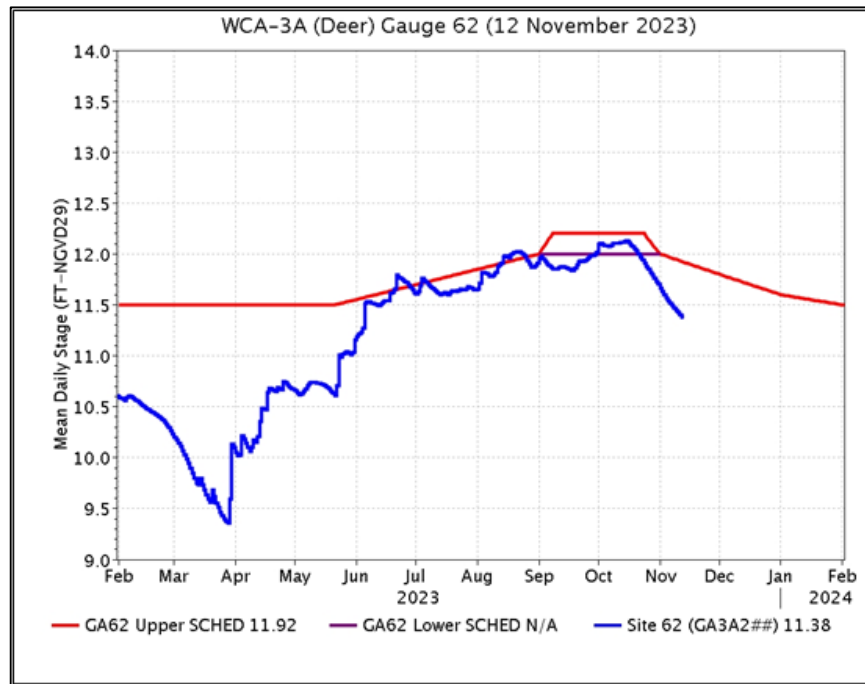
**Figure EV-4.** WCA-3A stage hydrograph (Deer gauge; Site 62) and GA62 regulation schedule.

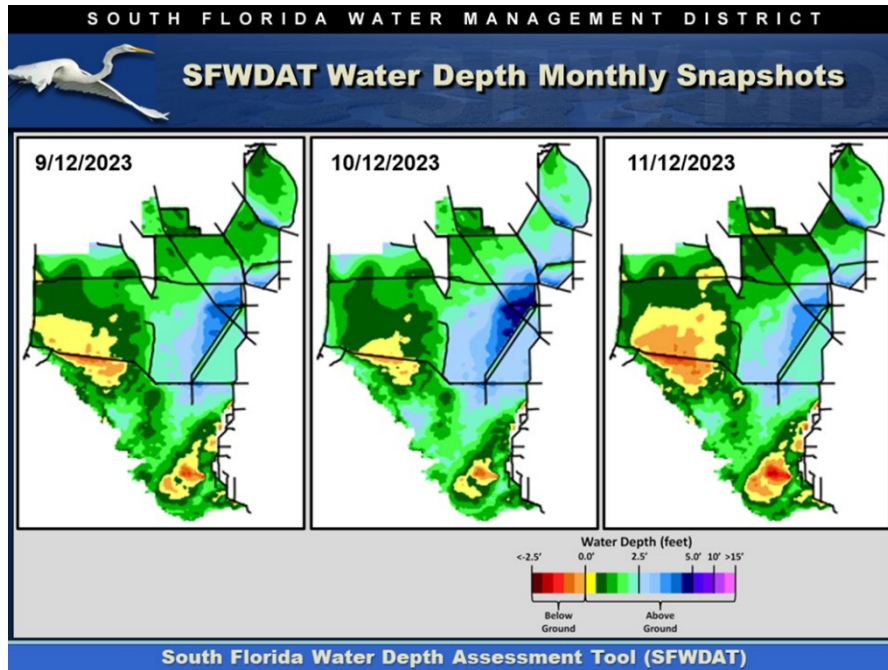
**Figure EV-5.** Everglades water depths from two months ago (left), one month ago (center) and present (right), based on SFWDAT.

The SFWDAT tool illustrates water depths have receded along the upper reaches of the L-67s. Pondered in the southern portions of WCA-3A but the spatial extent of flooded areas is contracting. Hydrologic connectivity is strong within all the major sloughs of ENP. The area with the potential for significantly below ground stages in southern BCNP continues to expand, and conditions look drier in eastern rocky glades of ENP. Comparing current WDAT water depths to one month ago conditions across the Everglades are significantly drier especially in northern WCA-2A and downstream of the S-11s in WCA-3A. Looking back a year ago, conditions are slightly drier in the north and west, slightly wetter in the south. (**Figure EV-5** and **Figure EV-6**).

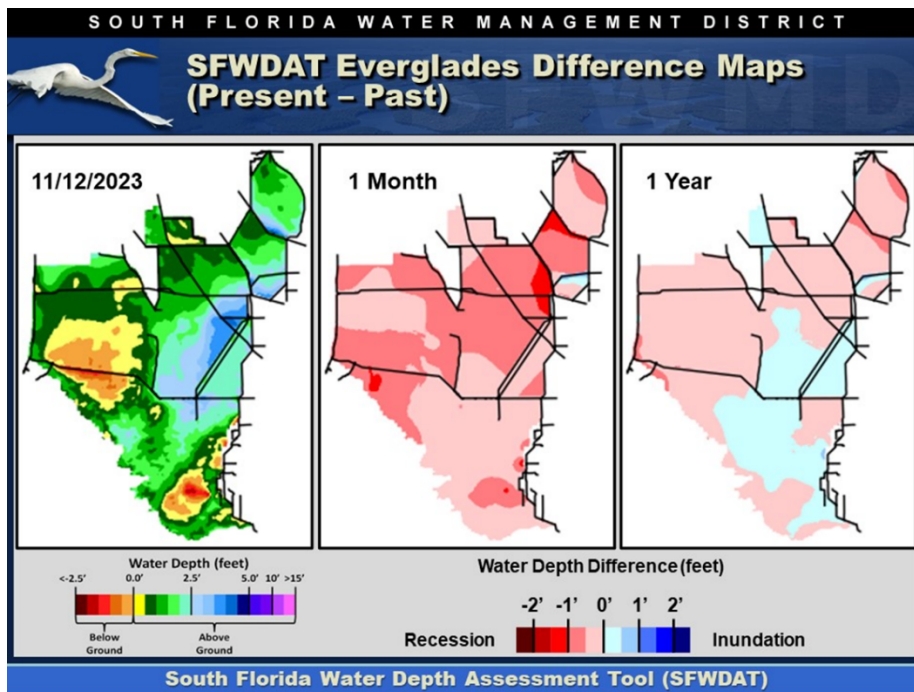
**Figure EV-6.** Present Everglades water depths (left) and water depth changes from one month (center) and one year (right) ago, based on SFWDAT.

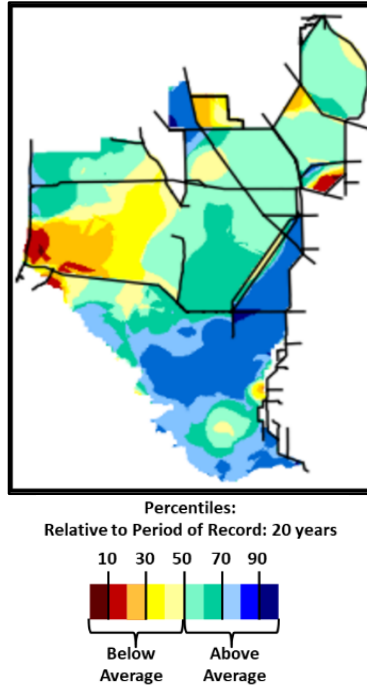
**Figure EV-7.** Present water depths (11/12/2023) compared to the day of year average over the previous 20 years.

Comparing current conditions to the 20-year average on November 12th: Above average depth conditions continue in WCA-3B and northeastern ENP, but to the north conditions are trending towards average or below ecologically problematic in historically overdried regions like northern WCA-2A and -3A (**Figure EV-7**).

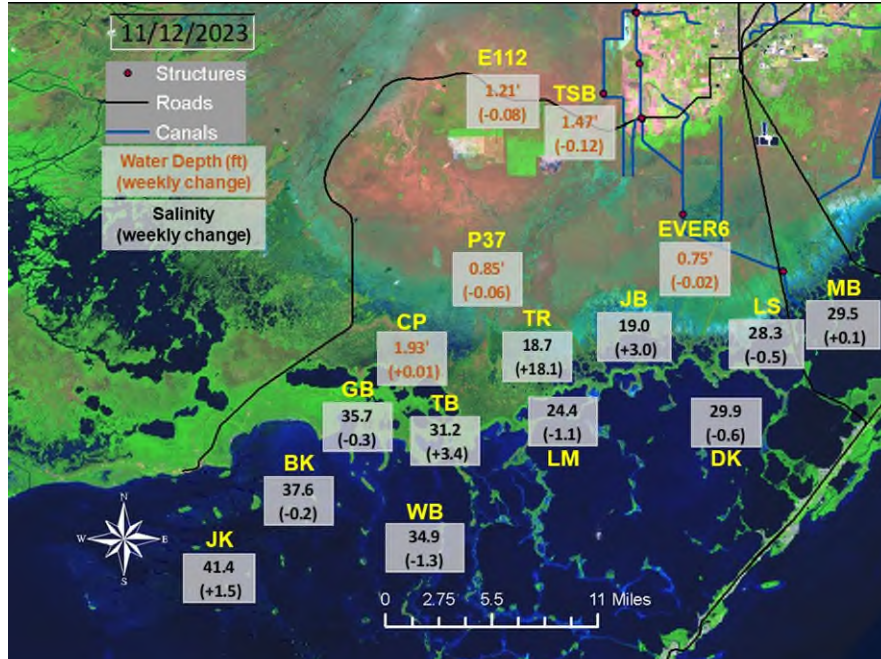
**Figure EV-8.** Taylor Slough water depths with changes since a week ago and Florida Bay salinities with changes since a week ago.

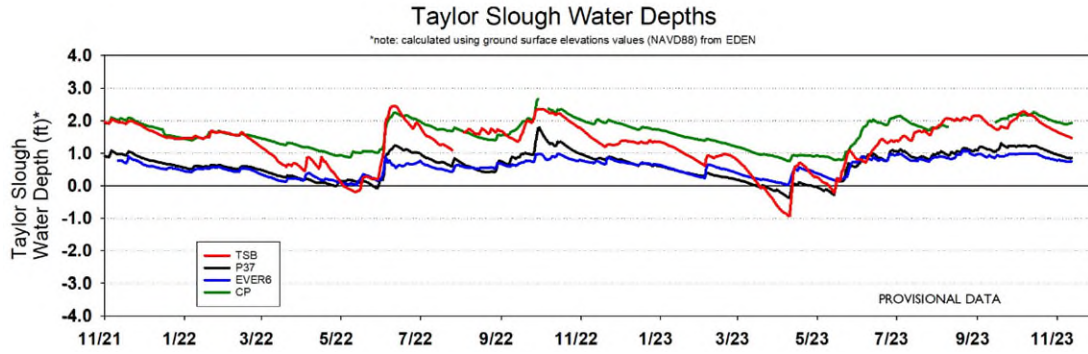
**Figure EV-9.** Taylor Slough water depth time series.

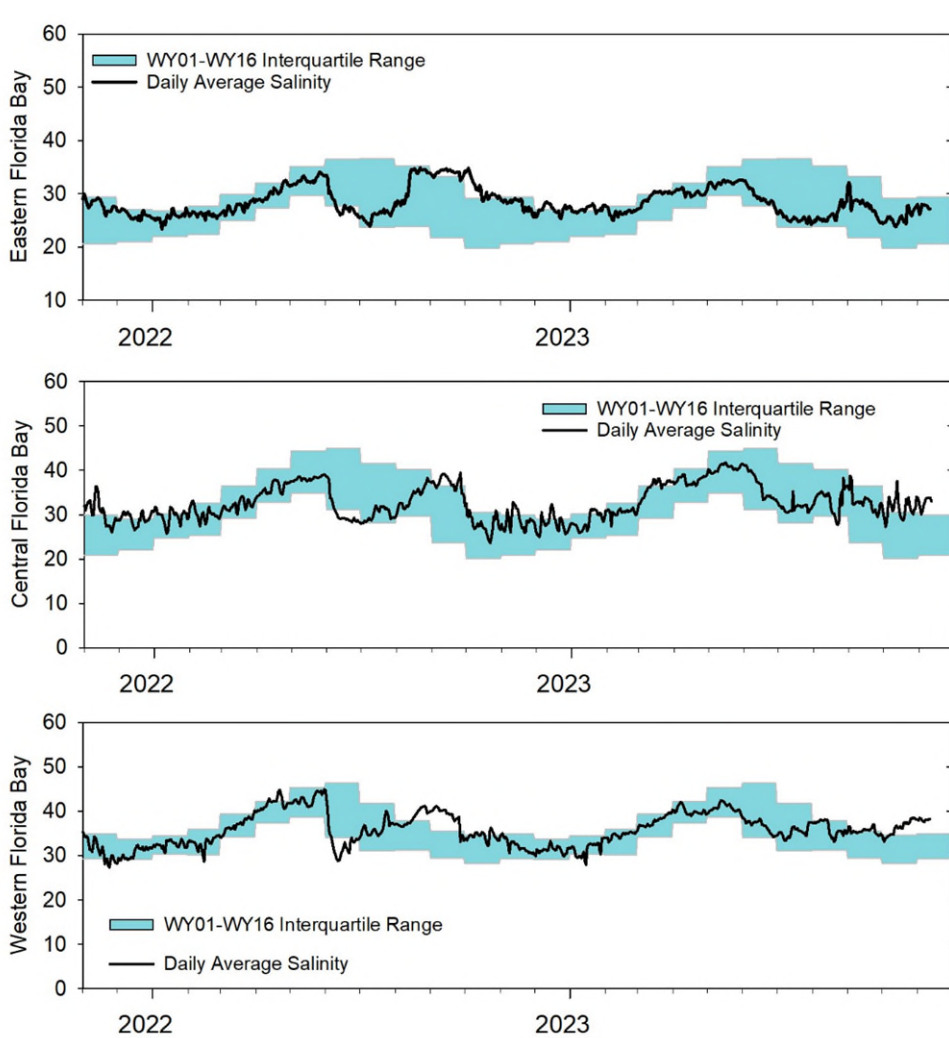
**Figure EV-10.** Eastern (top panel), Central (middle panel) and Western (bottom panel) Florida Bay daily average salinities with interquartile (25-75 percentile) ranges.

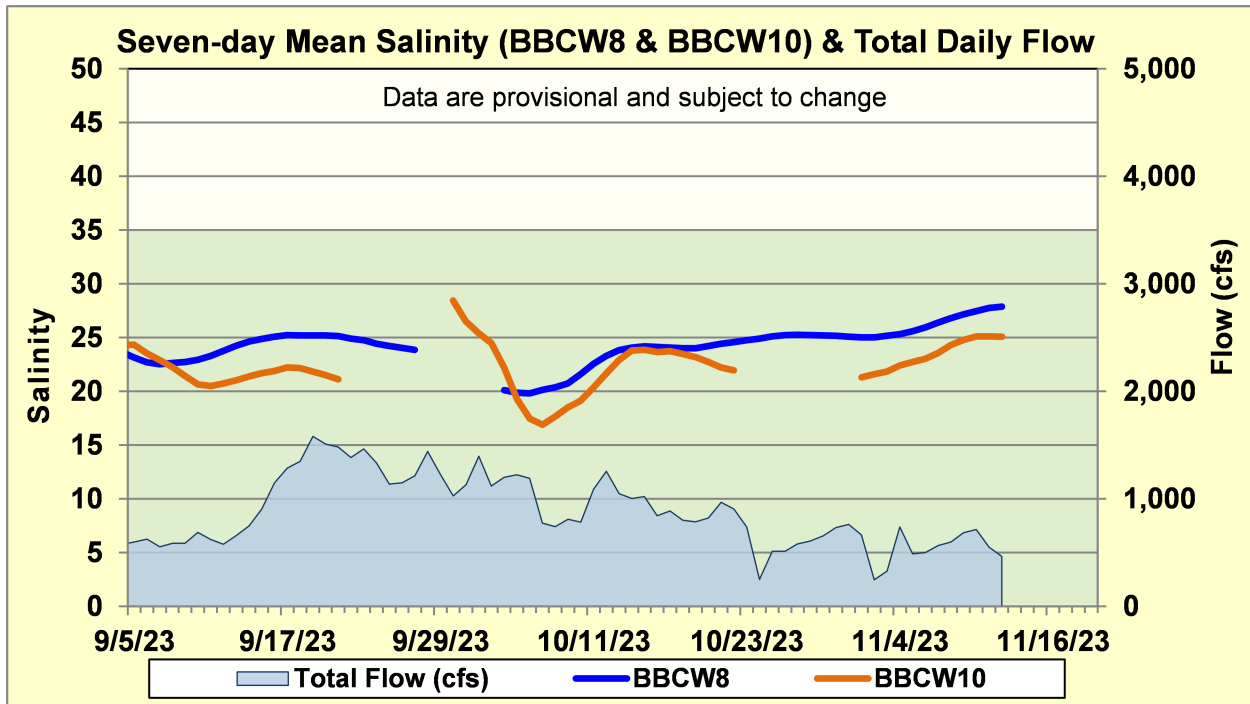
**Figure BB-1.** Seven-day mean salinity at BBCW8 and BBCW10 and total daily flow in Biscayne Bay. Total daily flow was calculated using flow from structures S20G, S20F, S21, S21A, S123, and S700P.

As shown in **Figure BB-1**, mean total inflow to Biscayne Bay was 584 cfs, and the previous 30-day mean inflow was 665 cfs. The seven-day mean salinity was 27.9 at BBCW8 and 24.6 at BBCW10, both within the ideal salinity range for estuarine organisms in this region (salinity less than 35). Data were provided by Biscayne National Park.
